**FINAL**  
KNKT.11.03.08.04

**Aircraft Accident Investigation Report**

**Aero Flyer Institute  
Cessna 172 ; PK-HAF  
Cakrabhuwana Airport, Cirebon, West Java  
Republic of Indonesia**

**4 March 2011**

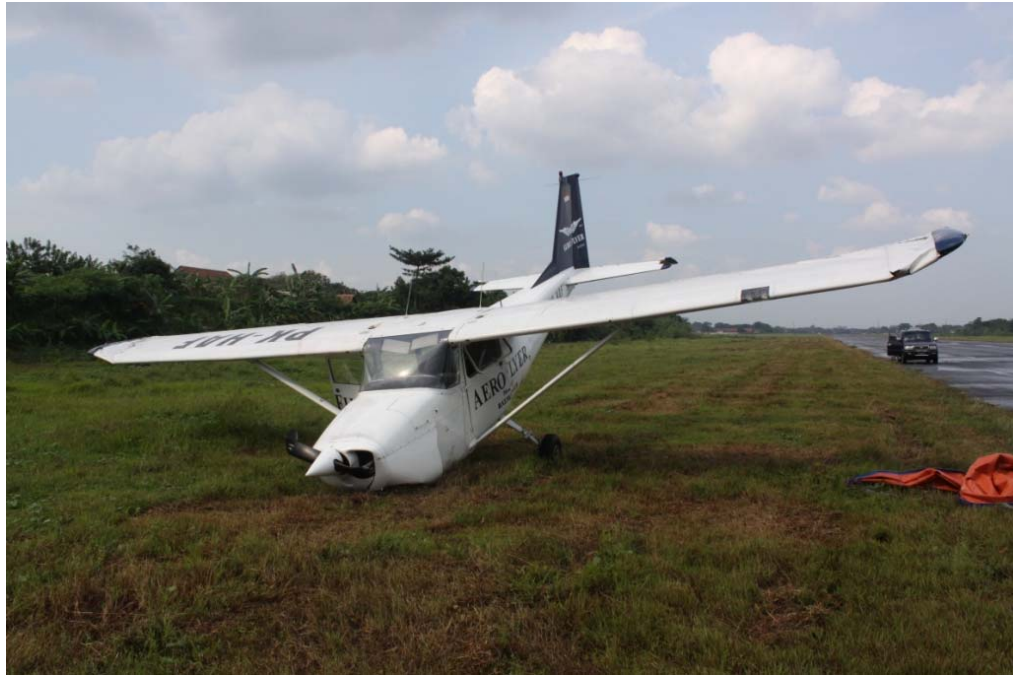
**Figure 1: The last aircraft position**

The aircraft veered to the left and out of the runway, the aircraft stopped on left shoulder opposite the landing direction runway 04, at the coordinate of 6° 44' 11" S 108° 33' 50" E.

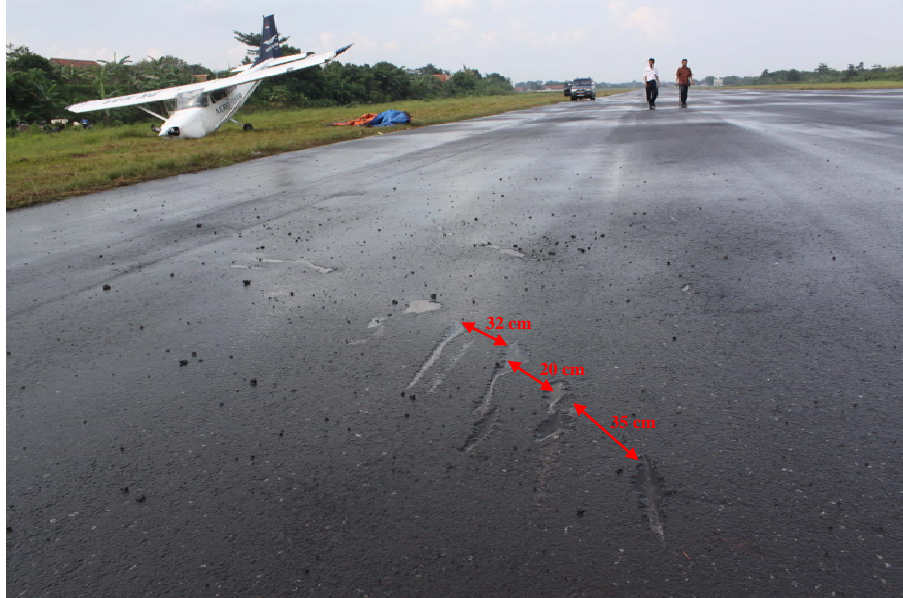
Figure 2: Scratch on the runway surface

The runway surface was scratched at the propeller impact point.

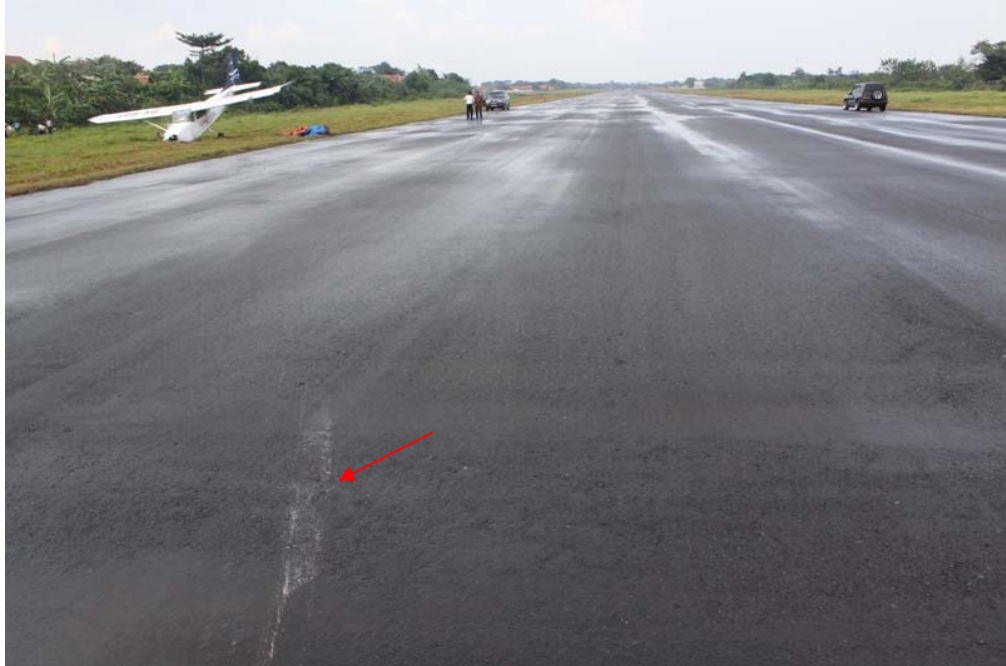
**Figure 3: The left wing tip paint mark**

The aircraft stopped on left shoulder about 23 meters from runway centreline and 165 meters from beginning runway 04 with the aircraft heading opposite the landing direction runway 04. There was a paint mark indicated of the first impact of the left wing tip to the runway.
