FINAL
KNKT.11.02.05.04

Aircraft Accident Investigation Report

PK-LHH

Boeing 737-900ER

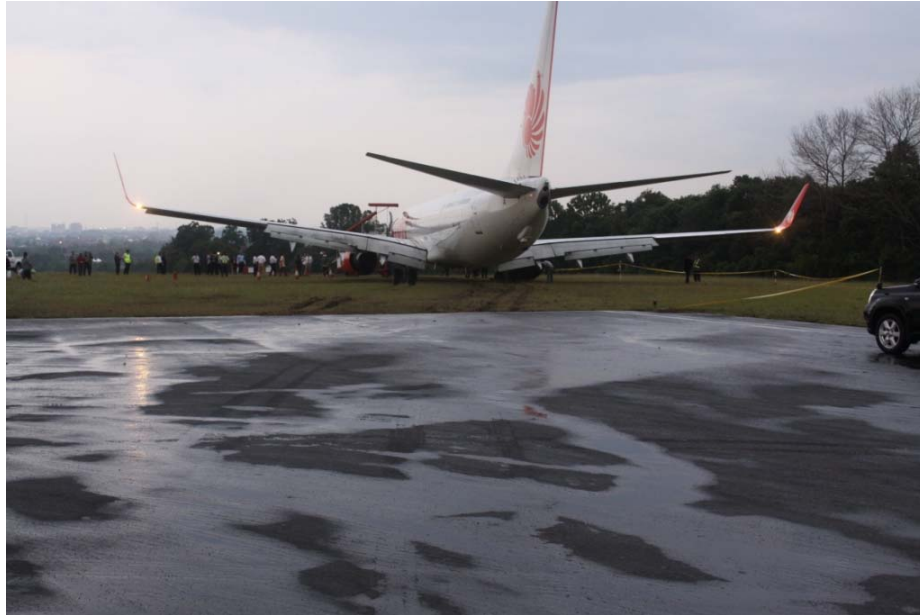
The aircraft stop approximately 12 meters at the right side from the end of the runway 36.

Figure 1: The aircraft position after the serious incident.

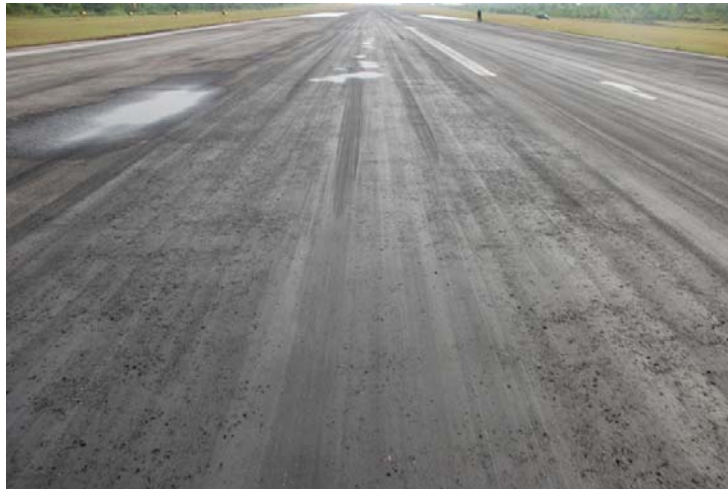
Figure 2: Rubber deposit on the touchdown zone runway 18.

The airport operator scheduled for rubber deposit removal on six month interval bases. The last runway rubber deposit removal was performed on 31 December 2010 on the end of runway 36 and the result was good. (refer to letter number BAC.14.09.04/12/2010/330)

The last runway overlay was performed at 2010. After the overlay, the runway skid resistance was measured by Mu meter. The measurement found that the skid resistance was 0.55 to 0.59. According to the DGCA Advisory Circular number SE.04 issued in 2012, the minimum skid resistance was 0.6.

At the day of the serious incident, the rubber deposit was found on the runway especially between the thresholds up to touch down zone runway 18 (see figure 2).

The runway skid resistance was found 0.55 to 0.59 which was measured after the overlay on 2010. The minimum runway skid resistance was 0.60. Runway examination found rubber deposit on the runway especially between the thresholds up to touch down zone runway 18. The runway skid resistance will decrease with the existing of rubber deposit.

1. The airport authority of Sultan Syarif Kasim II was revised the interval schedule for the rubber deposit cleaning. The previous cleaning schedule was 6 (six) months, the revised schedule became "*On Condition*", depends on the inspection result;
2. The airport authority of Sultan Syarif Kasim II was conducted some repair on runway surface to ensure the standing water will be eliminate;
3. The airport authority of Sultan Syarif Kasim II shall issue a notam³ to inform that the runway skid resistance was 0.55 and was below the minimum requirements of 0.60. This condition may result in poor braking action when the runway is wet.

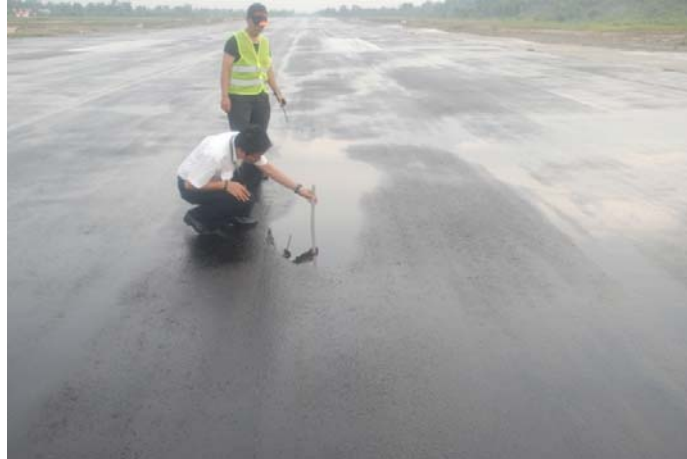
After the serious incident, the runway was examined for existing of standing water. It found several water spots on the runway up to 3 cm depth.

Figure 3: standing water examination performed 1 hour after rain.

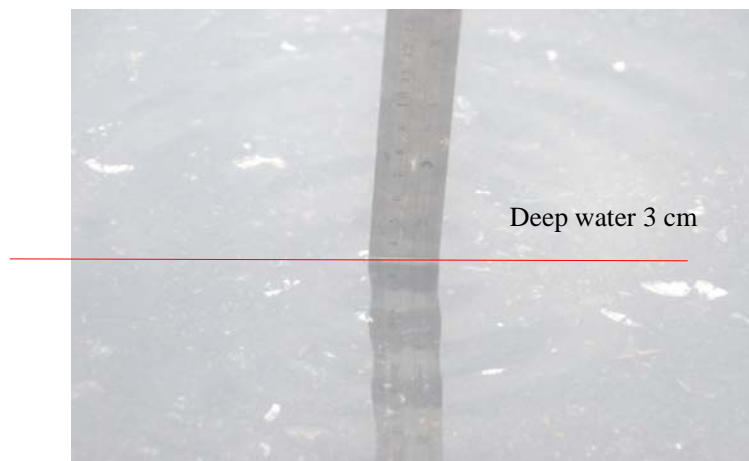
Figure 4: Standing water up to 3 cm.

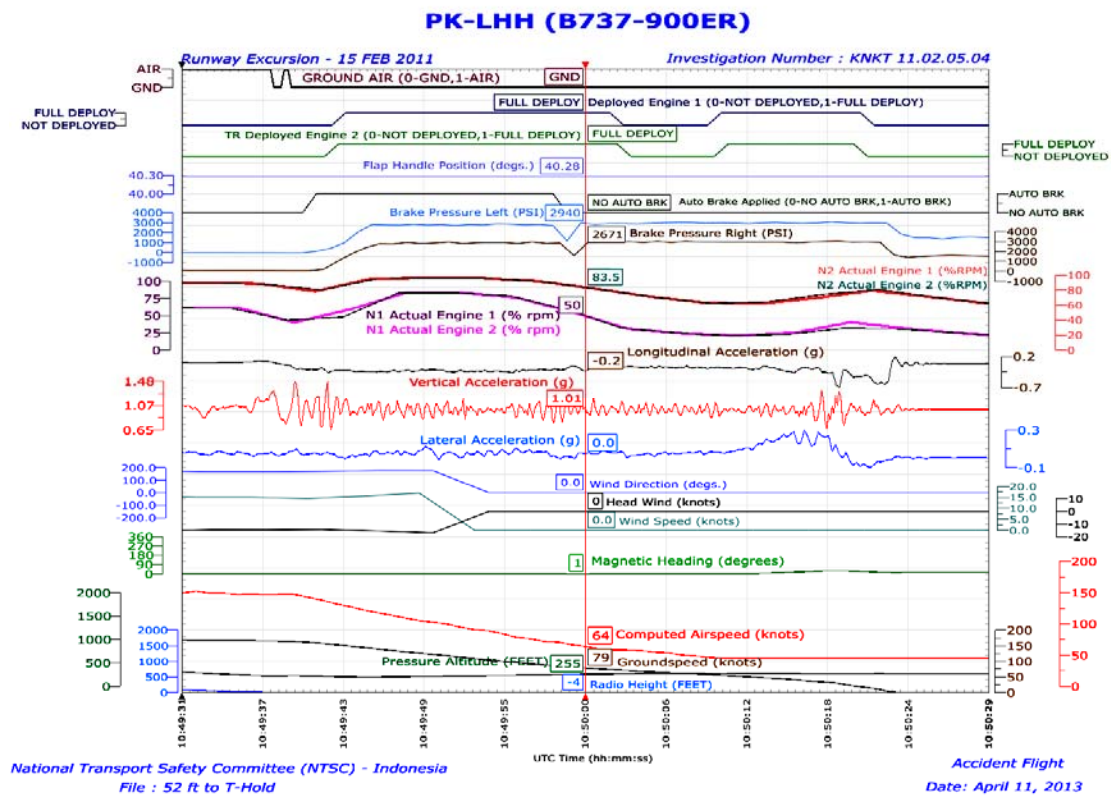
Figure 5: FDR data with special information during landing roll

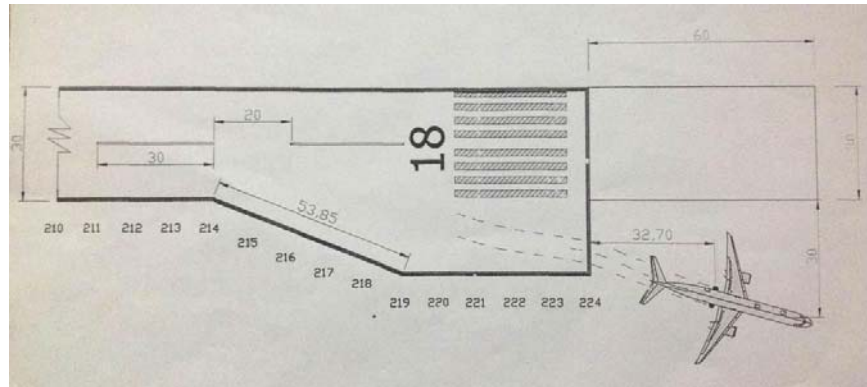
The investigation found several marks on the runway after the serious incident. The illustration below is based on the marks found on the runway

Figure 8: Illustration on the last part of aircraft movement

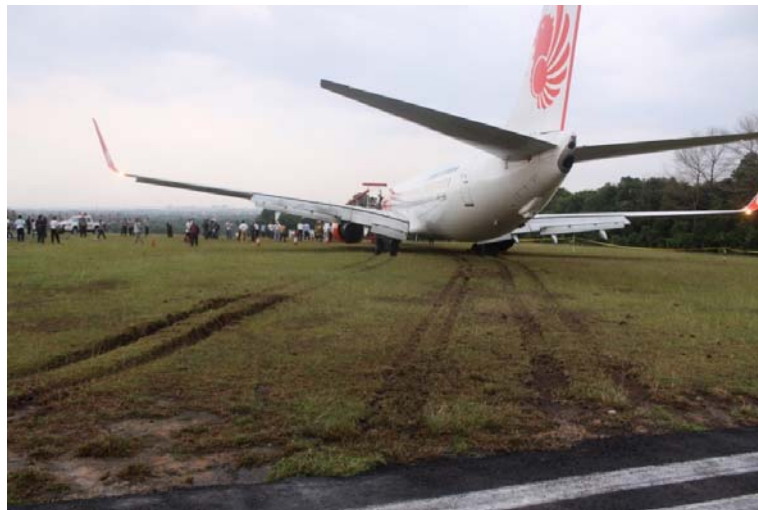
Figure 9: Aircraft position after serious incident

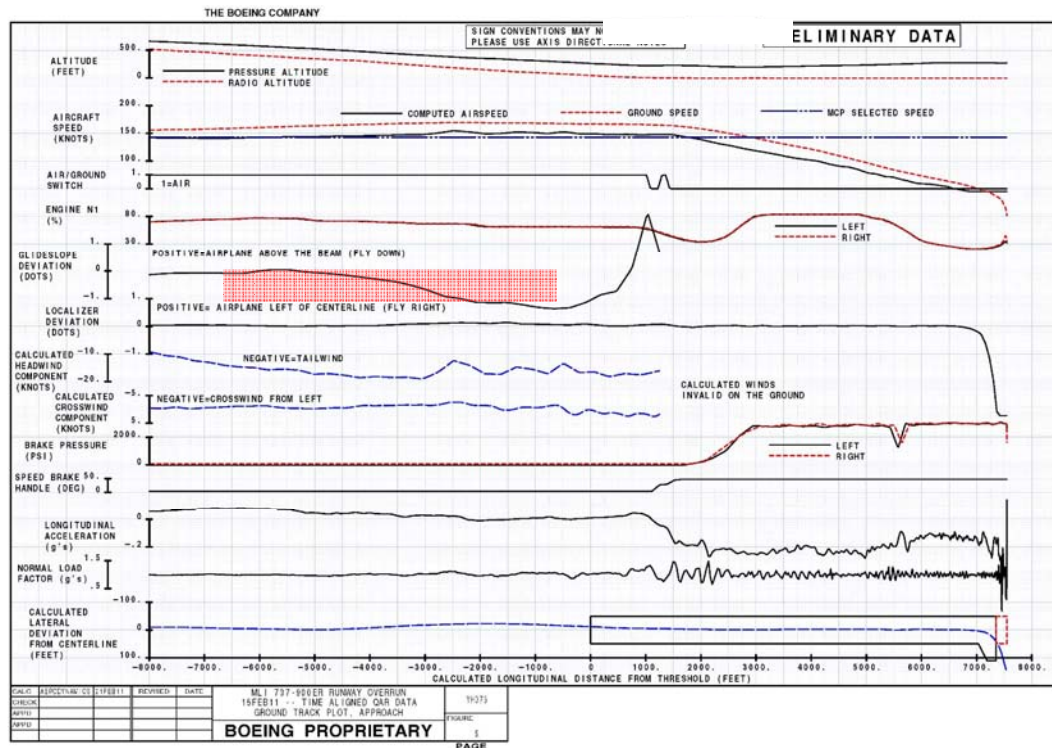
Figure 10: Tail wind information on the DFDAU data

Prior to land the pilot received information from the Tower controller that the surface wind was calm. The FDR data retrieved that the surface wind condition was tail wind up to 17 knots.

The discrepancy of the surface wind data might arise from the fact that the location of the anemometer was surrounded by vegetation and building which might generates turbulence that might cause reading inaccuracy. Based on this condition it can be concluded that the wind speed report from the Tower controller might be incorrect.

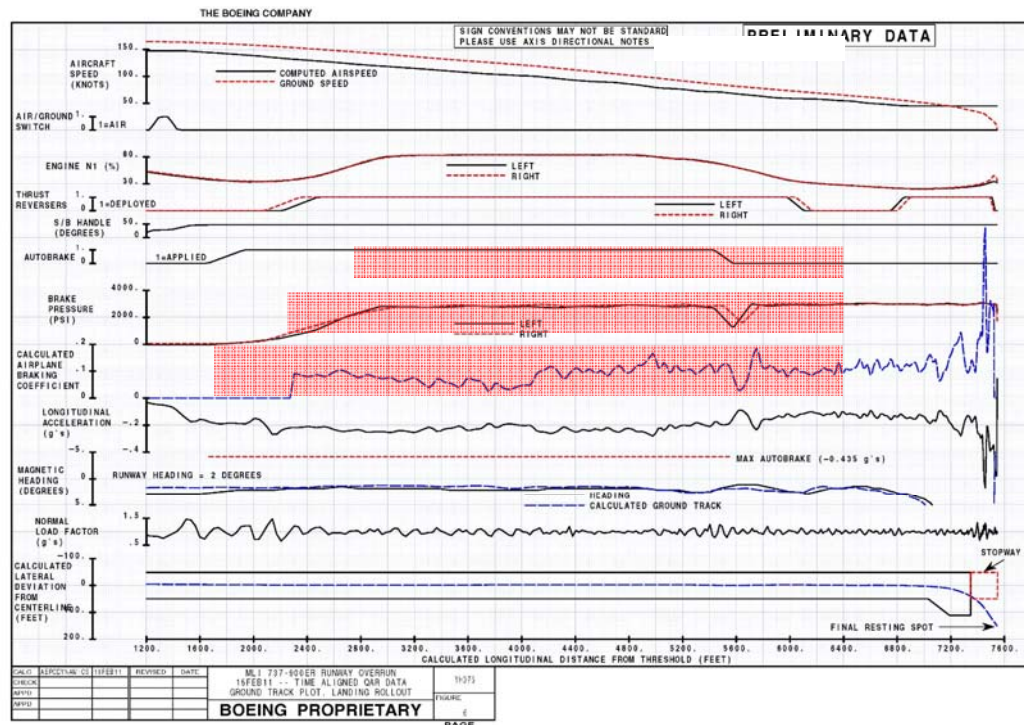
This can be concluded that the ineffective of calculated airplane braking coefficient most probably due to the combination of low skid resistance, rubber deposit and wet runway.

Figure 11: Factors contributed to the deceleration
