**KOMITE NASIONAL KESELAMATAN TRANSPORTASI
REPUBLIC OF INDONESIA**

Aircraft Serious Incident Investigation Report

Boeing 737-500; PK-MDT

26 December 2011

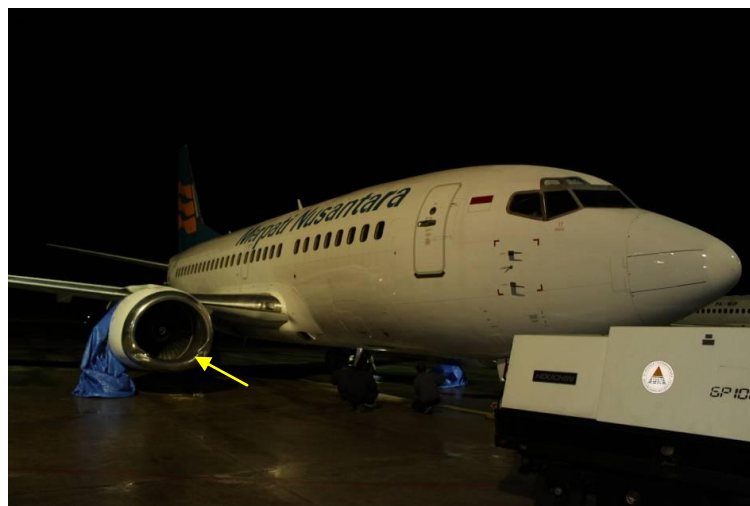
Figure 1: Damaged to the right engine cowl

An inspection following the occurrence found the right engine cowl had been damaged.

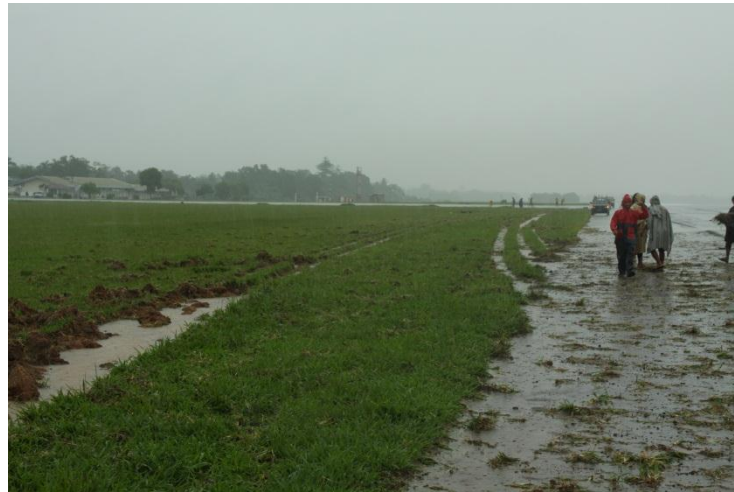
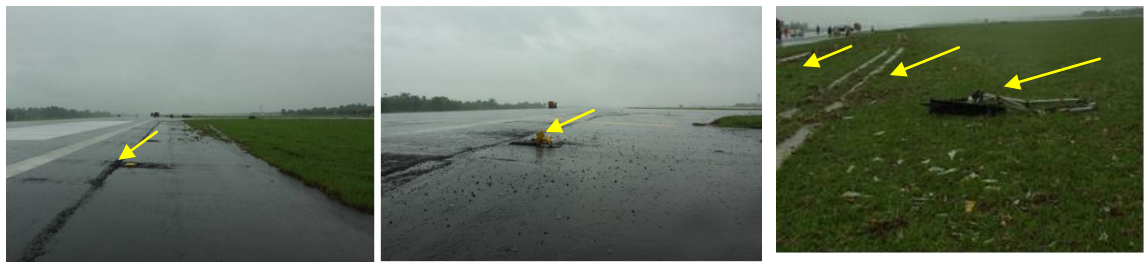
Figure 2: The broken runway lights, taxiway alpha signboard and wheels mark

At 1038 UTC, the aircraft landed and veered to the right off the runway, hit a taxi sign board and rolled on the shoulder for about 375 meters, then returned to the runway.

Two right runway lights and one of the taxiway alpha signboards was broken due to impact with nose gear and right engine.

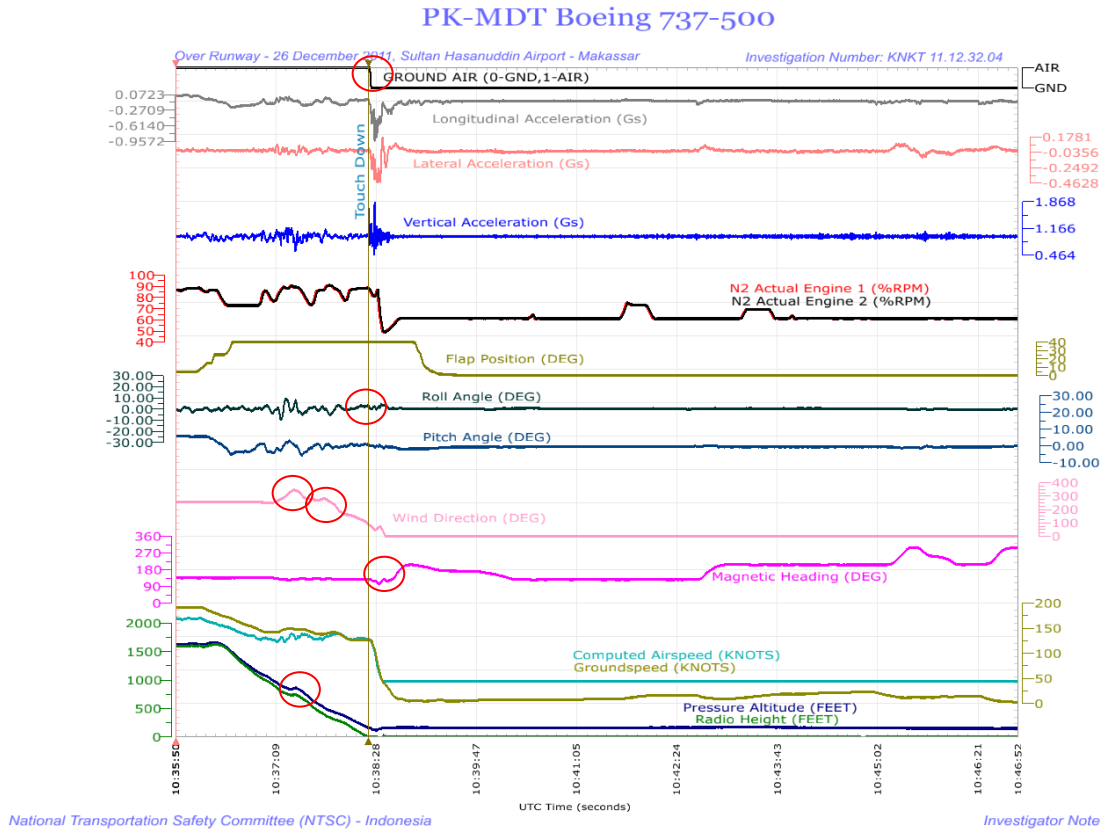
Figure 3: FDR from approximately 1,500 feet

The graph of the FDR showed the flight parameters from approximately 1,500 feet until the aircraft completed the landing roll. The circles on the following graph show the significant events.

- At an approximate radio altitude of 20 feet, the aircraft heading gradually changed from 129° to 126° at touchdown and continued to decrease to 106° during the landing roll for period of 8 seconds.

- At touchdown the left thrust reverser deployed a second before the right thrust reverser.
- Three seconds later the N-1¹ of the right engine indicated a greater value than that of the left engine. The maximum differential value recorded was up to 35% for 16 seconds later.

- Braking application after touchdown indicated asymmetric application and more left brake pressure than right brake pressure for 12 seconds.

The FDR data recorded that at touchdown the left thrust reverser deployed a second before the right thrust reverser, momentarily resulting in asymmetric reverse thrust. Three seconds later the N1 of the right engine was greater than that of the left engine, with a momentary differential value recorded up to 35%.

The increasing of the N1 after the thrust reverser deployed would increase the drag and asymmetric reverse thrust would also create asymmetric drag. The N1 of the right engine was greater than the left engine which mean that the drag induced by the right engine was greater than the left engine. This condition led to the aircraft veered to the right.

Moreover, the FDR also showed asymmetric brake pressure application 12 seconds after touchdown, in which the average left brake pressure was 200 psi greater. The FCTM stated that the reverse thrust side force component drifts the airplane to the downwind side of the runway and high braking forces reduce the capability of the tires to corner in order to regain the aircraft direction.

The operator should review the un-stabilised approach procedure and to include the un-stabilised when crossing the runway threshold and directional control after touchdown.
