FINAL
KNKT.11.12.27.04

**KOMITE
NASIONAL
KESELAMATAN
TRANSPORTASI**

Aircraft Serious Incident Investigation Report

**PT. Merpati Nusantara Airlines
Xi An MA60; PK-MZG
M. Salahuddin Airport, Bima,
Nusa Tenggara Barat
Republic of Indonesia**

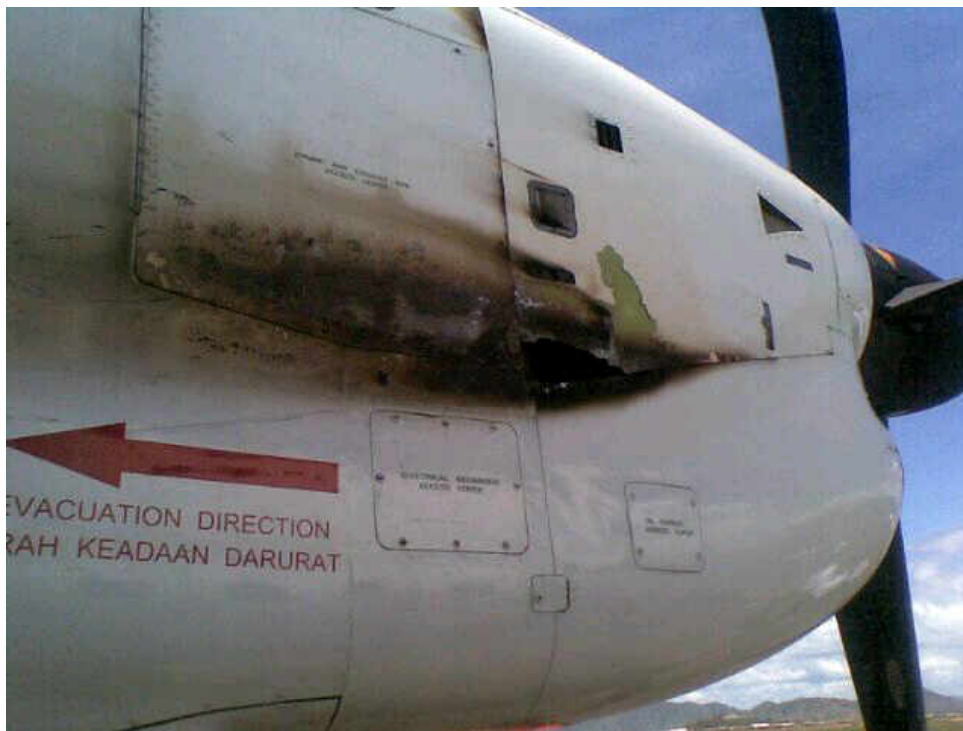
The number-1 engine experienced in-flight fire. Several components of the engine were burnt, such as wire harness and the cowling.

Figure 1: The left engine cowling was damaged

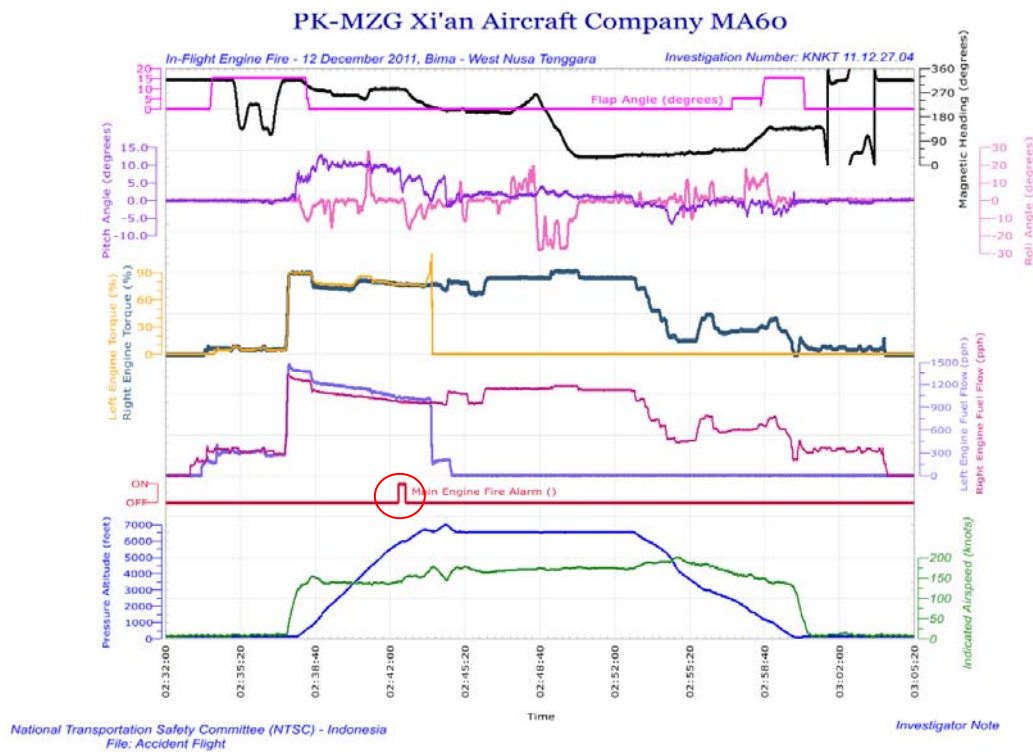
Figure 2: FDR data plot from the incident flight

The difference of fuel flow can be observed in the plot of fuel flow for engine number 1 and number 2. The difference of fuel flow indicated that there was fuel leak in the fuel line of engine number 1.

The plots also show the engine fire warning activation, the torque decreasing and fuel shut off.

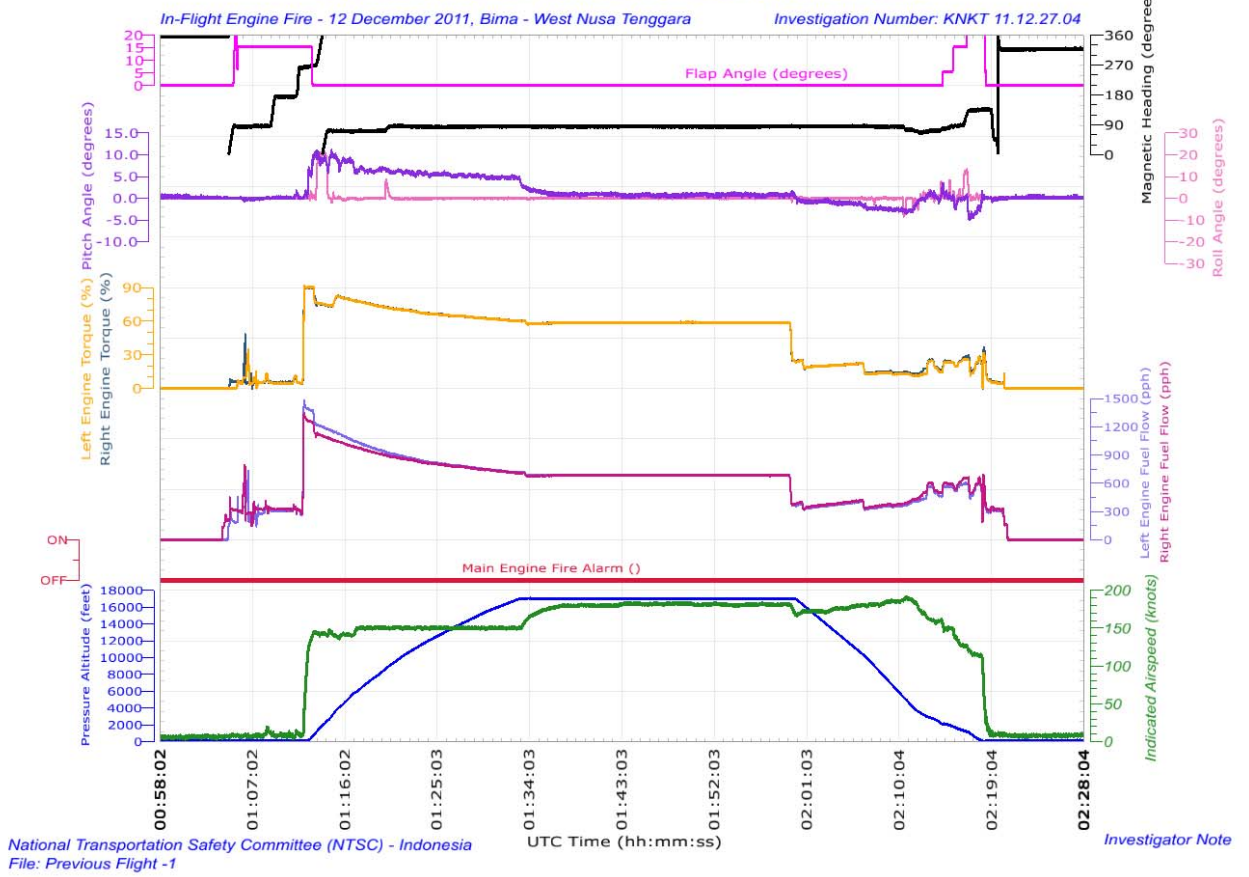
Figure 3: FDR data plot from previous flight

FDR data plot from several flights before the incident showed also a similar pattern of fuel flow. These patterns were observed in the 9 flights before the incident. It indicated that the fuel leak occurred in several flights before the incident.

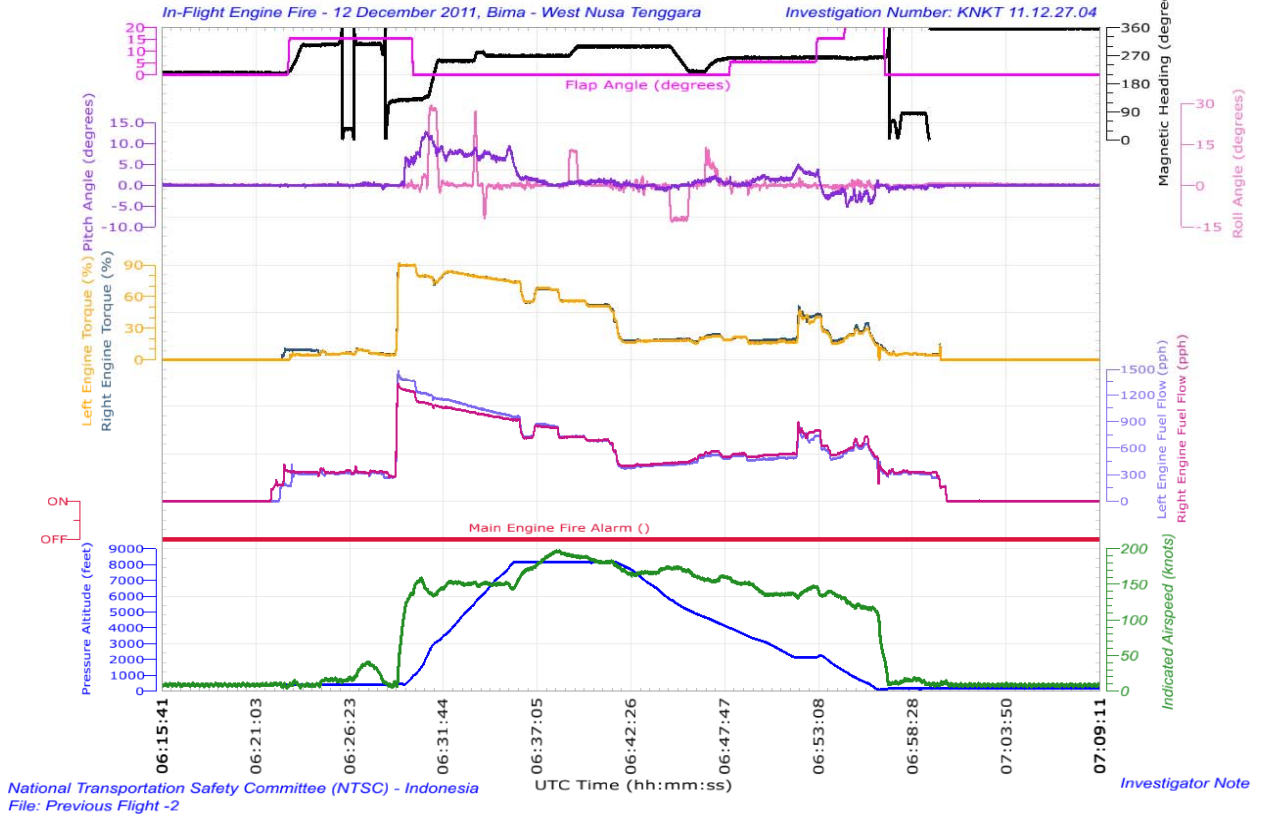
Figure 4: FDR data plot from the previous flight: 2nd flight before the incident

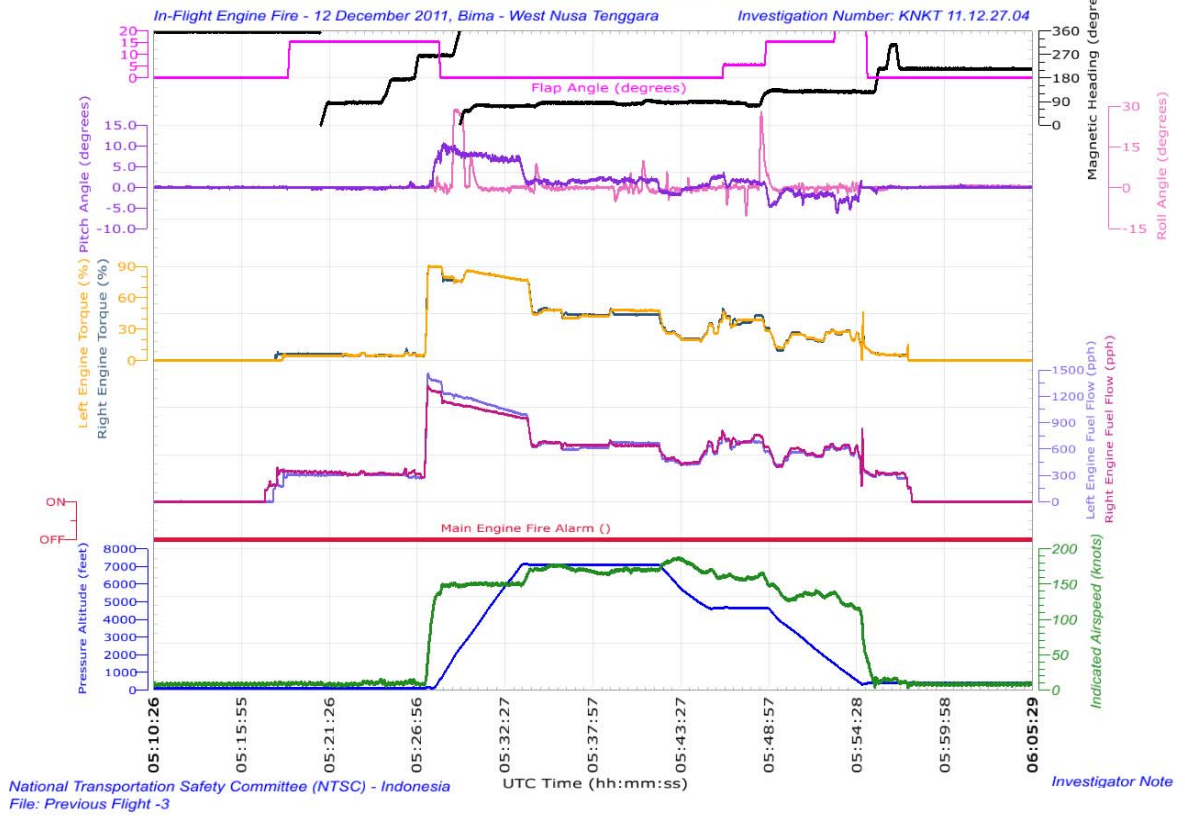
Figure 5: FDR data plot from the previous flight: 3rd flight before the incident

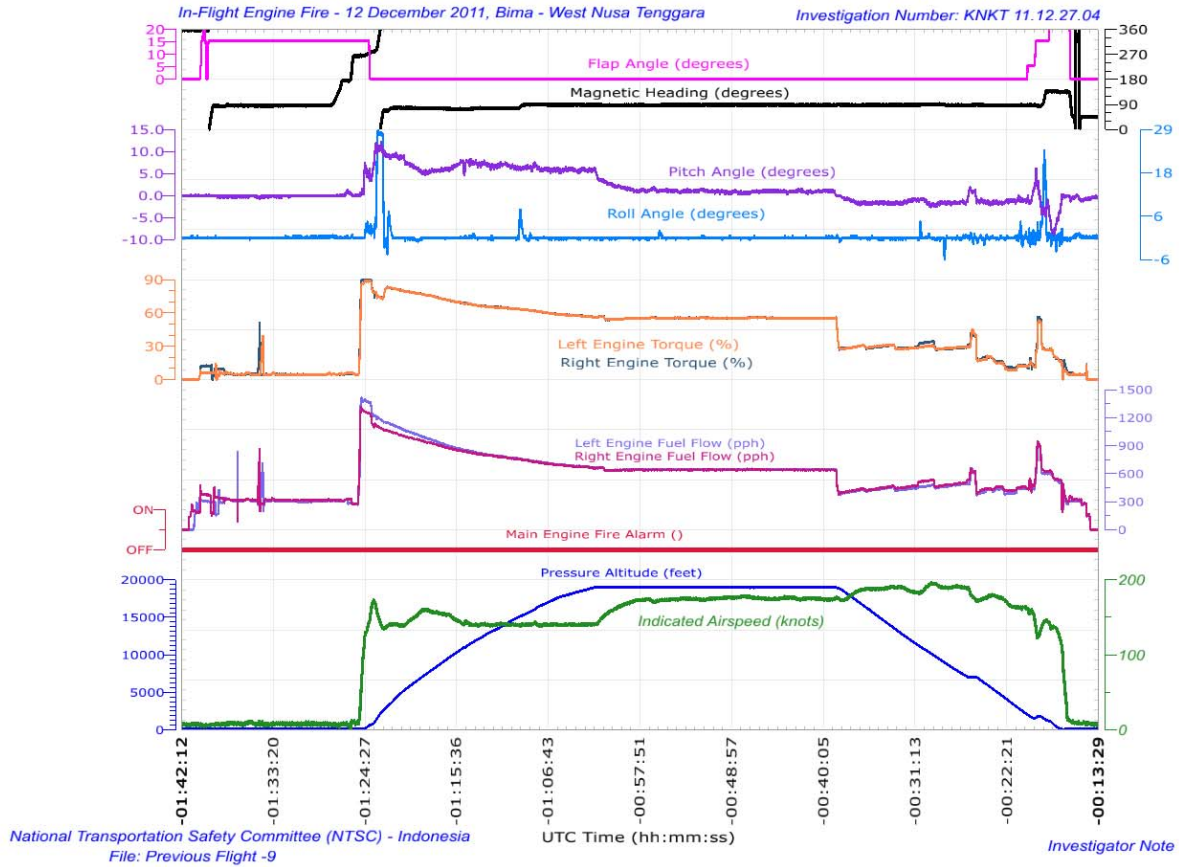
Figure 6: FDR data plot from the previous flight: 9th flight before the incident

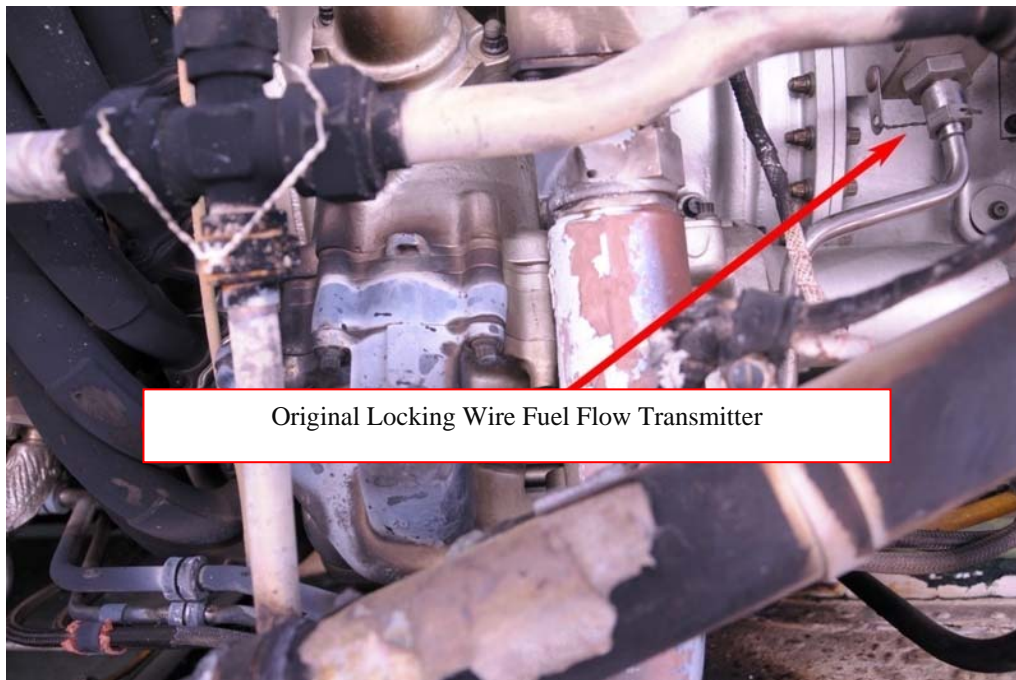
Figure 7: Original locking wire at the fitting

The original locking wire on the fuel fitting at the lower part of the fuel flow transmitter was intact. After opening the locking wire, the fitting was found to be not properly tightened. A further tightening could rotate the nut of about 5mm.

6. The fuel line fitting attached to the fuel flow transmitter was originally installed by the aircraft manufacturer was found un-properly tightened although the locking wire was still in place.

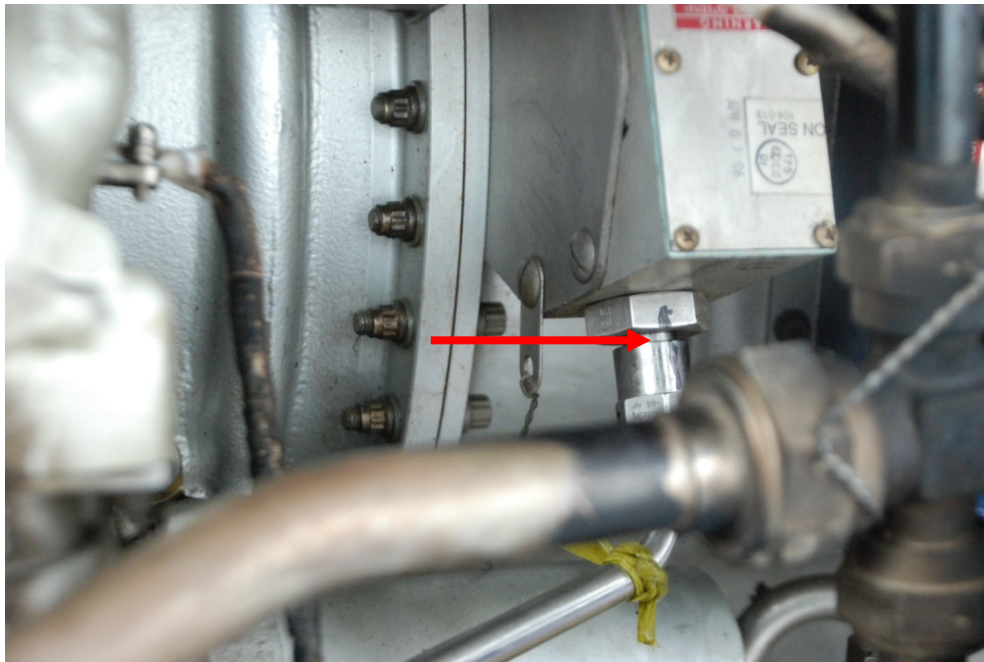
Figure 8: A blue line drawn on the fitting showing the original position

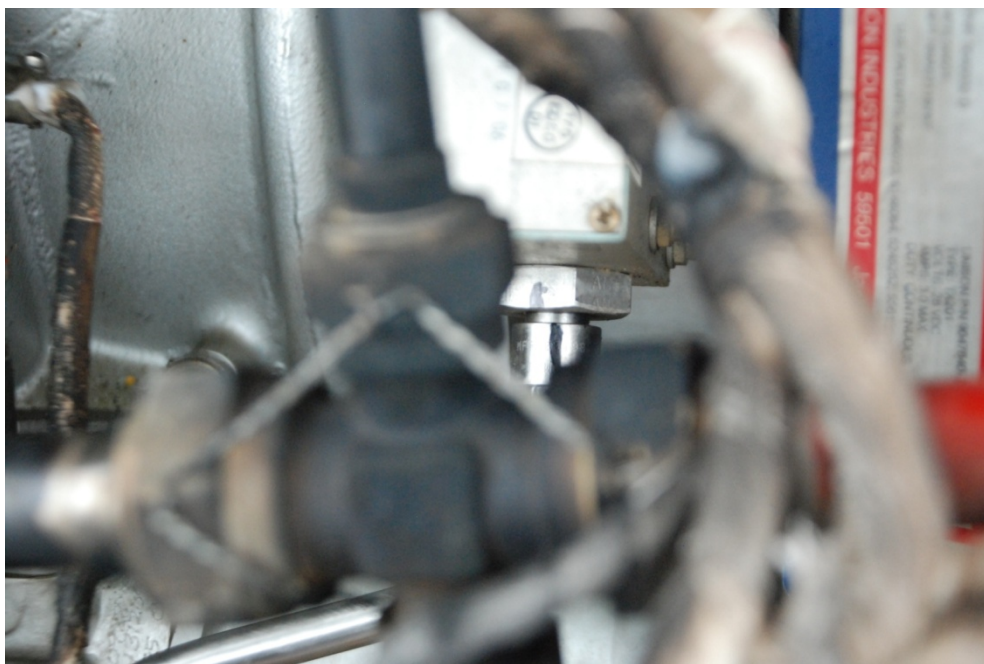
Figure 9: The shifting of blue line after tightening of the fitting

After a retightening the fuel fitting, a cold cranking was performed and there was no fuel leak observed in the corresponding tube.

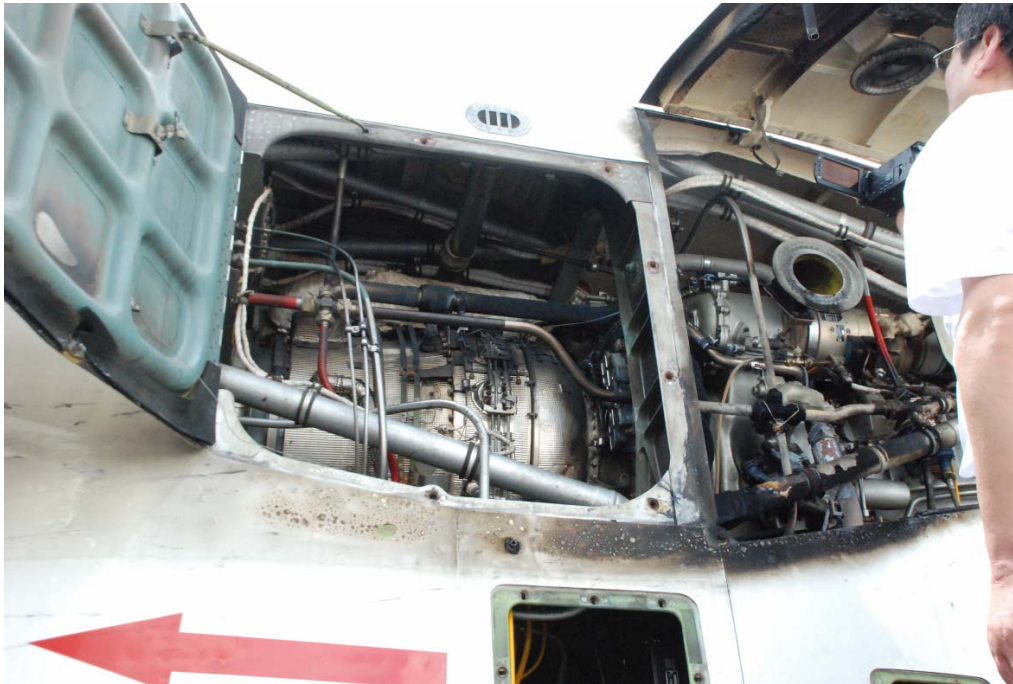
Fire initiated from the lower part of the cowling in front of the partition between hot and cold section of the engine number 1 where the fuel leak accumulated at that location. The fire moved upward crossing the frame bulkhead to the hot section as revealed in figure 2 showing the sign of fire direction.

Figure 10: Signature of fire in front of bulkhead frame

Fire initiated from the lower part of the cowling in front of the partition between hot and cold section of the engine number 1 where the fuel leak accumulated at that location. The fire moved upward crossing the frame bulkhead to the hot section.

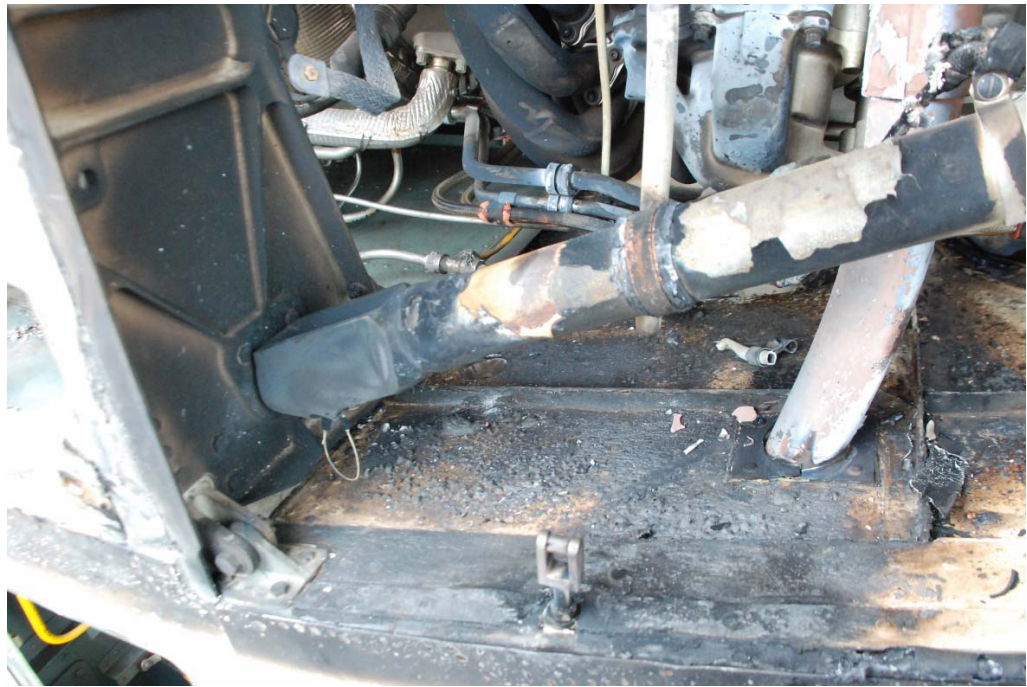
An inspection performed on the aircraft to find the location of fire as well as the location of fuel leak. The sign of the most severe fire was at the bottom plate just in front of the partition of hot and cold section. The fuel line under the fuel flow transmitter was found wet.

Figure 11: The most intense fire occurred on the floor just in front of the bulkhead frame
