**FINAL**  
KNKT.11.11.23.04

**NATIONAL  
TRANSPORTATION  
SAFETY  
COMMITTEE**

*Aircraft Accident Investigation Report*

**Cessna 172 ; PK-NIP  
PT. Nusa Flying International (NFI)  
Mount Ciremai, West Java  
Republic of Indonesia**

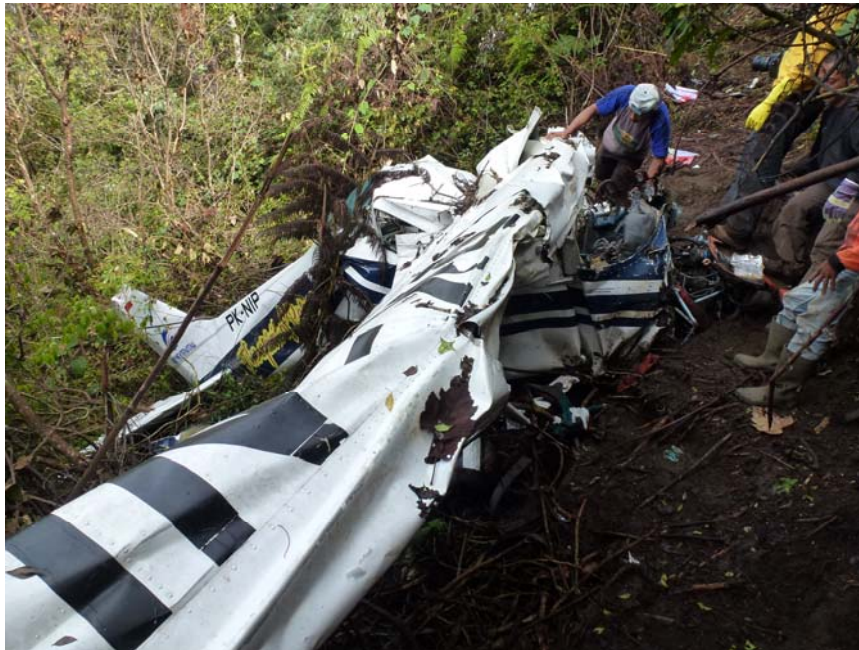
Figure 1: The aircraft has severely damaged

The aircraft suffered severely damage, mostly on the forward side up to the wing leading edge. The aircraft engine was buried on the ground.

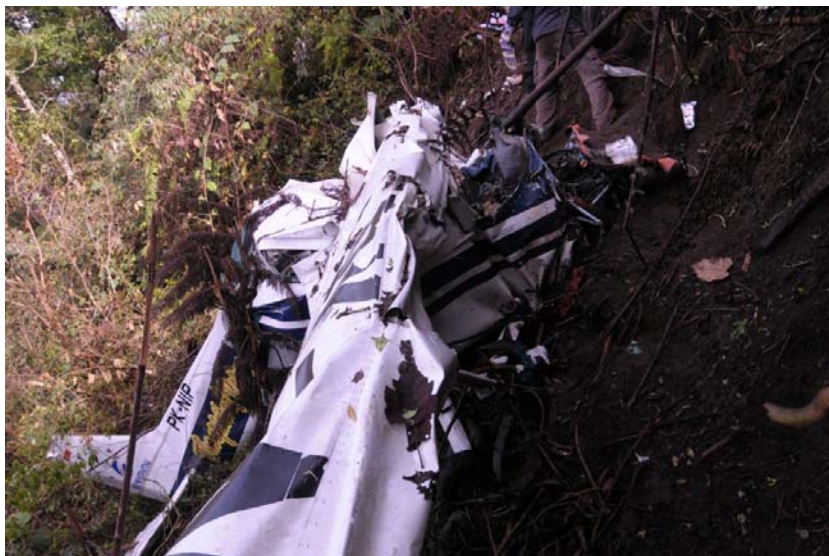
The aircraft found impacted to 70 degrees slope ridge of mount Ceremai at 2400 meters. The wing leading edges were found dent on an angle of approximately 70 degrees.

**Figure 2: Damage on the wing leading edge and forward section.**

The aircraft found impacted to 70 degrees slope ridge of mount Ceremai at approximately 2400 meters. The wing leading edges were found dent on an angle of approximately 70 degrees. The symmetrical of the slope ridge and the damage on the aircraft wing leading edge suggested that aircraft was in level position during the impact. This might occur when the aircraft was on cruising flight. The impact altitude was at approximately 2400 meter or approximately 7800 feet while the reported the cruising altitude was 7500 feet.

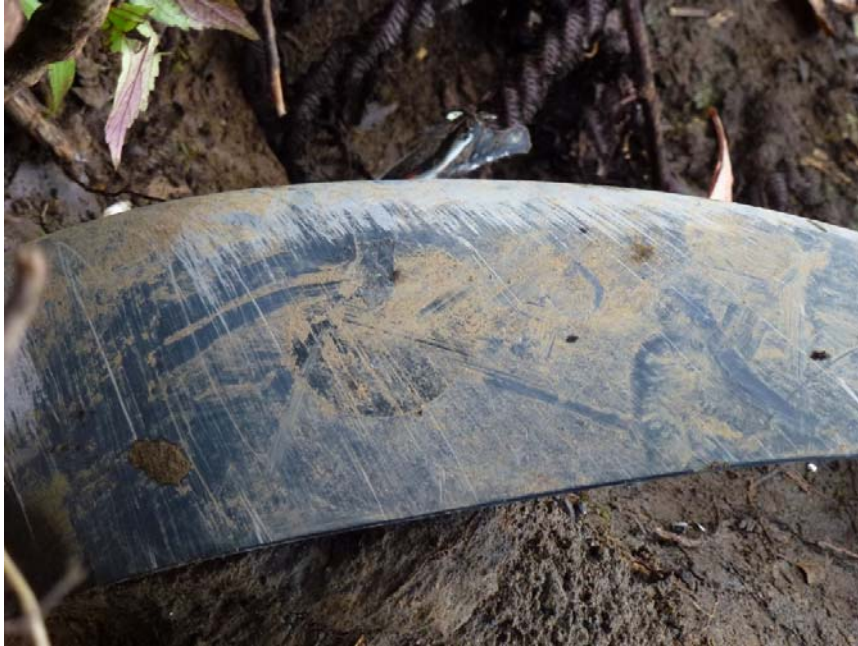
**Figure 3: Scratch marks found on the propeller leading edge.**

The aircraft suffered severely damage, mostly on the forward side up to the wing leading edge. The aircraft engine was buried on the ground. Scratch marks found on the propeller leading edge indicated that the propellers were still running during the impact (*see figure.3*). This indicated that the engine was still running during the impact. This supported by the fact that there was no report of any aircraft malfunction or distress message.

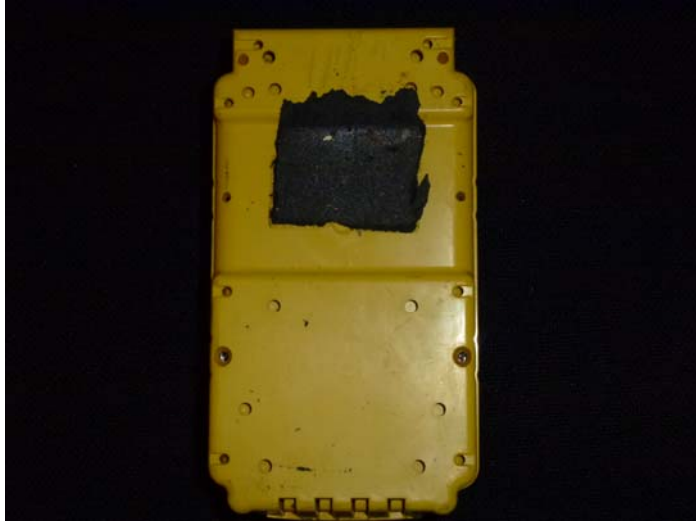
**Figure 4: The ELT installation used double tape instead of fastener**

- The aircraft was airworthy prior the departure.
- The aircraft had a valid Certificate of Airworthiness.
- All pilots held valid licenses and qualified for the flight in accordance with existing Indonesia regulations.
- The weather on route was cloudy.
- There was no evidence of in-flight or post impact fire.
- The aircraft was seen fly into the cloud.
- The pilot might have reduces their vision to the ground while flying in the cloud.
- The impact information suggested that the aircraft was on level flight while impacted the terrain.
- There was no evidence of aircraft system failure or malfunction.
- The ELT was improperly installed (Using only double tape) detached from the airframe as result of impact.
- There was no distress message.

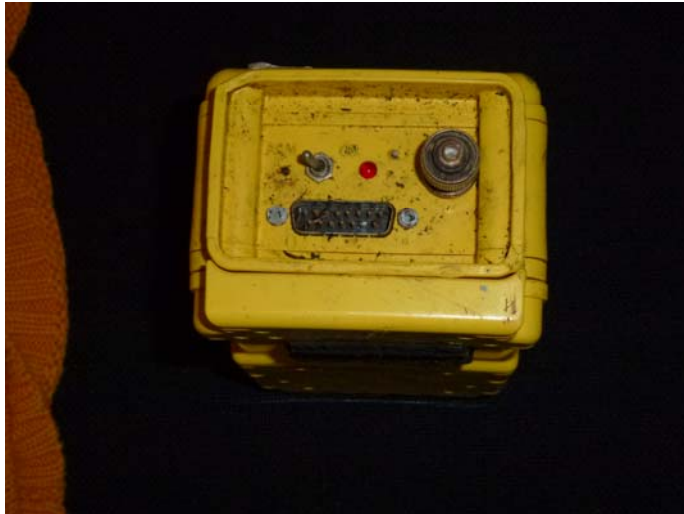
The ELT was found intact to the airframe, however, the antenna was found detached from the unit. The separation from the antenna from the unit has disabled the unit of transmission, hence there was no distress signal transmitted.

**Figure 5: The antenna detached from the ELT unit.**
