**NATIONAL
TRANSPORTATION
SAFETY
COMMITTEE**

Aircraft Serious Incident Investigation Report

De Havilland DHC 6-300 Twin Otter; PK-NUH

**Dabra Airstrip, Papua
Republic of Indonesia**

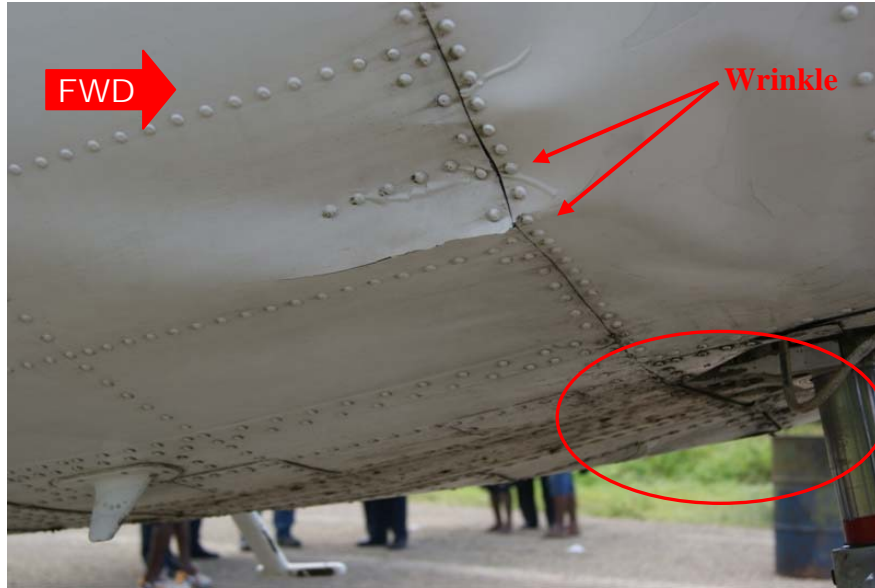
Figure 2. PK-NUH Station 60 (Lower Fuselage) Section

- Lower forward fuselage Station 60 twisted,
- Right wing leading edge damage,
- Right main landing burst,
- Left compressor block upper and lower broken,
- Left main gear shifted rearward.

About 18,4 metres from the end of runway 24, there was an scoured mark on asphalt of the runway surface that indicate the aircraft conducted a quick and steep turning (ground loop) on right main wheel. This action caused the right main wheel deflated, the left main gear shifted rearward and lower forward fuselage station 60 twisted.

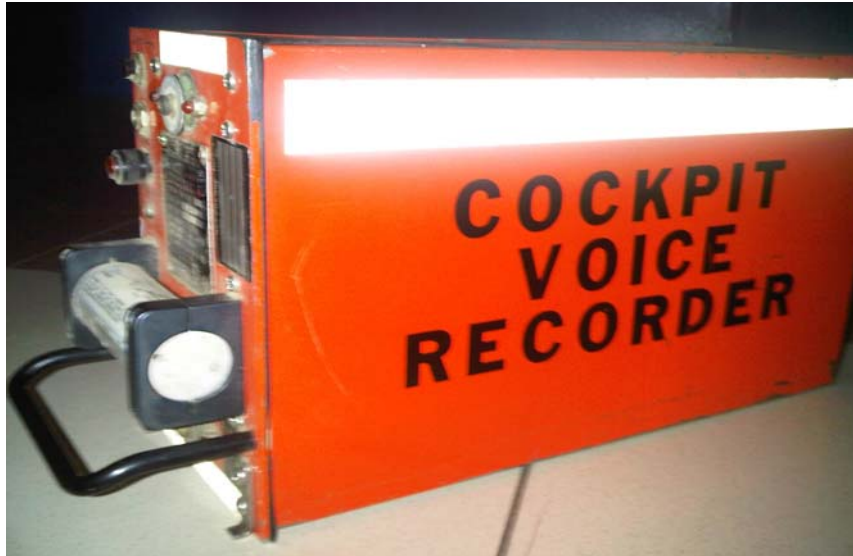
Figure 4. PK-NUH Cockpit Voice Recorder

The investigation could not find significant information related to PK-NUH occurrence, due to the relevant recorded data was overridden by the un-related conversation after the occurrence.

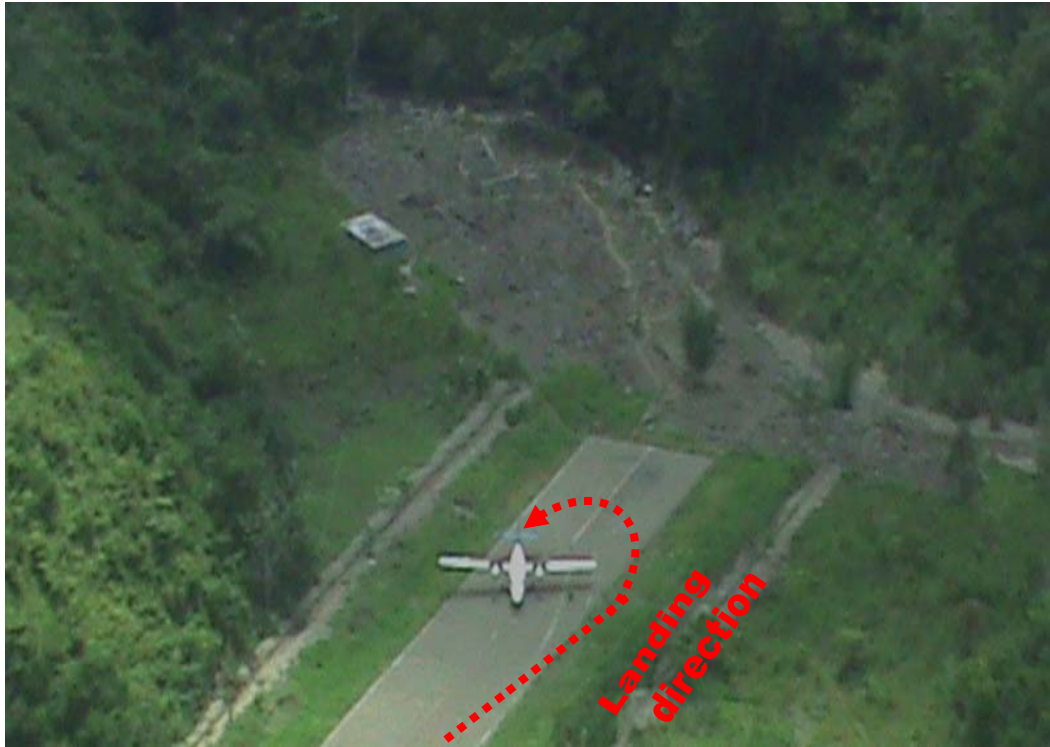
Figure 5. PK-NUH Final Position after the Occurrence

The following wheel mark indicated the aircraft veered to right of runway 24. The aircraft was out of the runway 24 and rolling on the right shoulder about 120 metres and the aircraft right wing hit banana trees 6.5 metres in the right of runway, and the PIC recovered the aircraft directed the aircraft entering into the runway and conducted a quick steep turning to the right and stop on the runway in the opposite direction.

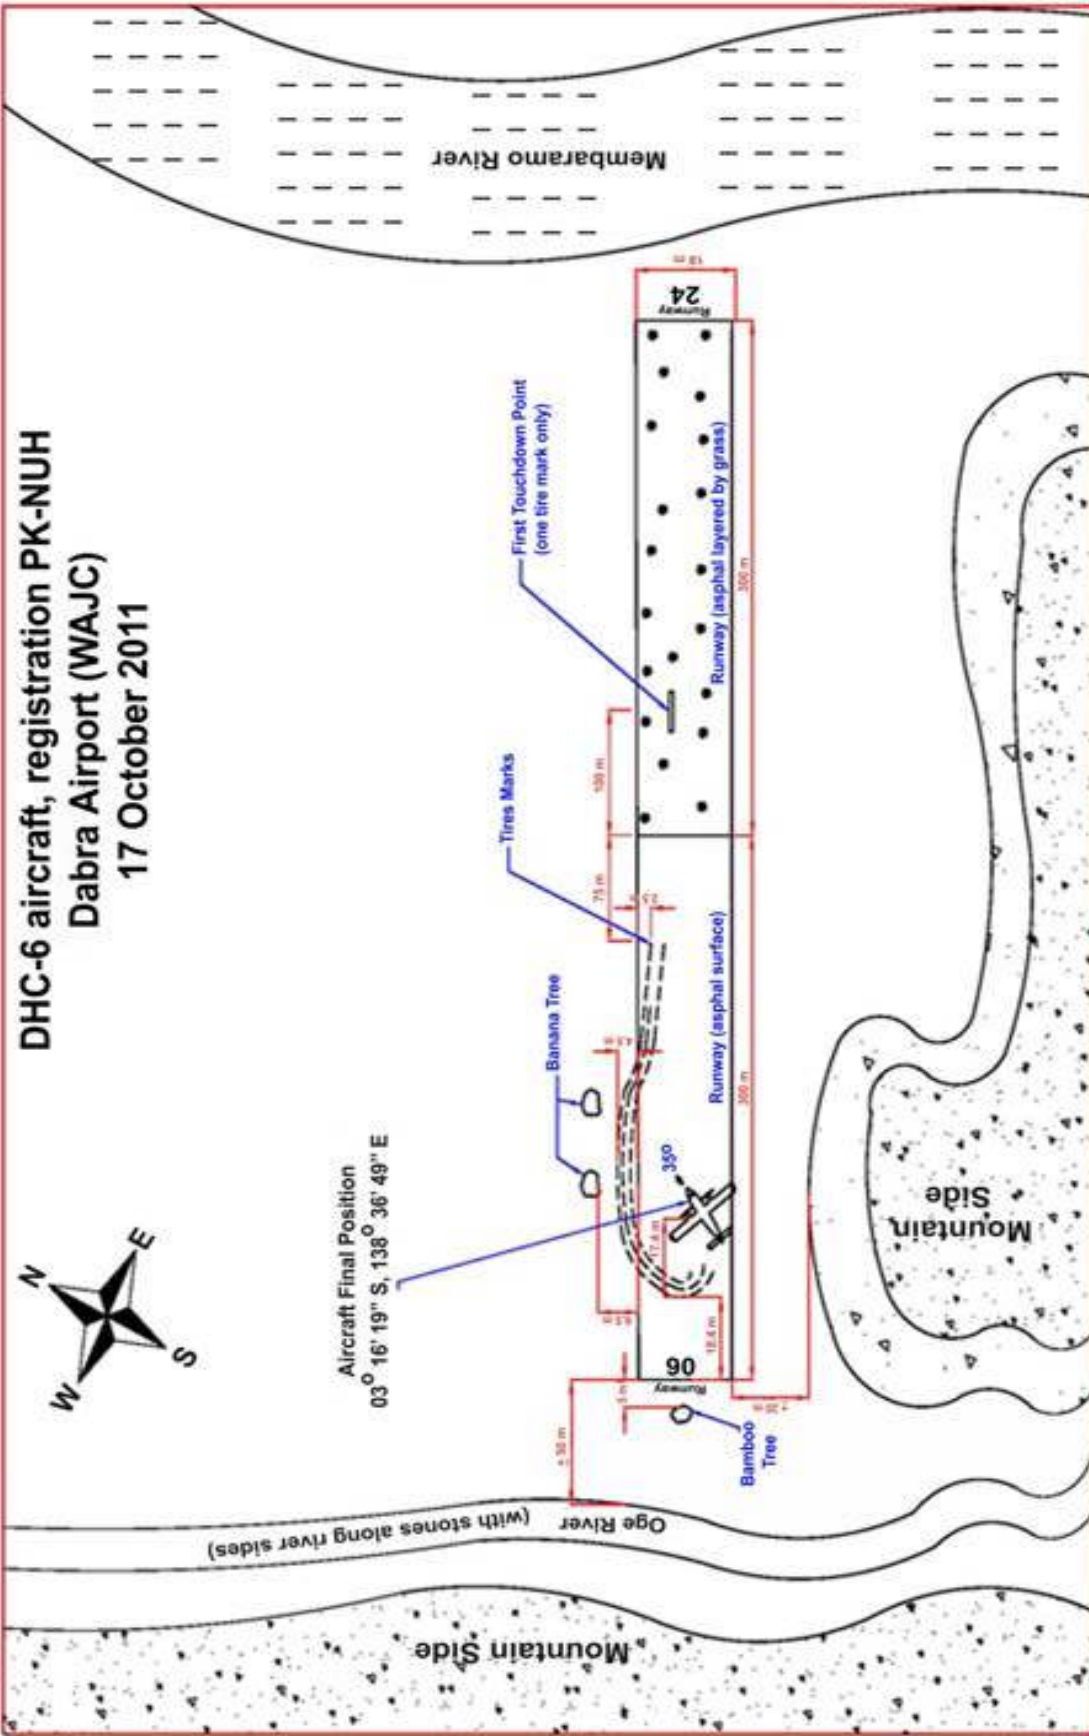
Figure 6. The Sketch of PK-NUH Final Position

The first main wheel tire mark was one main wheel on the runway about 200 metres and the second marks were about 375 metres from the beginning of the Runway 24, it indicated that the aircraft experienced bouncing during touchdown.
