**FINAL**  
KNKT.11.09.19.04

Helicopter Accident Investigation Report

**PT. Airfast Indonesia**  
**Bell 412 Helicopter; PK-OCV**  
**Lemurung area, Sumbawa, Nusa Tenggara Barat**  
**Republic of Indonesia**

**25 September 2011**

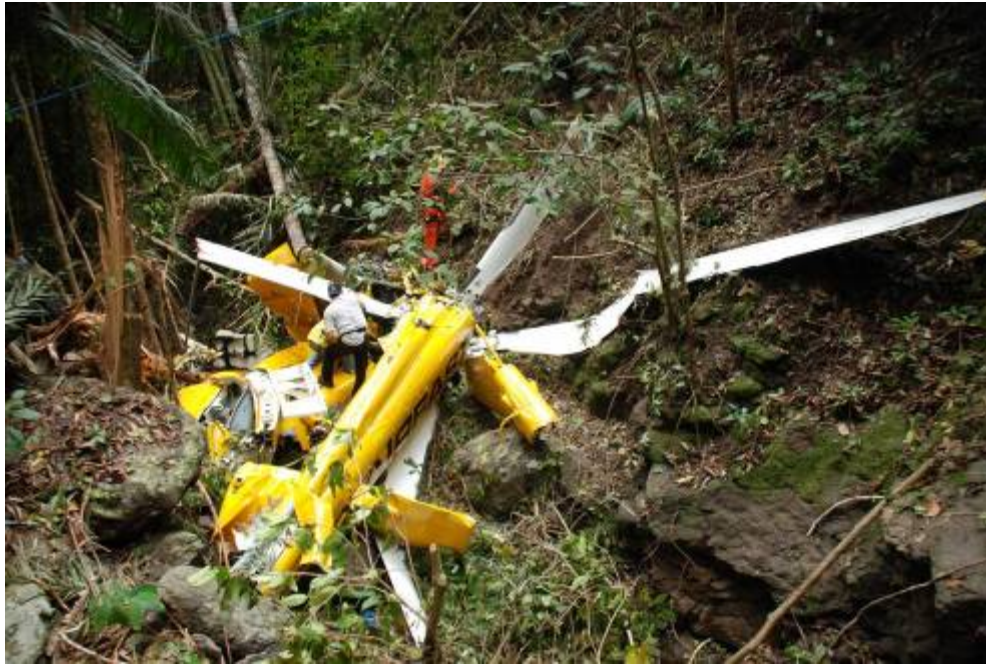
Figure 1: PK-OCV accident site

The wreckage was found at a coordinate 08°54'00"S 117°23'10" E at an elevation of approximately at 850 meters. Most of the wreckage was found in a relatively confined space at the bottom of a dry, narrow, river bed.

The tail rotor and tail rotor gearbox were not immediately located. These parts were found and recovered amidst vegetation at a rain forest several weeks after the accident about 300 meters from the accident site approximately on the flight path (Figures 1 and 2).

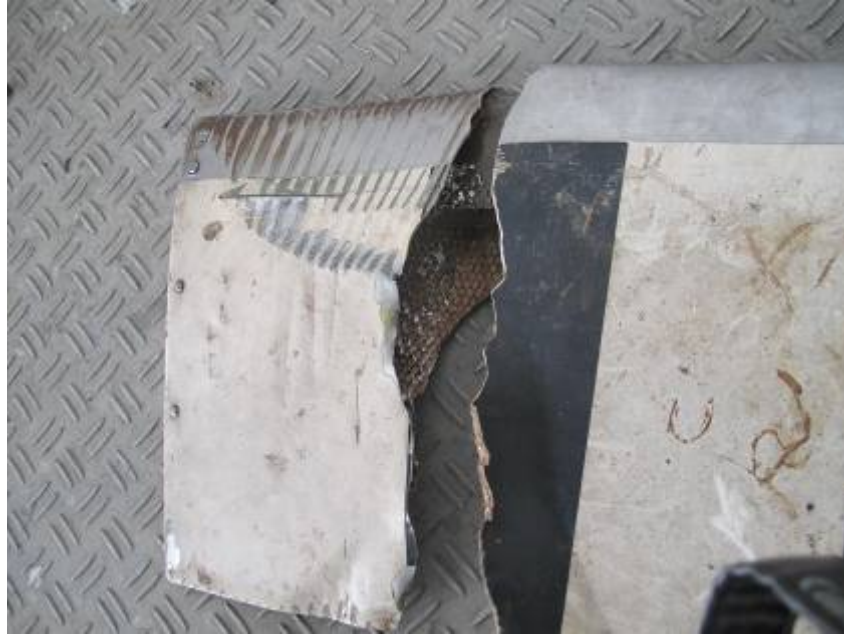
Both tail rotor blades were fractured approximately 8 inches from the outboard tips. Only one tail rotor blade tip was recovered. An examination of the cable (long-line) and the tail rotor blade provided evidence that the cable had struck the tail rotor blade while the blade was being driven (Figure 3). The evidence confirmed that the cable struck the tail rotor and fractured the blade.

Figure 3: Tail rotor blade tip showing evidence of contact with cable

The wreckage examination found evidences of the tail rotor blades coming into contact with the steel long-line cable, while being driven with significant energy. The evidences were found on the steel cable of the long-line assembly, coupled with the marks on the separated sections of the tail rotor blades.

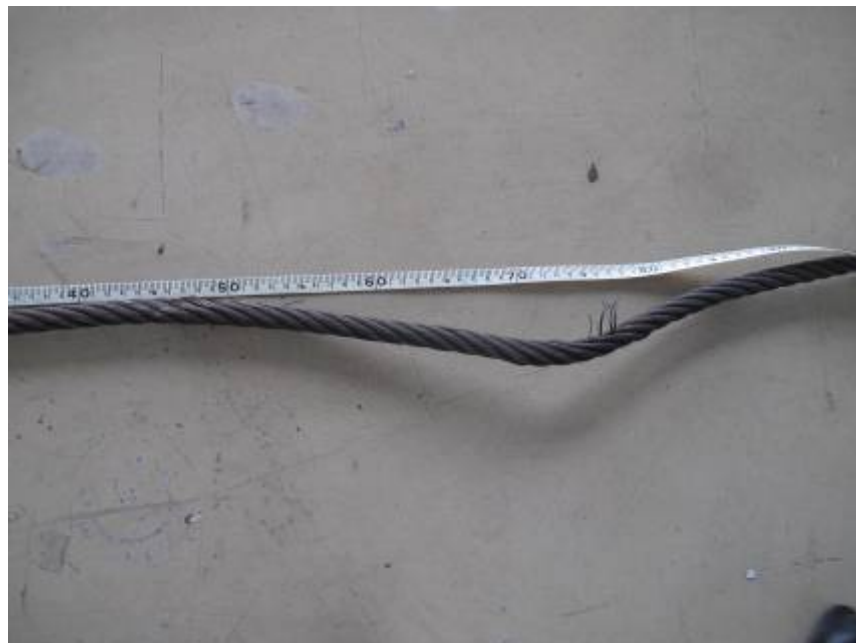
Figure 4: Damage on the sling cable

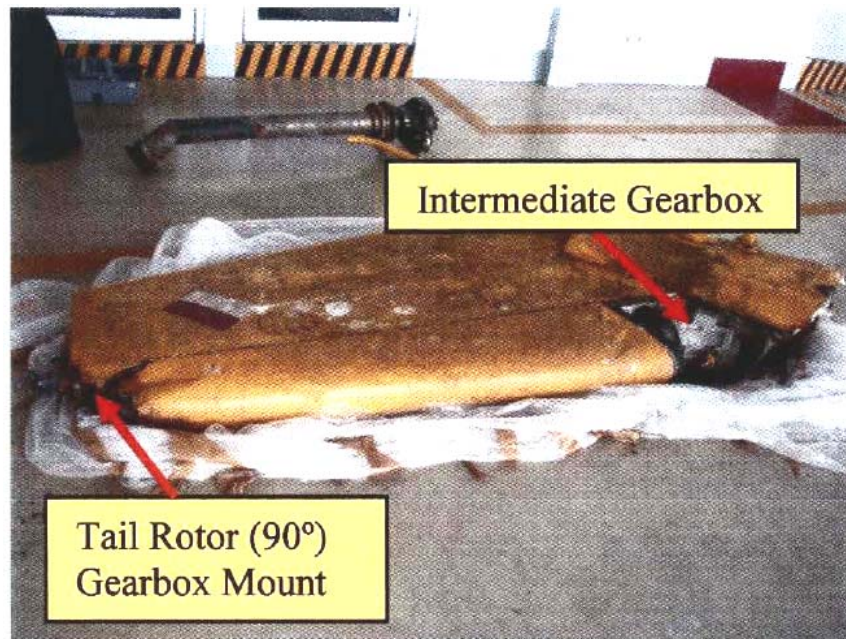
Figure 5: The tail rotor gearbox mount

The tail boom, intermediate gearbox, vertical fin and main driveshaft were examined and all damage was determined to be a result of impact and not contributing to this accident. The vertical fin 90° gearbox mounting bulkhead consistent with overload fractures.

The cable strike, in turn, resulted in the tail rotor system entering an extreme out-of-balance condition, manifesting into loads that fractured the mounting bulkhead of the 90° gearbox.

As the bulkhead fractured, the tail rotor assembly and gearbox separated from the helicopter, resulting in uncontrollable flight due to the significant center of gravity (CG) shift.
