FINAL
KNKT.11.09.17.04

Aircraft Accident Investigation Report

**PT. ASI Pudjiastuti Aviation
Cessna 208 B Grand Caravan ; PK-VVE
Notnare Village, Distrik Samenage,
Yahukimo, Papua
Republic of Indonesia**

9 September 2011

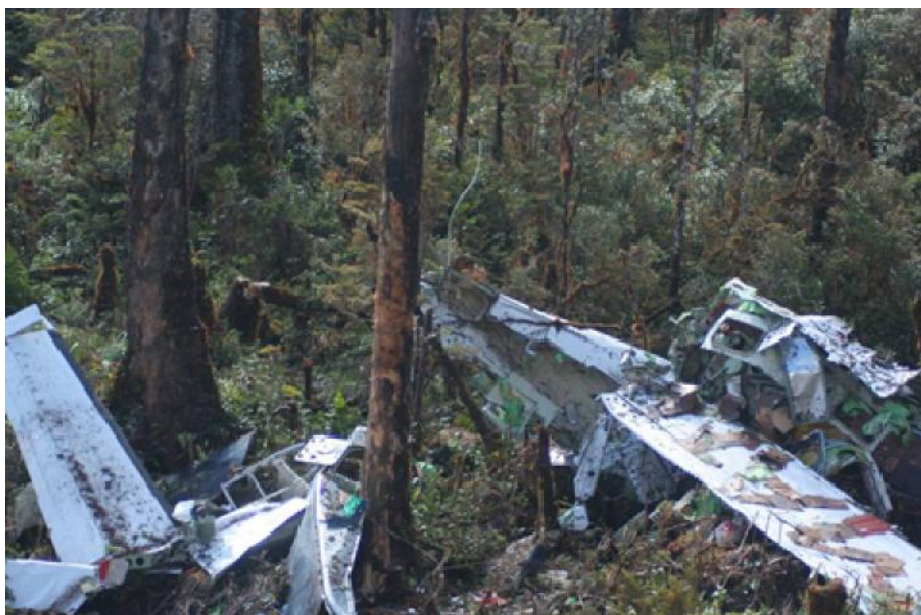
Figure 7: PK-VVE wreckage

The aircraft was destroyed.

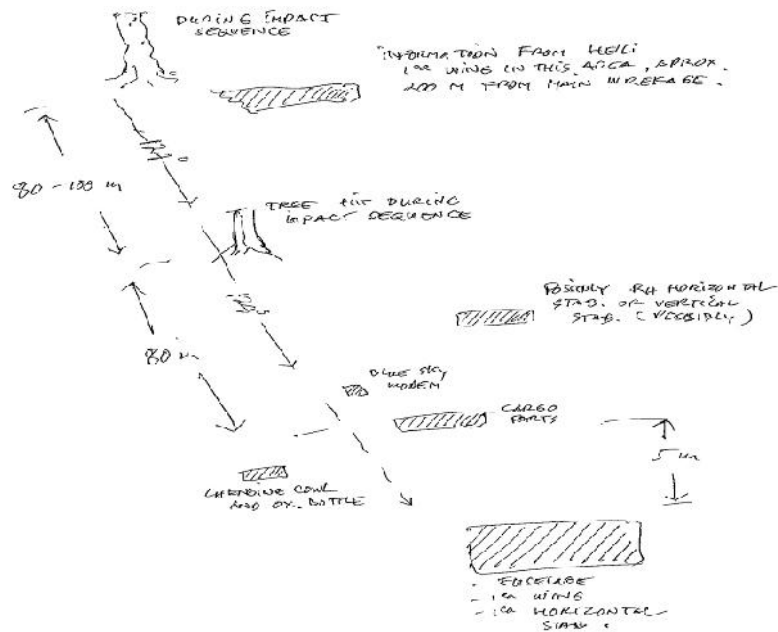
Figure 11: Wreckage distribution (not to scale)

The wreckage was spread along a line of 124° magnetic over a length of about 200 metres. The initial impact was by the right wing with high trees, separating part of the wing which was found away from the main wreckage. The main wreckage was located about 200 metres from that initial impact point, starting with the right horizontal stabilizer, and then the cargo load, the fuselage, left wing, propeller, engine cowling and left stabilizer. Damage to the propeller blades was consistent with the propeller rotating at low RPM at initial impact. The propeller was reported to have been found with the blades in the feathered position. This was consistent with the propeller assembly separating from the engine during the impact sequence and the blades moving to the feathered position due to the loss of oil pressure and the action of the feathering springs.

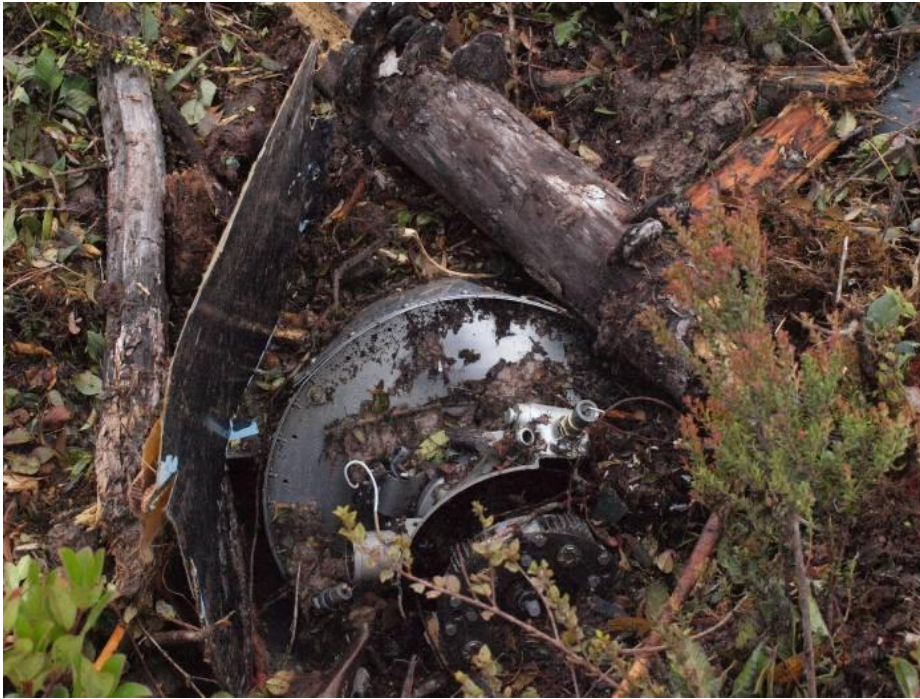
Figure 12: The Reduction Gearbox & Propeller detached from the engine

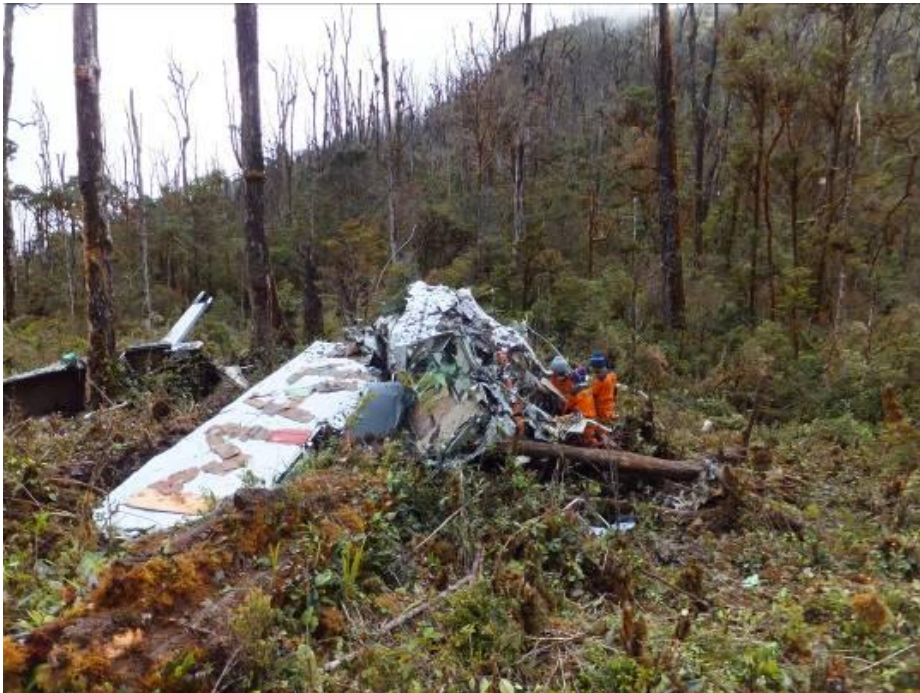
Figure 13: The left wing

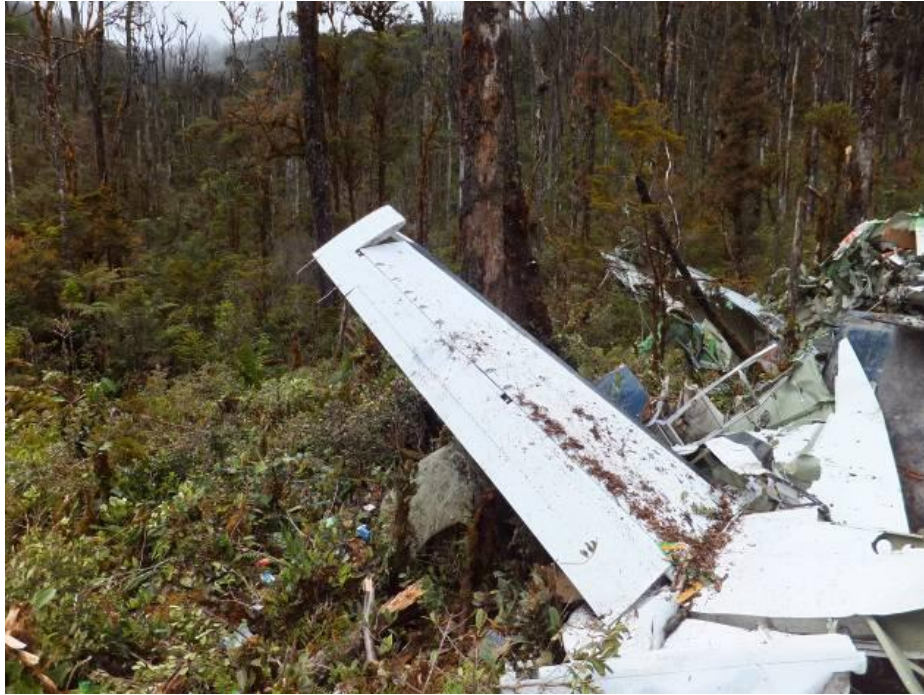
Figure 14: The left horizontal stabilizer

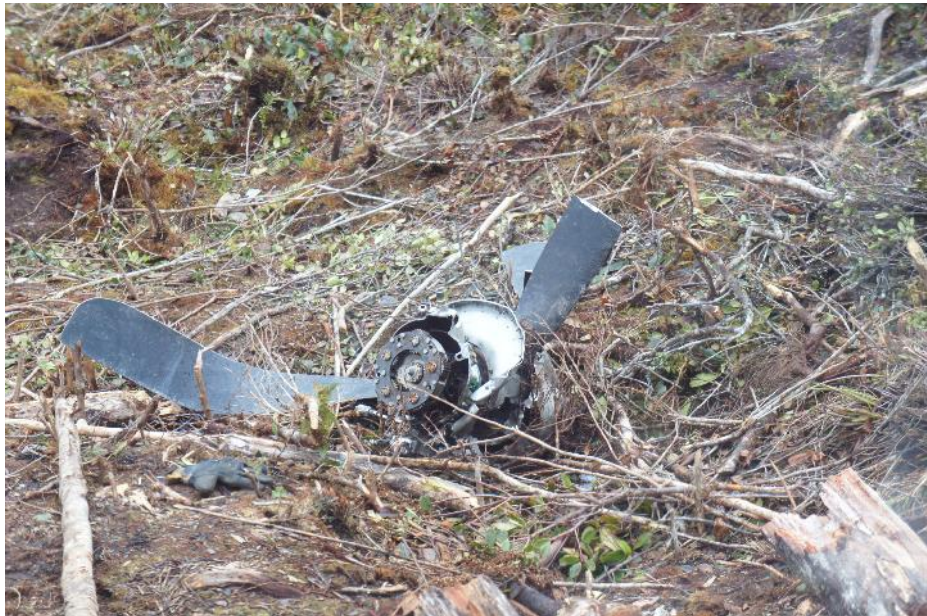
Figure 15: The detached propeller with two blades bent rearward (one blade cut for recovery)

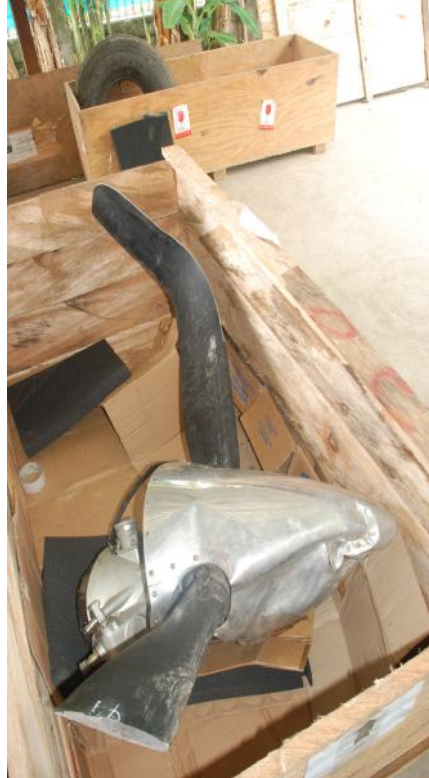
Figure 16: The twisted propeller spinner (one blade cut for recovery)
