**Aircraft Accident Investigation Report**

**Wings Flying School**

**Cessna 172P; PK-WTF**

**19 December 2011**

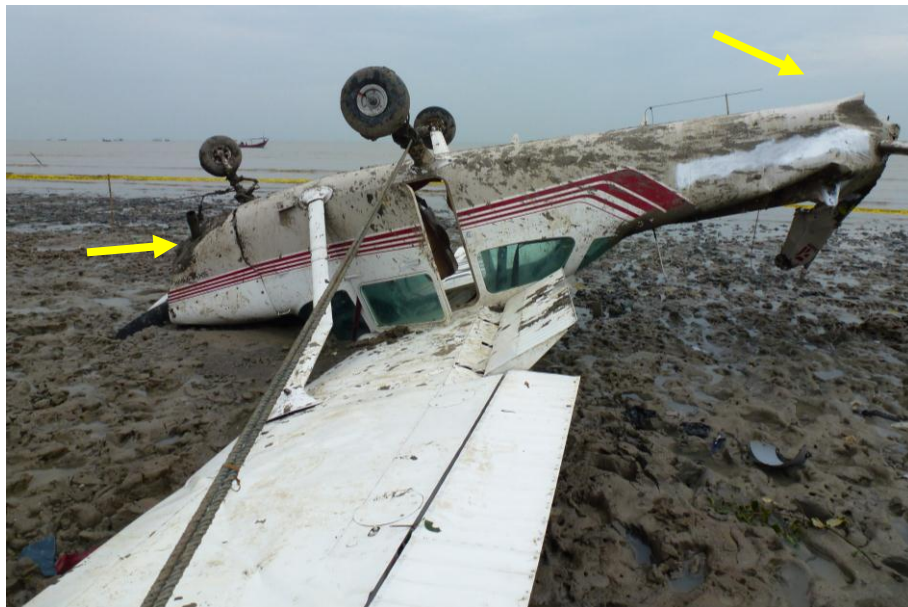
The aircraft was upside down and substantially damaged. The damages found were on the nose and tail section wrinkle, the left engine cowling loose and broken, and the right-wing strut assembly curved.

**Figure 2: The aircraft condition after impact**

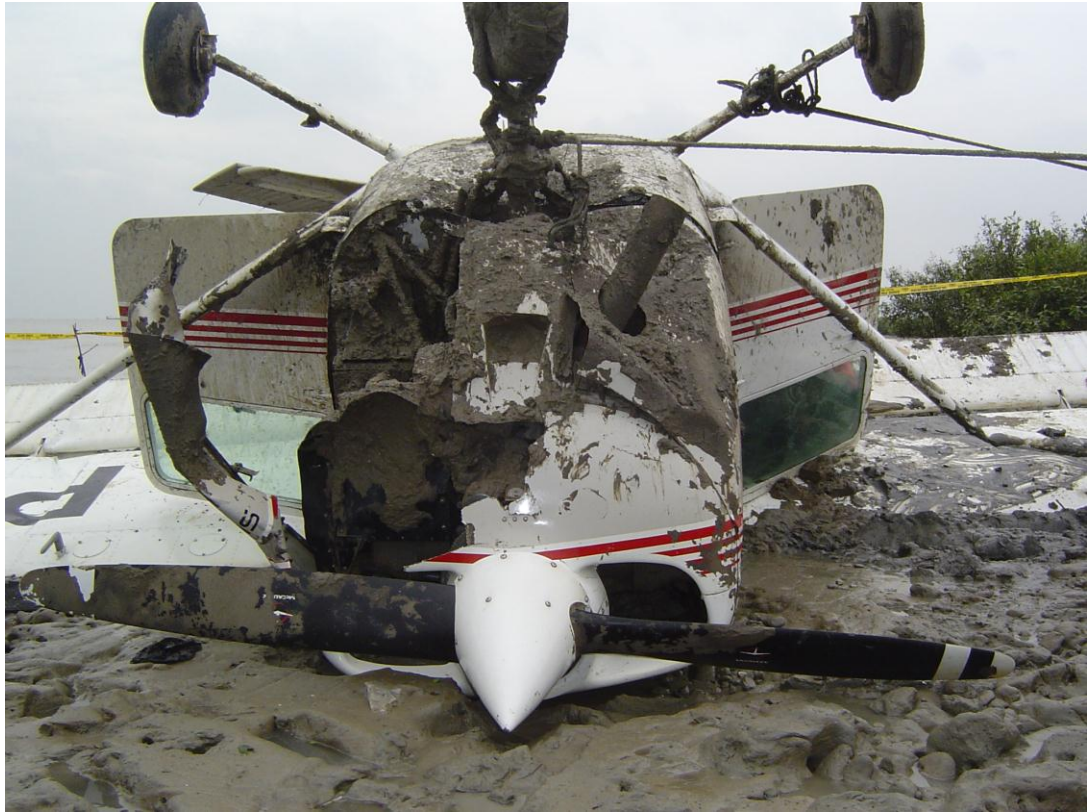
**Figure 3: Broken on the engine cowling**

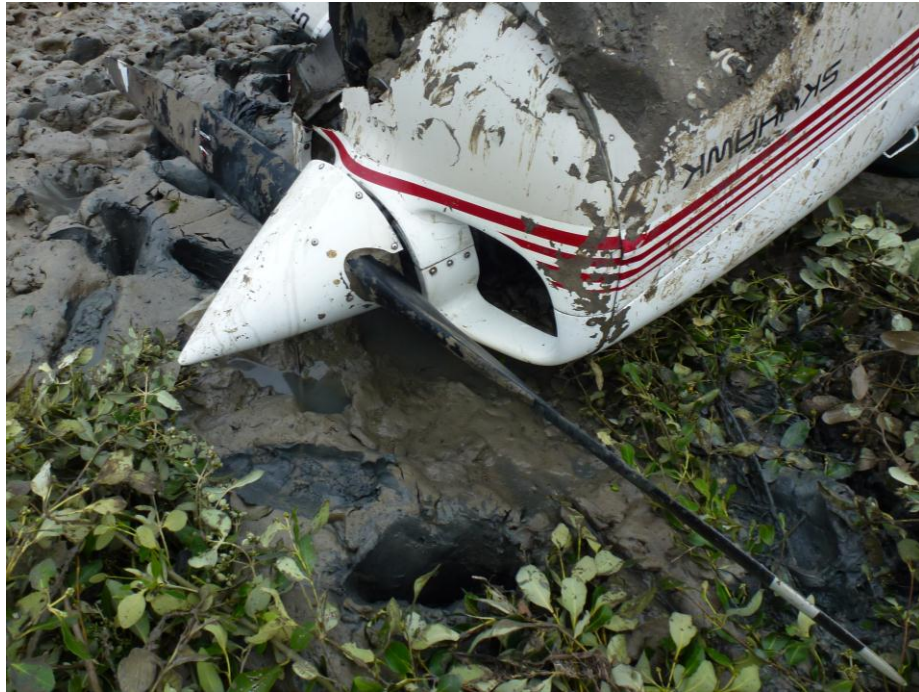
- No damage or scratch found on both propellers.
- The left part of the engine cowling damaged.
- The tail section bent to the left.

**Figure 5: The propeller condition**

The wreckage examination found no damage the propeller, which indicated that the propellers were not rotating during impact. This condition was consistent, with the information that the engine was producing low power when impacted the ground.

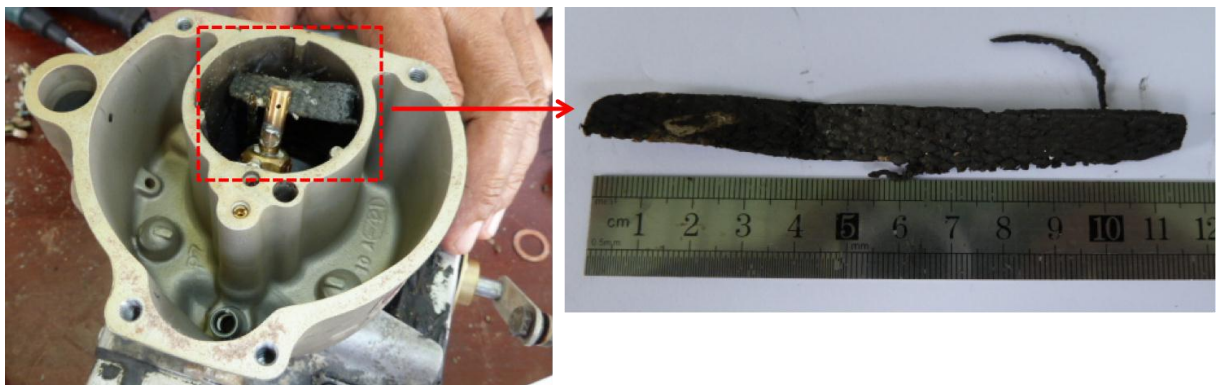
The inspection revealed there was a piece of rubber in the carburetor heater or induction airbox with dimension of 12 cm length and 0.8 cm width (figure 7) in the throttle chamber of the carburetor.

**Figure 7: The rubber in the carburetor**

The detached rubber of the induction airbox while the engine was running would be sucked into the carburetor air intake. The presence of the rubber in the throttle chamber interrupted the supply of fuel air mixture to the piston chamber and resulted in the improper combustion. The improper combustion was identified by the pilot as the engine was hesitating.

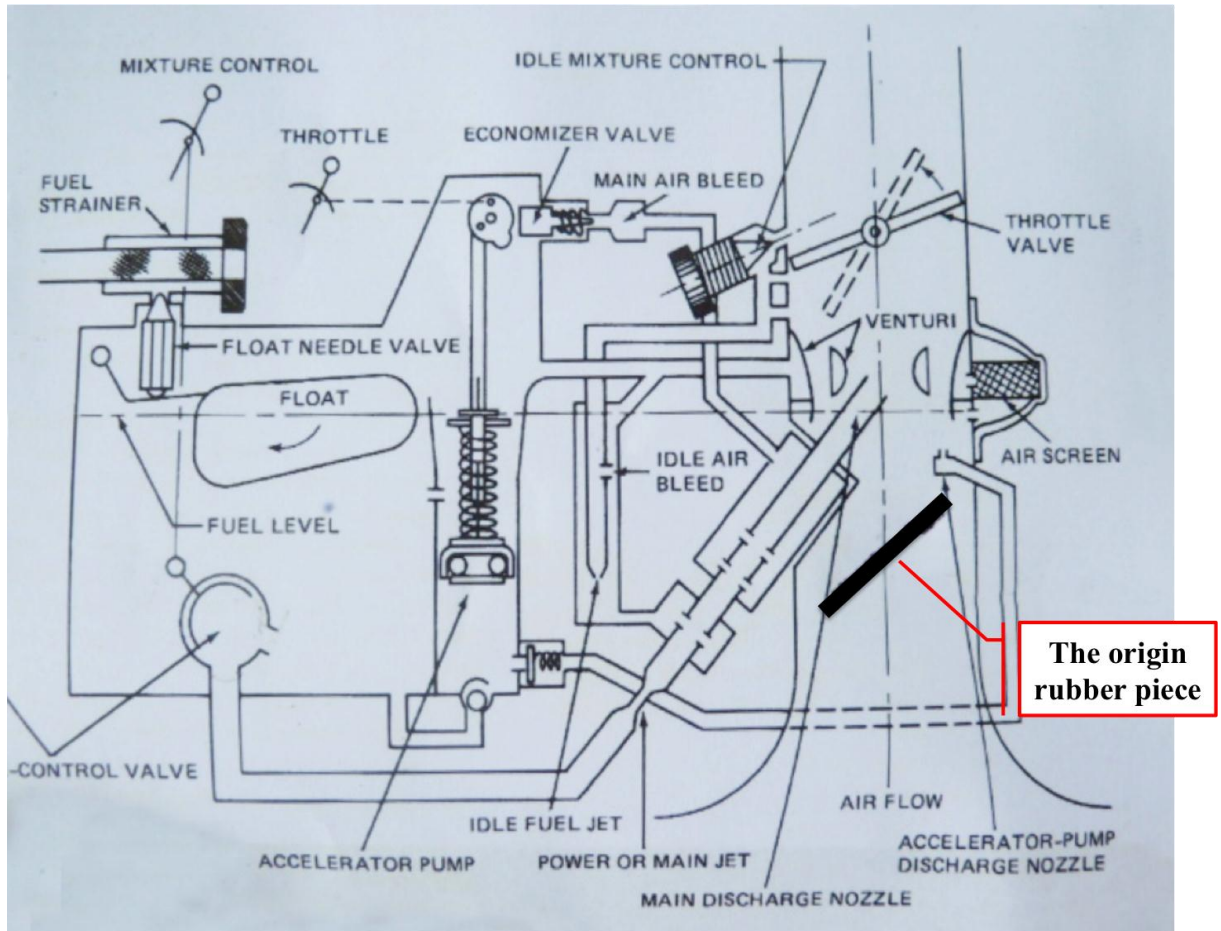
**Figure 8: The rubber location in the carburetor**

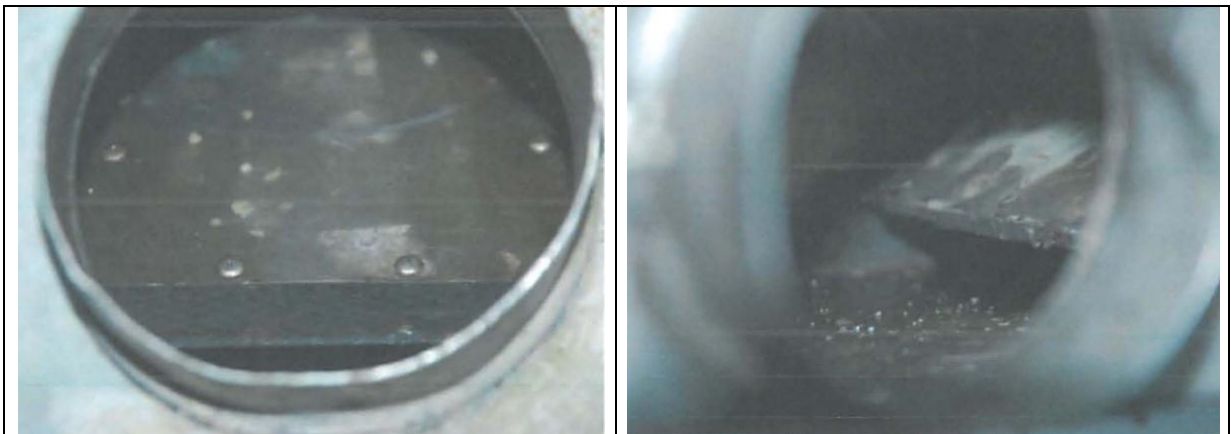
The investigation found that the origin of the rubber was the part of flapper valve of the carburetor heater or induction airbox. The induction system equipped with a flapper valve that was fitted with rubber on both sides. The examination of the flapper valve found that one of the rubbers was still intact and the other had detached.

**Figure 9: Flapper valve side with the rubber still intact (left picture) and the side with detached rubber (right)**

The investigation found that the detached rubber was wider than the attached rubber. Asymmetric size of the rubber on the flapper valve would have no effect on full open position. On close position, the correct size of the rubber would touch the box wall, while the wider side would hit the box wall and bent the rubber.

The detachment of the rubber of the flapper valve was presumably due to repeated bending action against the box wall at the position close and caused fatigue of the rubber.

The detachment of the rubber flapper was presumably due to repeated bending action against the box wall at the position of “CLOSE” caused fatigue of the rubber, therefore the KNKT recommends the DGCA to prevent detachment of the flapper valve rubber, the mechanism should be adjusted so that when the flapper is set to CLOSE position, the rubber edge is not bent against the wall.

The installed rubber dimension was improper which subsequently broken and detached. The installation of the rubber was not required special shop for repair, therefore the KNKT recommends the DGCA to oversight the quality assurance system of the maintenance facility to ensure the product meets the part specification.

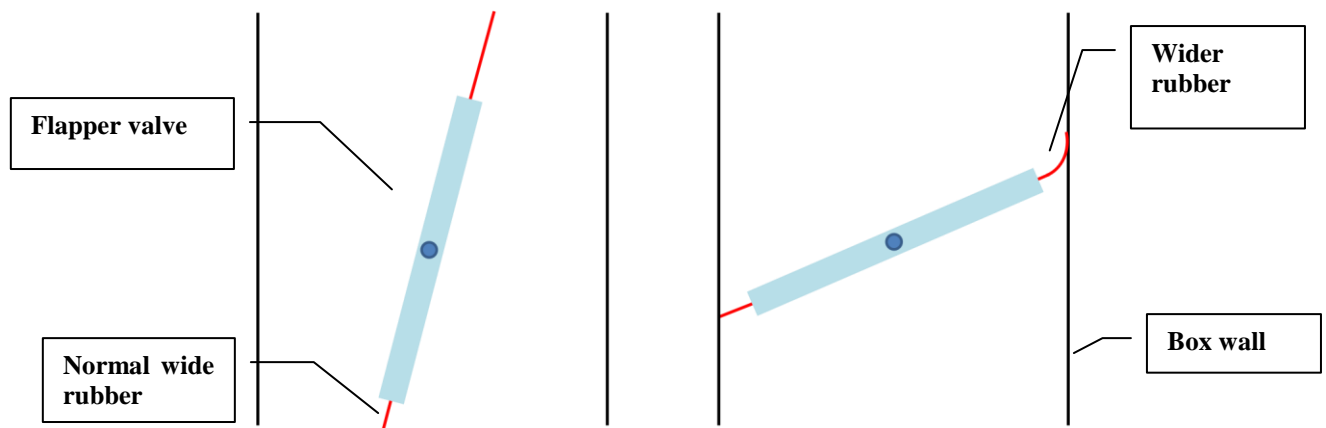
**Figure 10: Illustration of the flapper valve and the rubber position on open position (left picture) and close position (right picture)**
