FINAL
KNKT.11.02.03.04

Aircraft Accident Investigation Report

**PT. Sabang Merauke Raya Air Charter
CASA 212 - 100 ; PK-ZAI
30km North of Raja Haji Fisabilillah Airport,
Bintan Island, Riau
Republic of Indonesia**

12 February 2011

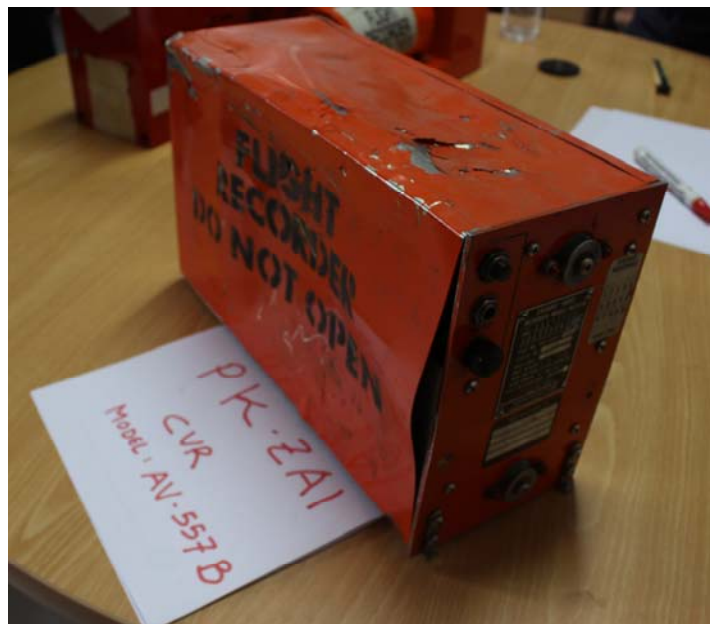
Figure 3: The Cockpit Voice Recorder

The CVR casing was damaged due to impact. The CVR was downloaded in the NTSC facility.

The CVR contained 30 minutes of recording of poor quality. The CVR recorded only the communication between the SIC and Tanjung Pinang APP. There was no recorded communication between the pilots and all with the observer during this flight.

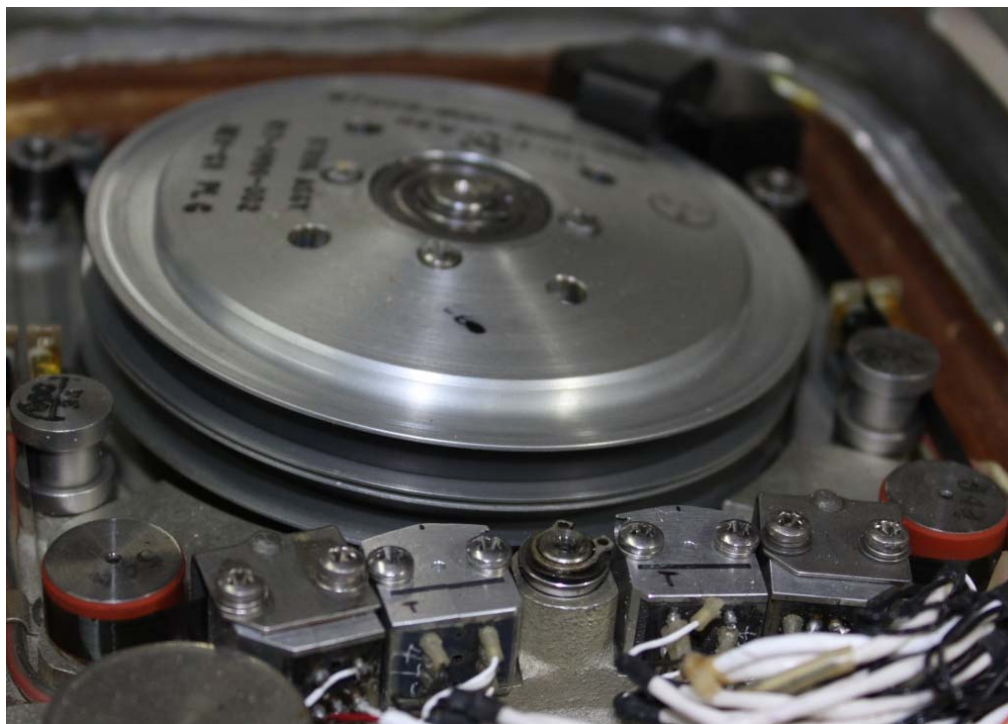
Figure 4: the CVR electric cable detached from its connection on central and PIC microphone sensor

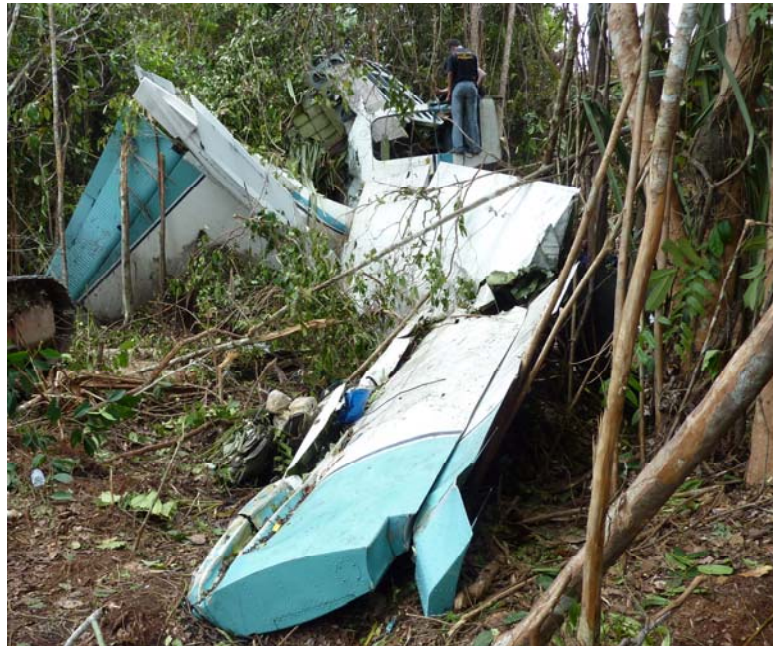
Figure 5: PK-ZAI aircraft after the accident

The main wreckage was found in the jungle rich of peat at the northern part of Bintan Island.

The forward fuselage including the nose section and, the propellers and the engines, were sunk down to 4 metres deep into the soft soil. The left wing was broken and disintegrated from the fuselage. The right wing was broken at the middle section in the area of the right engine attachment. The empennage section was broken and folded forward. The propeller blades of both engines were bent rearward.

The first impact mark was found on the trees about 16 metres to the west of the main wreckage. There was a broken tree at 6 metres above the ground.

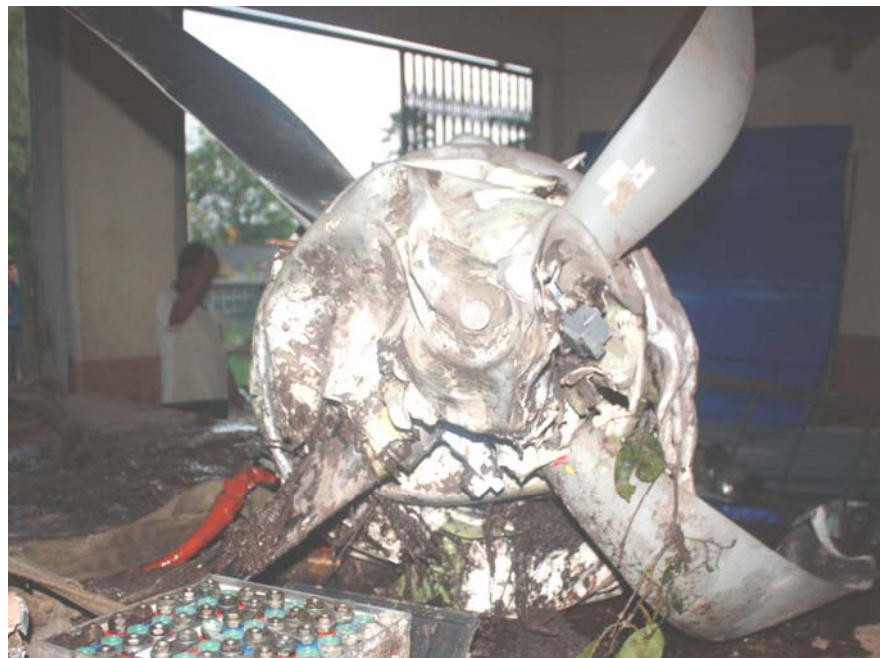
Figure 6: PK-ZAI Left Engine and Propeller

The left propeller blades were indicated no rotation prior impact,

The propellers piston distance position to the cylinder, the counterweight facing forward, and the propeller pitch were on fine pitch or reverse position.

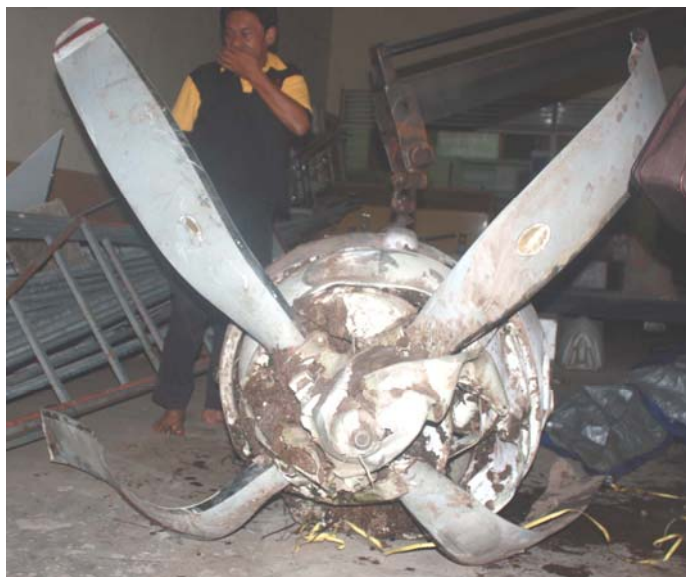
Figure 8: PK-ZAI Right Engine and Propeller

The propeller piston detached from its threads and the propeller

The link arm pushed toward to feather, opposite to the force acting to remove the piston from the hub.

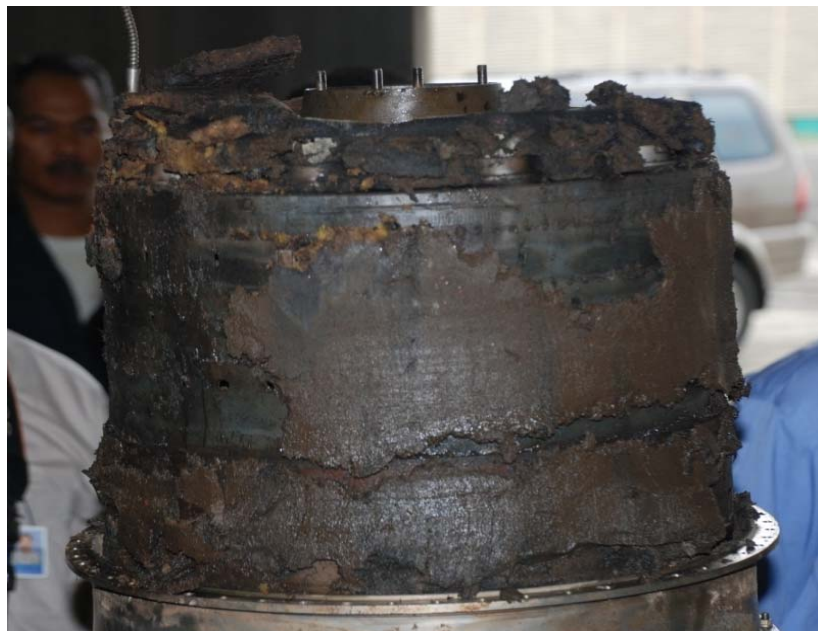
During the engine tear down, the investigation found the impeller was blocked by wood and ground debris, the transfer gear shaft was broken, the Hot Section was muddy, and the NTS transfer tube O-ring was damage.

Figure 10: Mud on Hot Section of Engine S/N. P-22327

The investigation of the left engine found the impeller was blocked by wood and ground debris, the transfer gear shaft was broken, and the Hot Section was muddy, It most likely the engine was on wind milling in a fine pitch blade propellers for some periods of time.

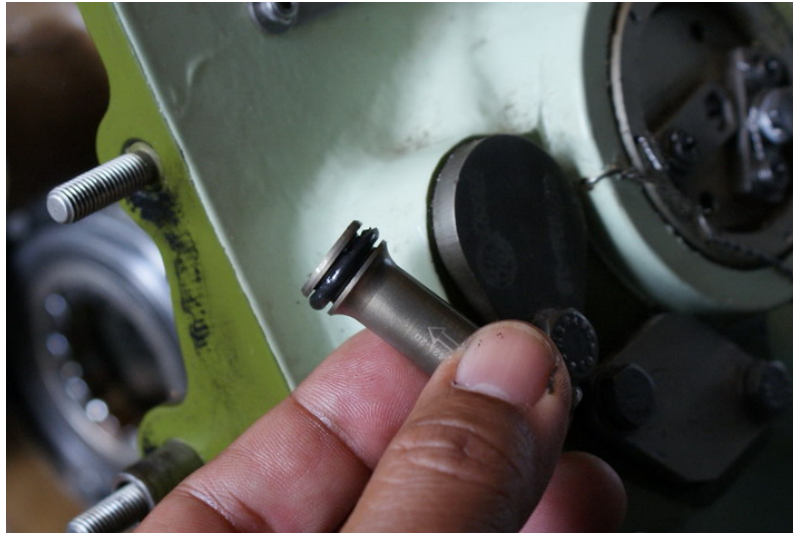
Figure 11: NTS Tube O-ring of Engine S/N. P-22327

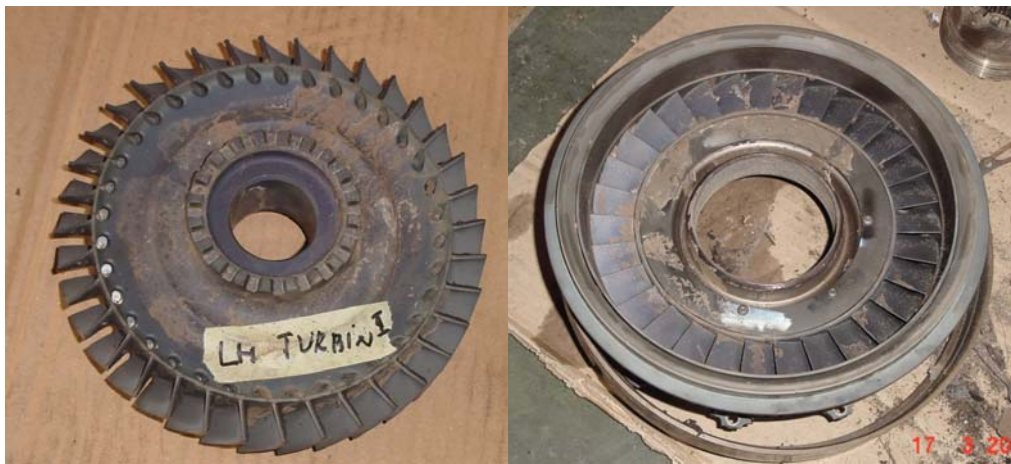
Figure 12: Turbine No. 1 of Engine S/N. P-22327, No sign of hot rotating impact

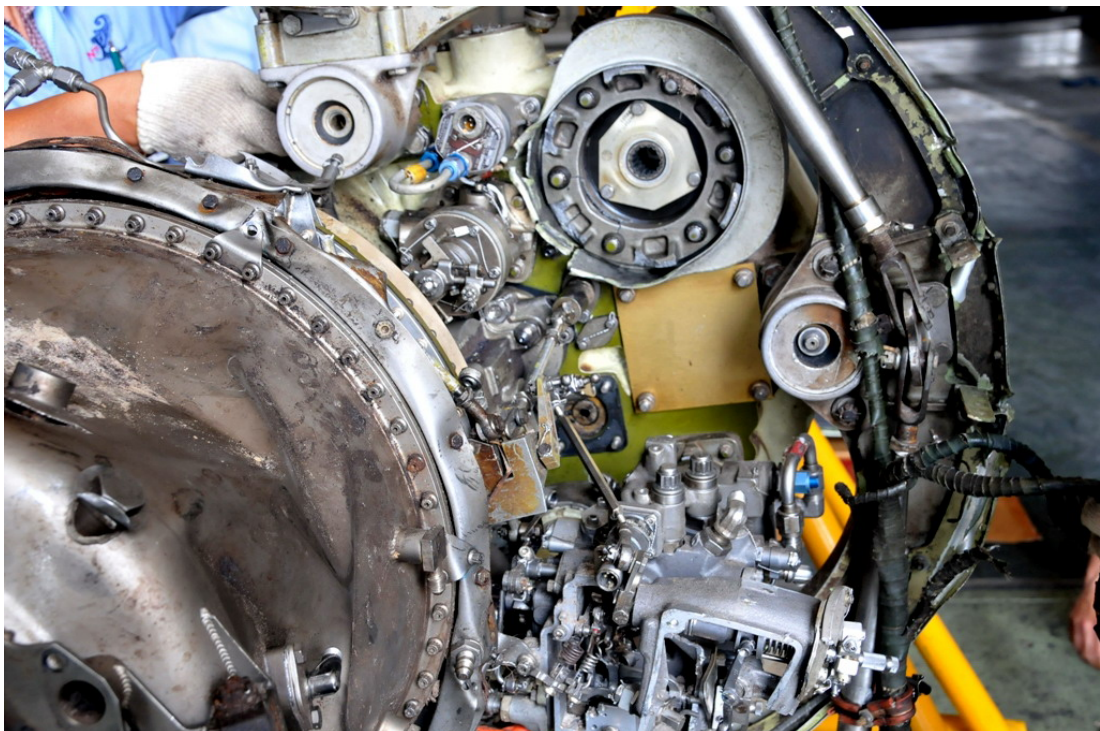
General condition of the engine number 2 was externally indicated damage as result of an impact. The FCU was broken, and the starter generator was detached.

Figure 15: Engine S/N. P-06217C, Starter Generator detached and FCU was Broken

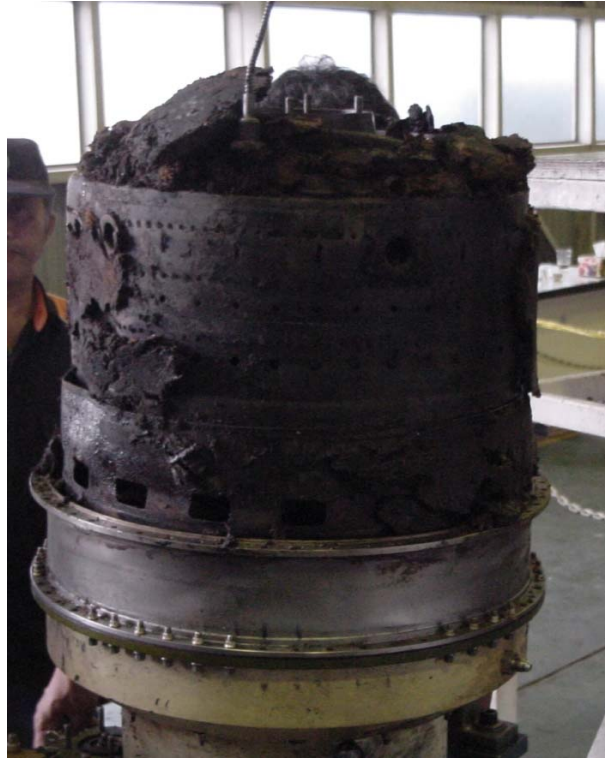
During the engine tear down, the investigation found the impeller was blocked by wood and ground debris, the transfer gear shaft was broken, the Hot Section was filled by dried mud.

Figure 16: Mud on Hot Section of Engine S/N. P-06217C

The investigation of the right engine found the impeller was blocked by wood and ground debris, the transfer gear shaft was broken, the Hot Section was filled by dried mud.
