NATIONAL TRANSPORTATION SAFETY COMMITTEE

Aircraft Serious Incident Investigation Report

SilkAir PTE LTD
A319-133; 9V-SBH
Adi Soemarmo International Airport
Solo, Central Java
Republic of Indonesia
6 March 2012

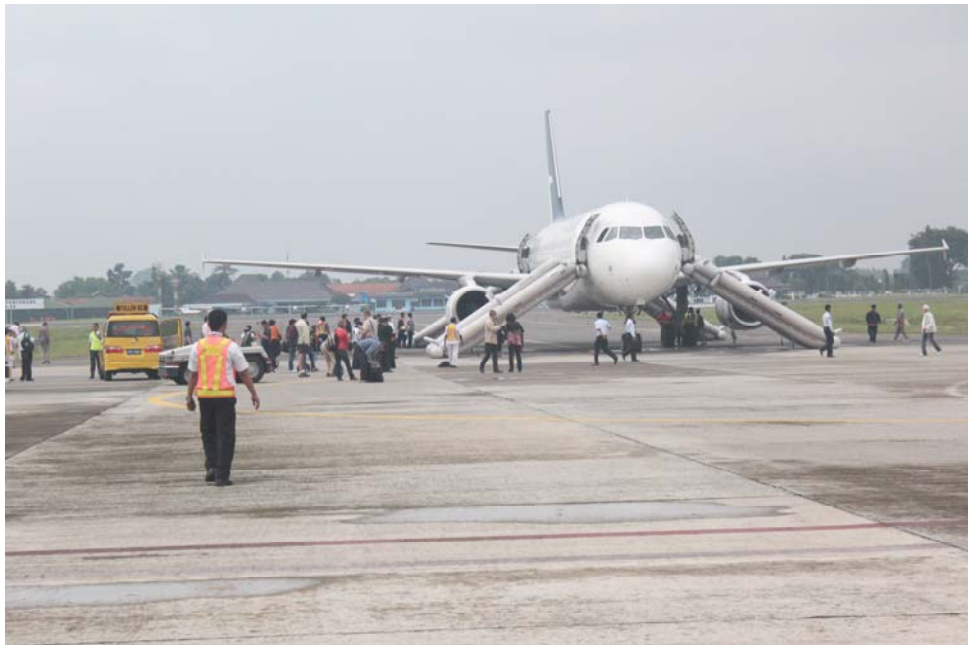
At 0204:04 UTC, the SLK pilot declared emergency and evacuated the passenger by the escape slides. One of the passengers had a minor injury during the evacuation.

Figure 1: 9V-SBH evacuation between the taxiway bravo and apron

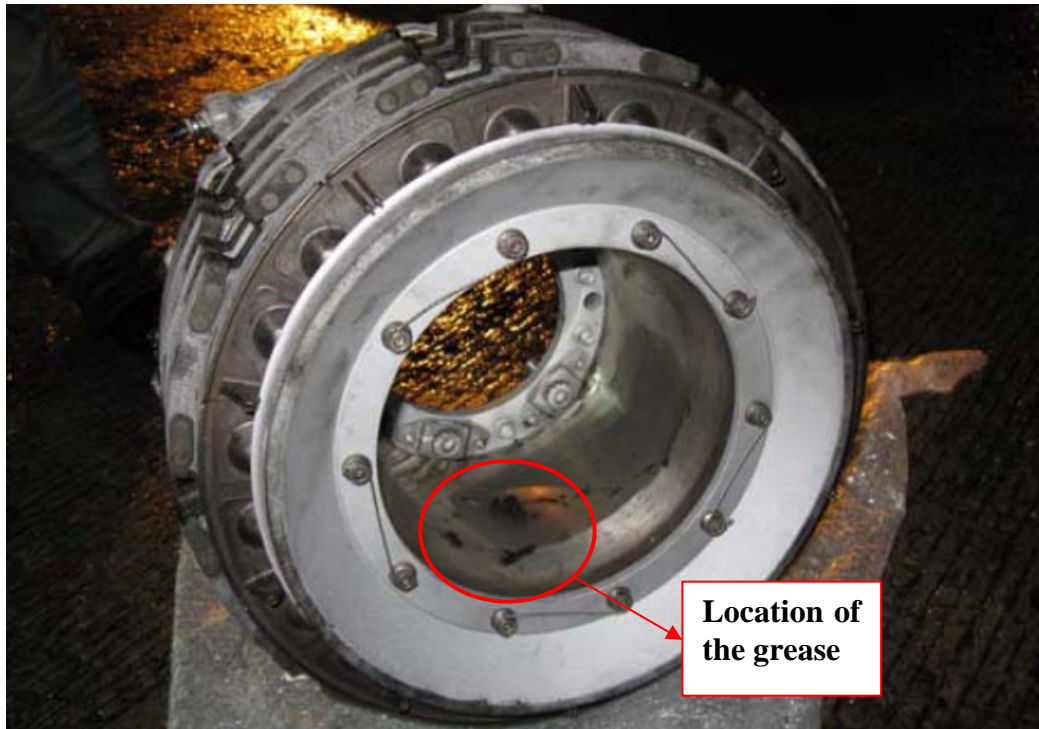
- There was no damage or sign of fire on the wheel and brake assembly number 2;
- Found dry/burnt grease of estimate size 8 cm³ on heat shield;
- The tire pressure was normal, no fuse plugs melted;
- There was no sign of any hydraulic leak or grease on brake number 2;
- There was no sign of damage on the axle sleeve number 2.

Figure 3: Residual grease on the brake number 2

During the installation of the wheel after brake replacement there was possibility of excess grease applied. On gear-up position, the grease could have migrate to the heat sink. The residue of grease with estimated size of 8 cm³ found on the heat sink was a positive indication of excessive grease applied. The grease heated during the brake application on landing and produced smoke.

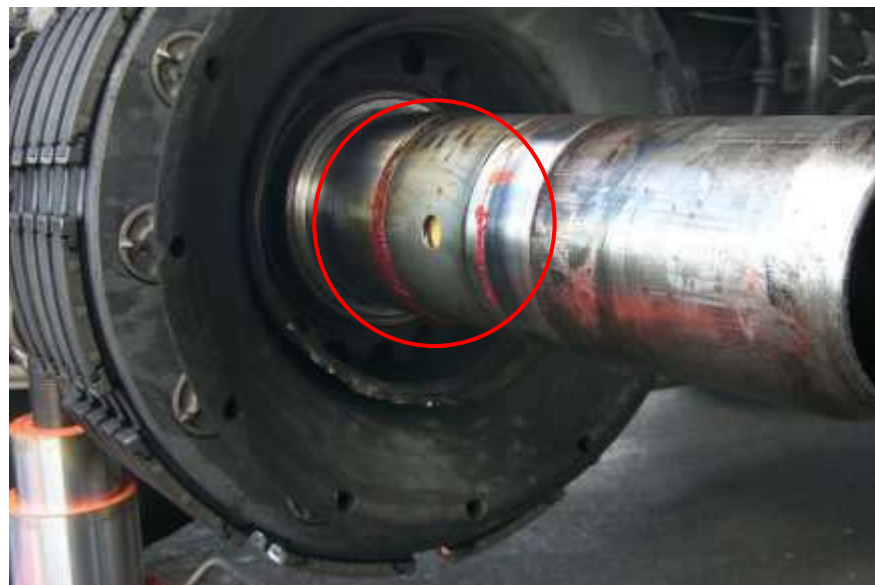
The brake unit number 2 (inner left main landing gear) was replaced prior the aircraft departed to Solo. During the installation of the wheel after brake replacement there was possibility of excess grease. On gear-up position, the grease could migrate to the heat sink. The grease is pushed by inner bearing up to torque tube bushing.

During the brake application on landing the temperature of the heat sink increased and heated the excessive grease and created smoke.

Figure 4: Hole that may allow excess grease to migrate to hot brake area
