FINAL
KNKT.12.02.02.04

Aircraft Serious Incident Investigation Report

**ERSA Eastern Aviation
PAC 750 XL ; PK-BSA
Bilai Airstrip, Papua
Republic of Indonesia**

04 February 2012

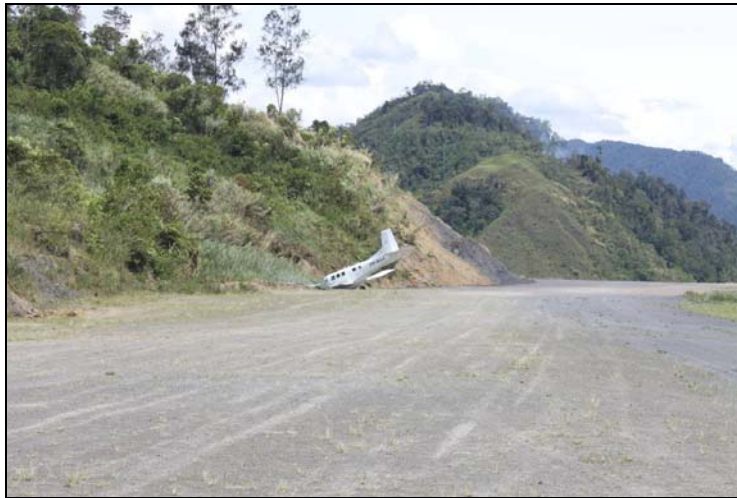
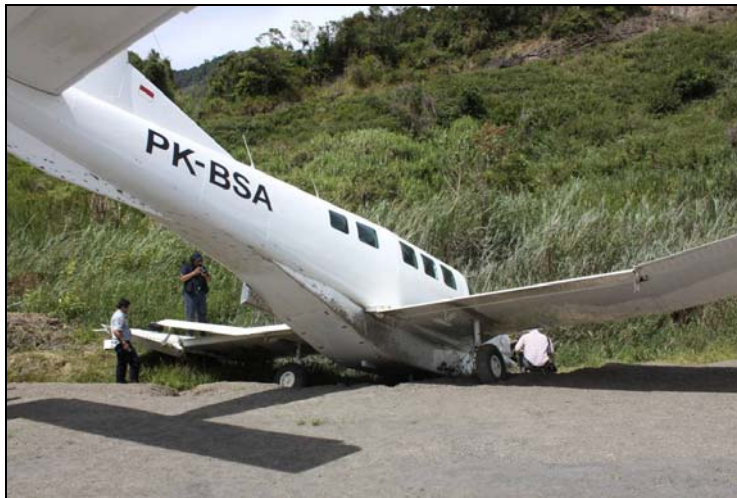
Figure 1: Last position of the PK-BSA aircraft

The aircraft approach in Bilai airstrip using runway 11. At 00.42 UTC the aircraft landed and experienced bouncing twice during touchdown, and veered to the left until hit the hill side even the pilot tried to keep centerline using brake and power reverse and nose gear was sank into the mud

The left flap and aileron was broken, the left main landing gear sited 90°, and the left upper wing skin tear.

The last aircraft heading was 038°, at the coordinate S 03°44'080" E 136°51'386", on the elevation about 6,000 feet.

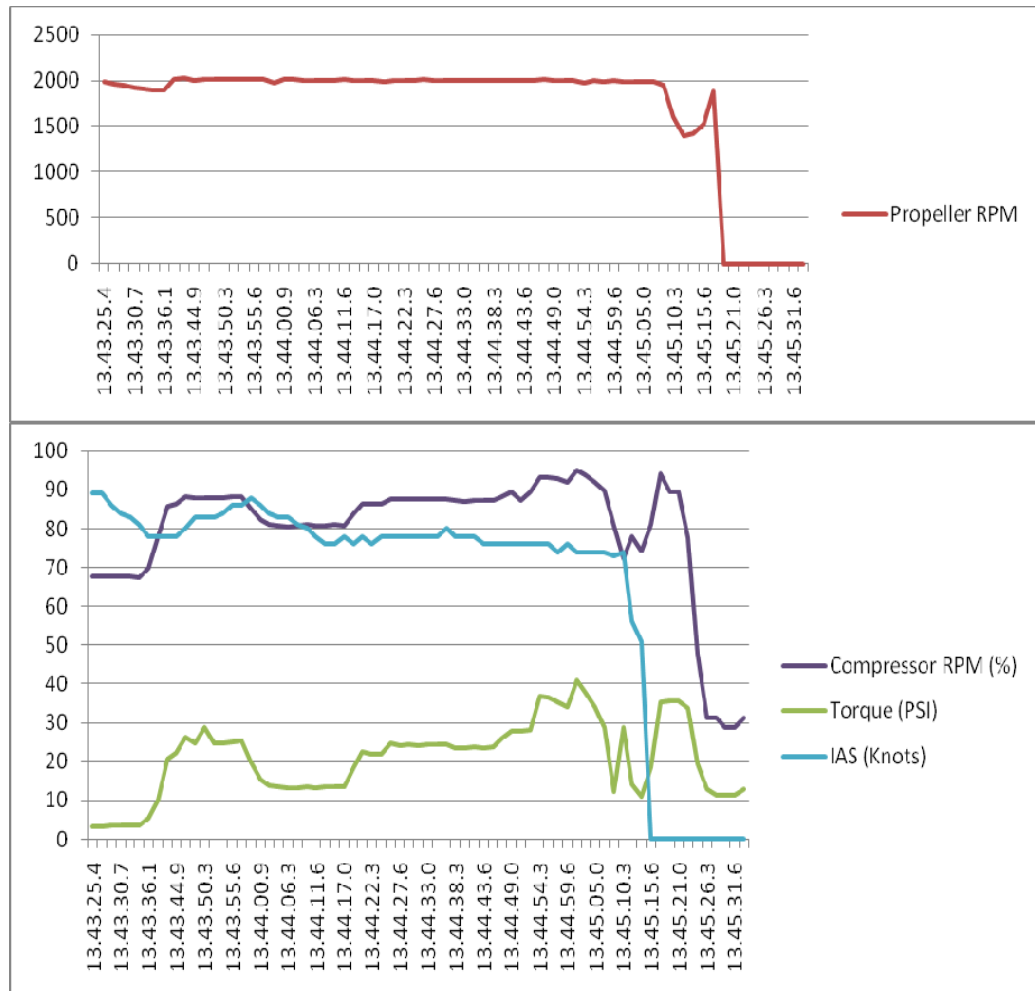
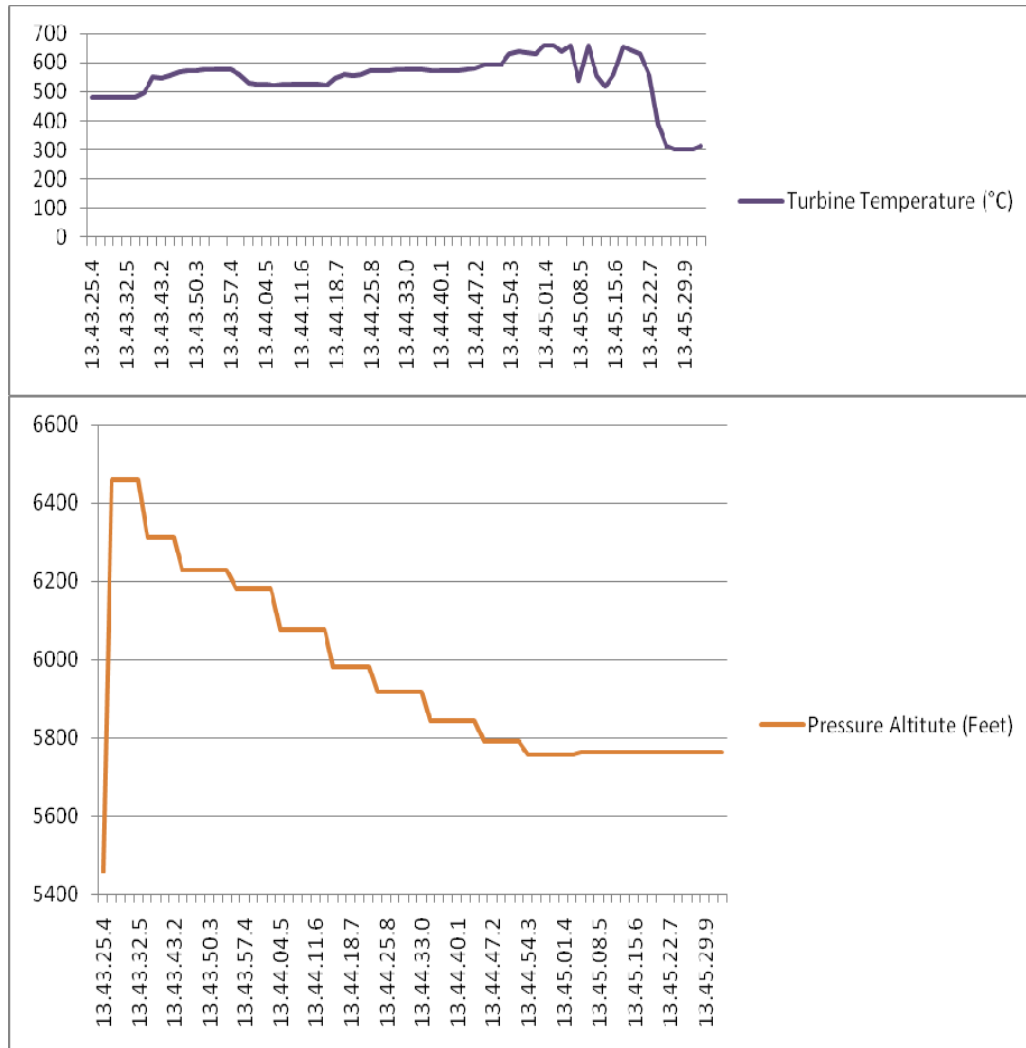
Figure 2: Engine trend monitoring data graphic

Referred the engine & performance trend monitor trend data that during short final the following data was recorded:

The following data was indicated the aircraft stop and possibly start to hit the ground as the recorded parameter was varied at the time of 13.45.15.6 - 13.45.31.6 Compressor RPM 81.2% - 94.1%, Propeller RPM. 1521- 1885 RPM, torque 18.6 - 35.2 PSI, Turbine Temperature 559 - 654 C, Indicated Air Speed 00 Kts, Pressure altitude. 5764 Feet (see Figure 2 and Appendix A)
