**KOMITE NASIONAL KESELAMATAN TRANSPORTASI
REPUBLIC OF INDONESIA**

FINAL
KNKT.12.10.21.04

Aircraft Serious Incident Investigation Report

Boeing 737-300; PK-CJT

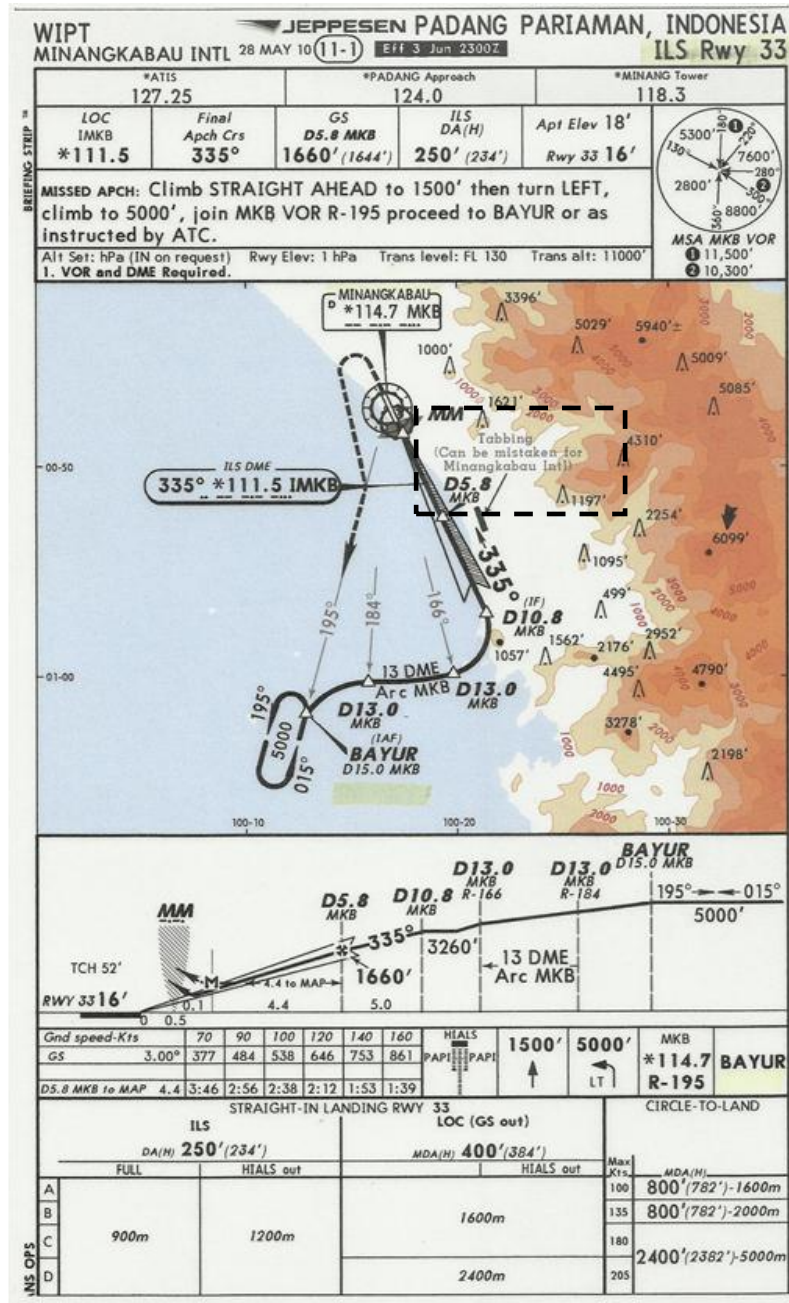
Figure 1: ILS approach chart procedure runway 33 Minangkabau Airport

The existing approach procedure of the ILS runway 33 Minangkabau Airport showed the localizer course was 335°, the Decision Altitude (DA) was 250 feet, the glide slope of 3° and vertical speed for aircraft category C⁸ was 753 feet/minute. The chart also contained information: *Tabbing (can be mistaken for the Minangkabau Intl)*.

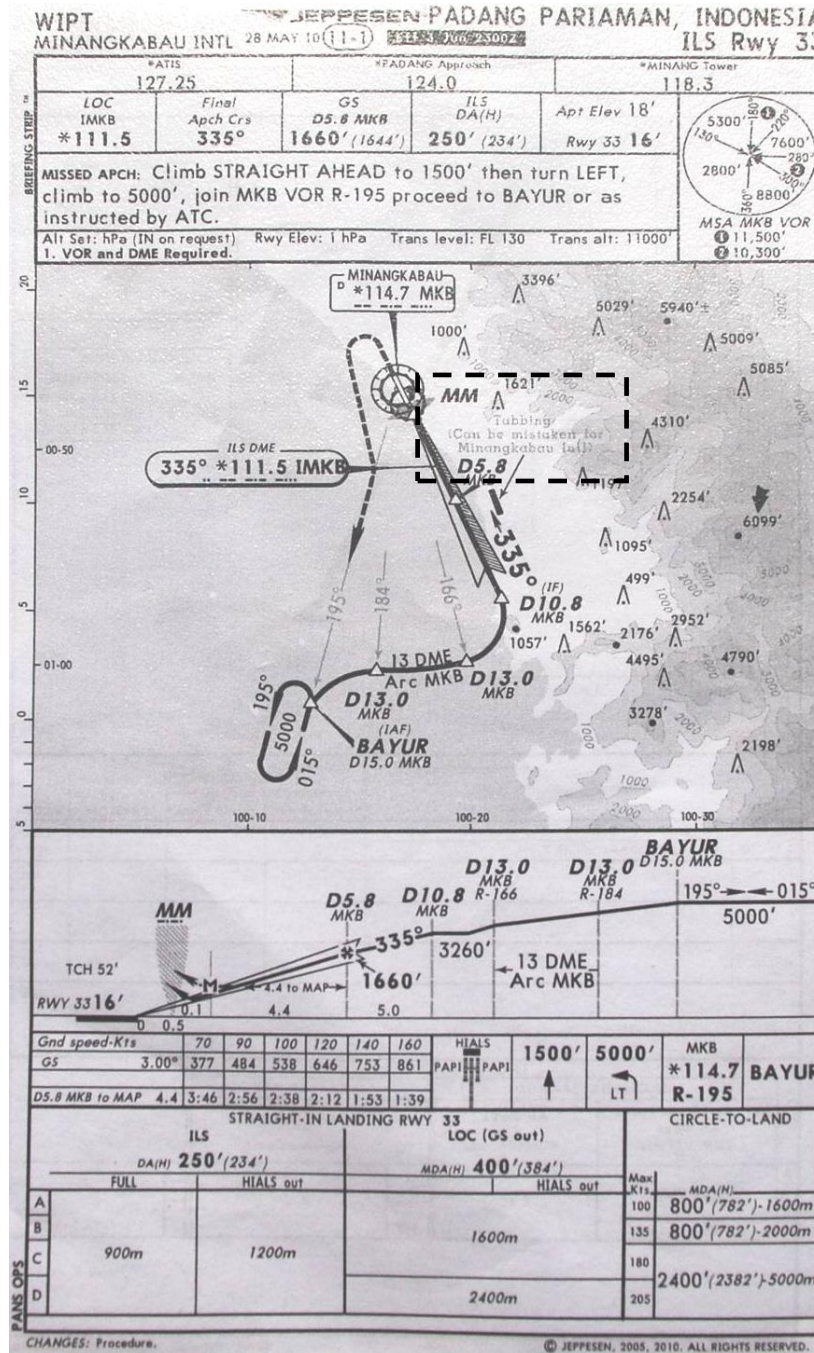
Figure 2: The photocopy of ILS approach chart procedure used by the pilot

During the flight, the pilots used a black and white photocopy of instrument approach charts procedure. The information of: *Tabbing (can be mistaken for the Minangkabau Intl)*, as shown on dash box figure 2, was not clearly readable.

- The unclear significant information in the copy (black and white) of the ILS approach chart might have missed by the pilot and might reduce the pilot awareness to the adjacent airport with similar runway direction and dimension.
- The previous experience of false VOR might have made the approach was continued in an un-stabilized approach condition.
- The information of incorrect runway was not provided during the abnormal approach as it was not observed.

To ensure additional information or caution of existing hazard is informed on published Aeronautical Information Publication, including on Instrument Approach Chart.
