FINAL
KNKT.12.10.22.04

Runway Excursion Investigation Report

**PT. Sriwijaya Air
Boeing 737-400; PK-CKN
Supadio International Airport
Pontianak, West Kalimantan
Republic of Indonesia**

19 October 2012

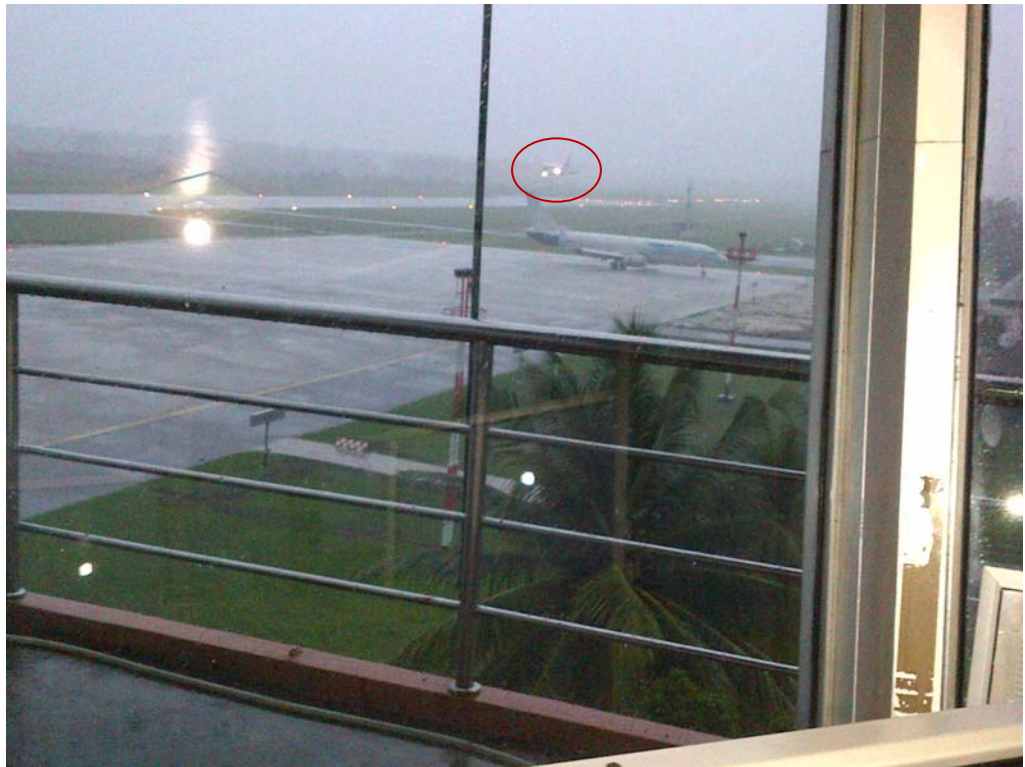
Figure 1: The aircraft picture taken by tower controller prior to touchdown

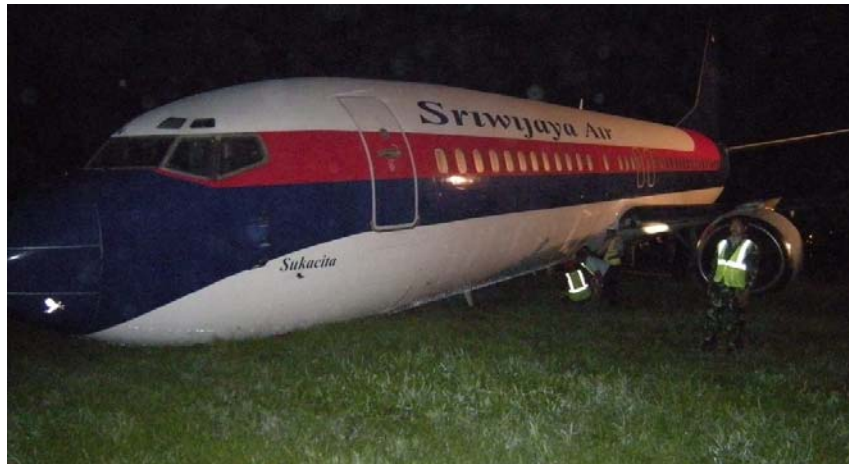
The aircraft stopped with the main wheels at about 2 meters from the end of stop-way runway 15 and the nose wheels sunk into the soft surface.

Figure 2: Final position of the aircraft

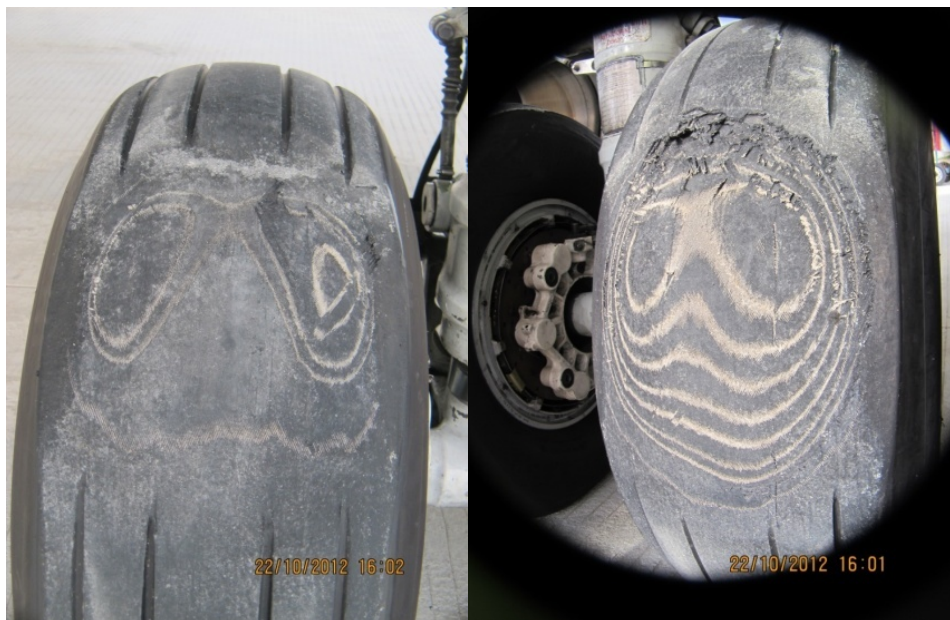
- The nose landing gear folded backward
- The nose wheel doors detached
- Reverted rubber found on the tire number two and number three (the inner main wheel).

Figure 3: The tire damage found at inner side of both main wheels

The observation found that on the tire number two and number three which were the inner main wheels were found reverted rubber marks (figure 3), and there was white tire marks on the runway (figure 7). The reverted rubber and white tire marks are the indication of hydroplaning.

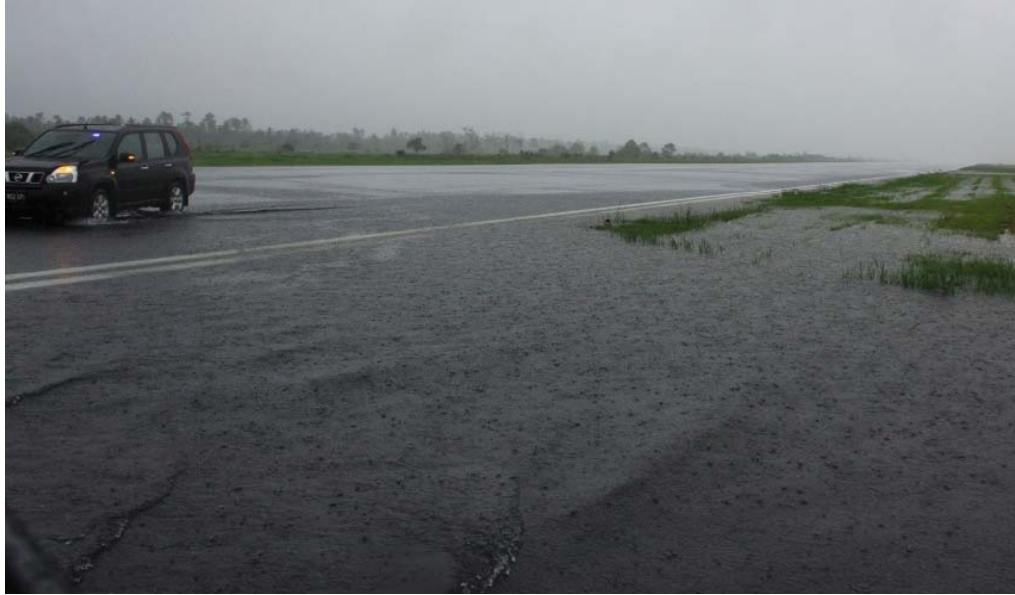
The KNKT investigators performed observation to the runway condition during a heavy rain one day after the occurrence. The observation found standing water at several areas in the runway and standing water approximately 15 cm on the intersection runway and taxiway Charlie which was the taxiway to Air Force apron (figure 5).

Figure 5: Standing water on intersection taxiway Charlie

Based on the observation of the runway condition during a heavy rain (figure 5) one day after the occurrence, the investigation found that several standing water areas on the runway. The worst depth was approximately 15 cm of standing water on the intersection runway and taxiway Charlie area.

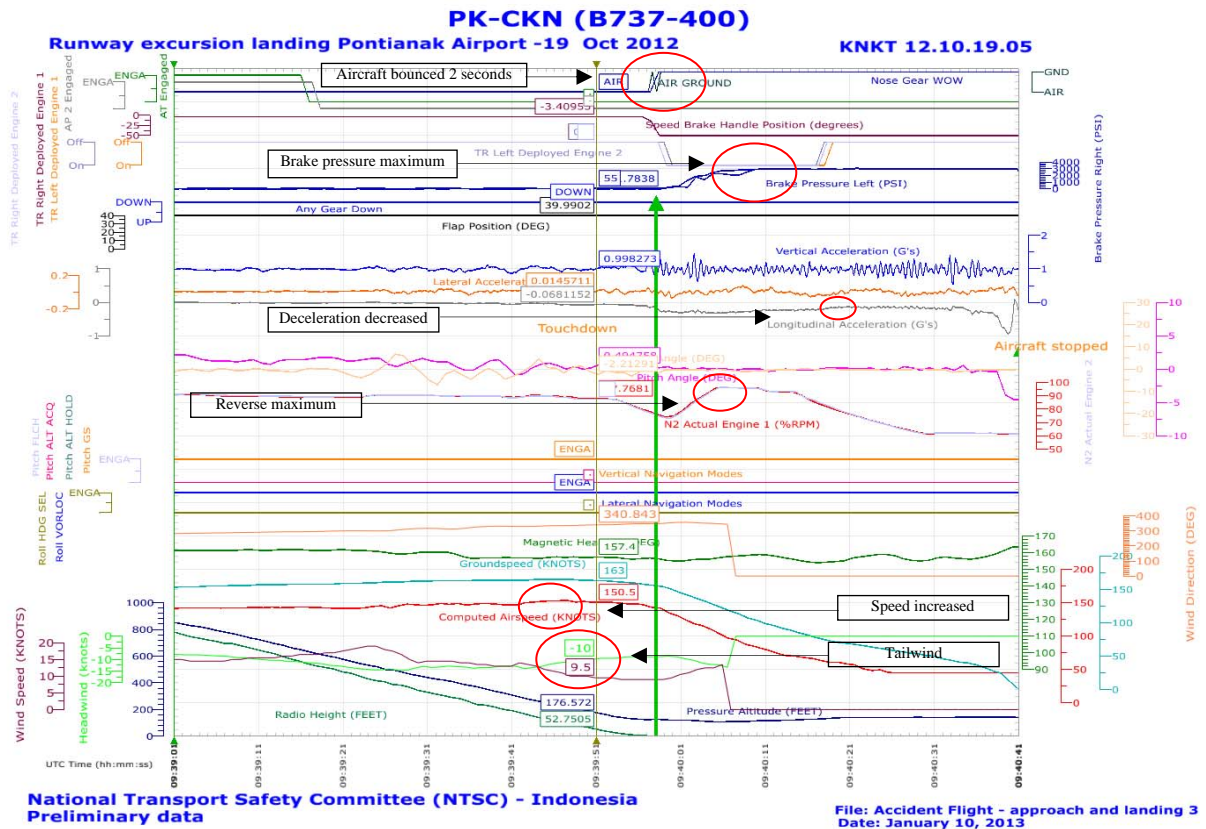
- a. The approach path was relatively steady.
- b. After passed 500 ft, the aircraft speed slightly increased.
- c. At 50 ft, the tail wind component was 10 kts the aircraft speed was 150 kts and ground speed 163 kts.
- d. The aircraft bounced for 2 seconds with aircraft speed was 143 kts and groundspeed 156 kts.

- e. During the landing roll, both thrust reversers were deployed and N2 recorded up to 96% and brake pressures were relatively equal up to maximum pressure of 3,000 psi.
- f. The longitudinal acceleration recorded approximately -0.3 G on the initial landing roll and gradually reduced to approximately -0.12 G. The longitudinal acceleration increased prior to aircraft stop.

Figure 6: Graph of FDR data

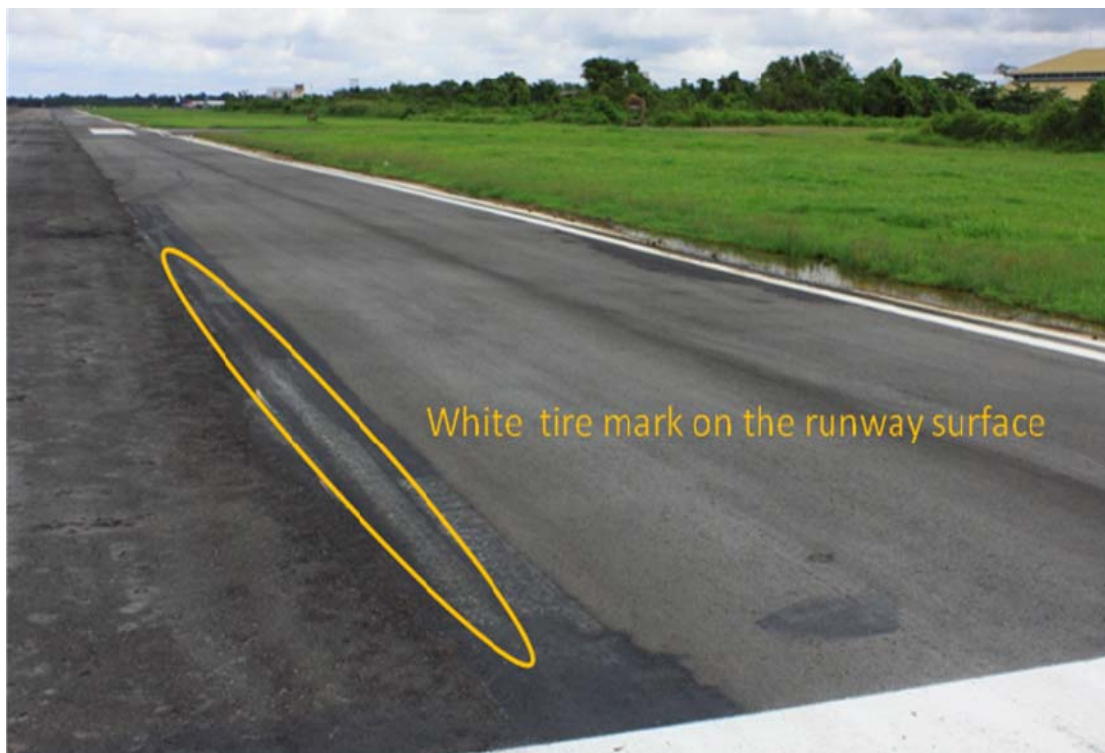
White mark of the tire was found on the runway.

Figure 7: White mark on the runway

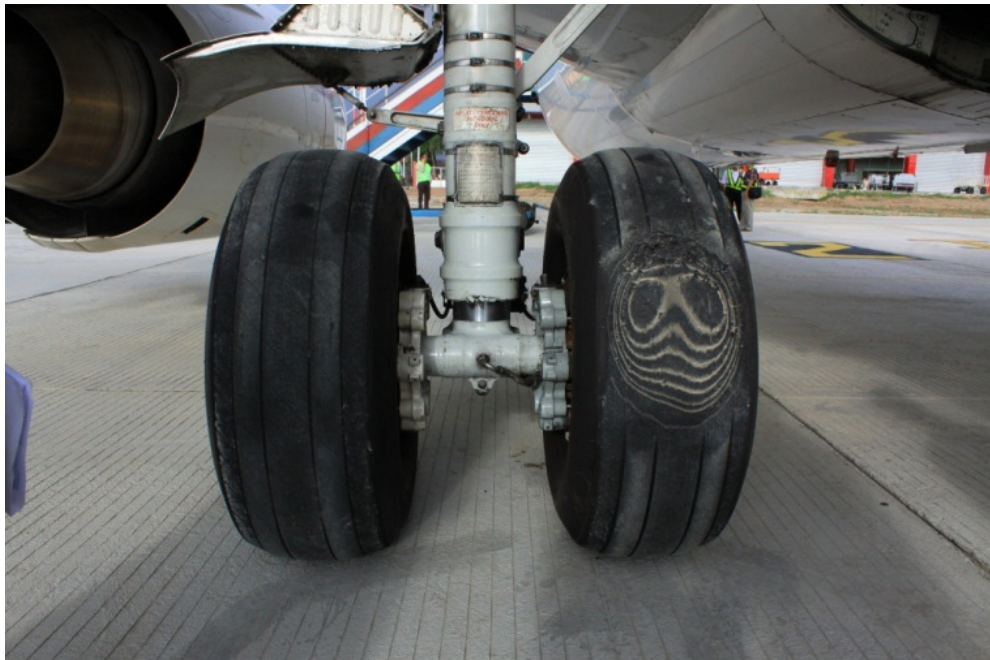
The nose wheel sunk into the ground up to the nose belly. The number two and three main wheel tires were spot and found reverted rubber marks.

Figure 8: Spot and reverted rubber on the main wheel number 2

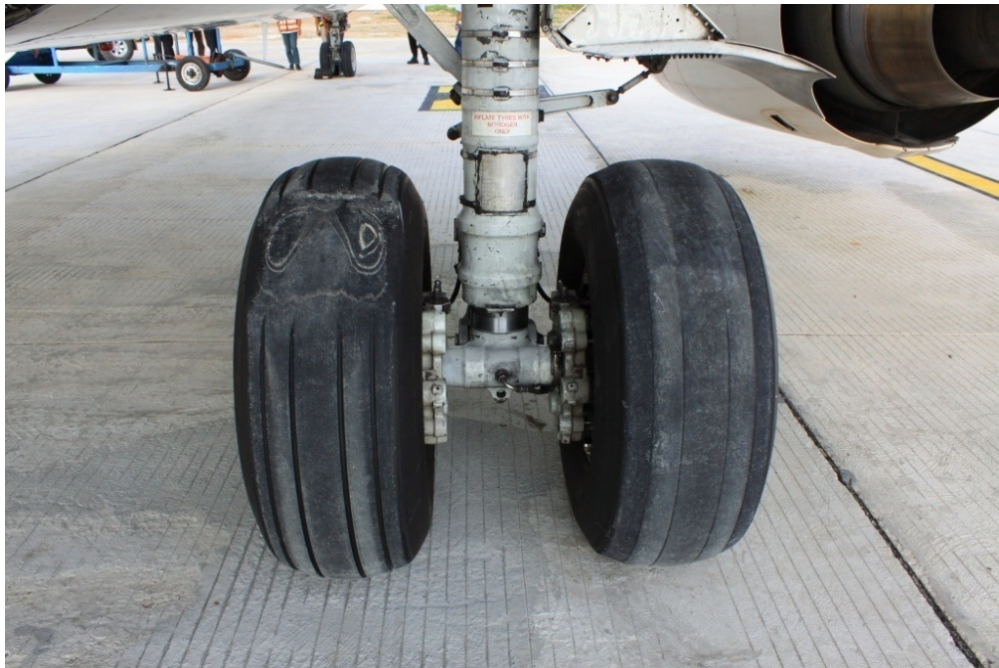
Figure 9: Spot and reverted rubber on the main wheel number 3
