NATIONAL TRANSPORTATION SAFETY COMMITTEE

Aircraft Accident Investigation Report

**PT. Intan Angkasa Air Service
PA-31-350; PK-IWH
Mayang Hill, Bontang
East Kalimantan
Republic of Indonesia**

24 August 2012

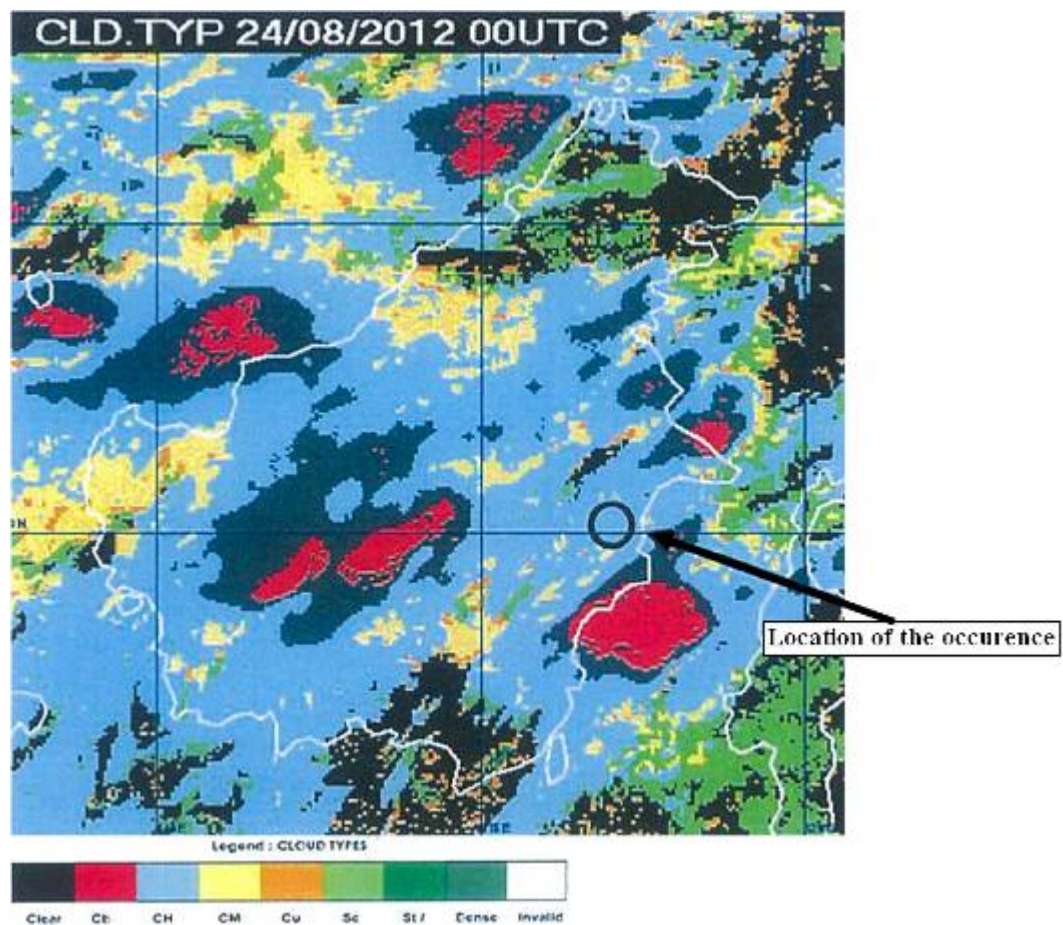
Figure 1: Satellite image at 0000 UTC

The analysis of the BMKG based from the satellite images, the weather surrounding the accident site was partially cloudy with towering cumulus type clouds.

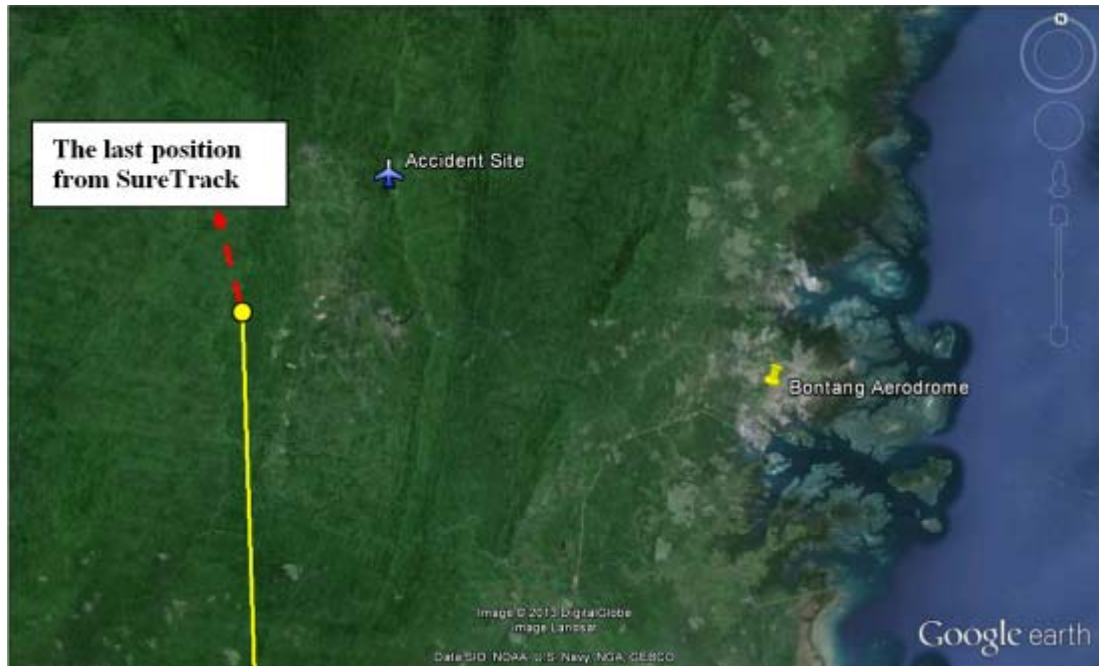
Figure 3: Bontang Aerodrome relative to the accident site

The Bontang Info officer observed dark cloud and rain on the west of Bontang Aerodrome.

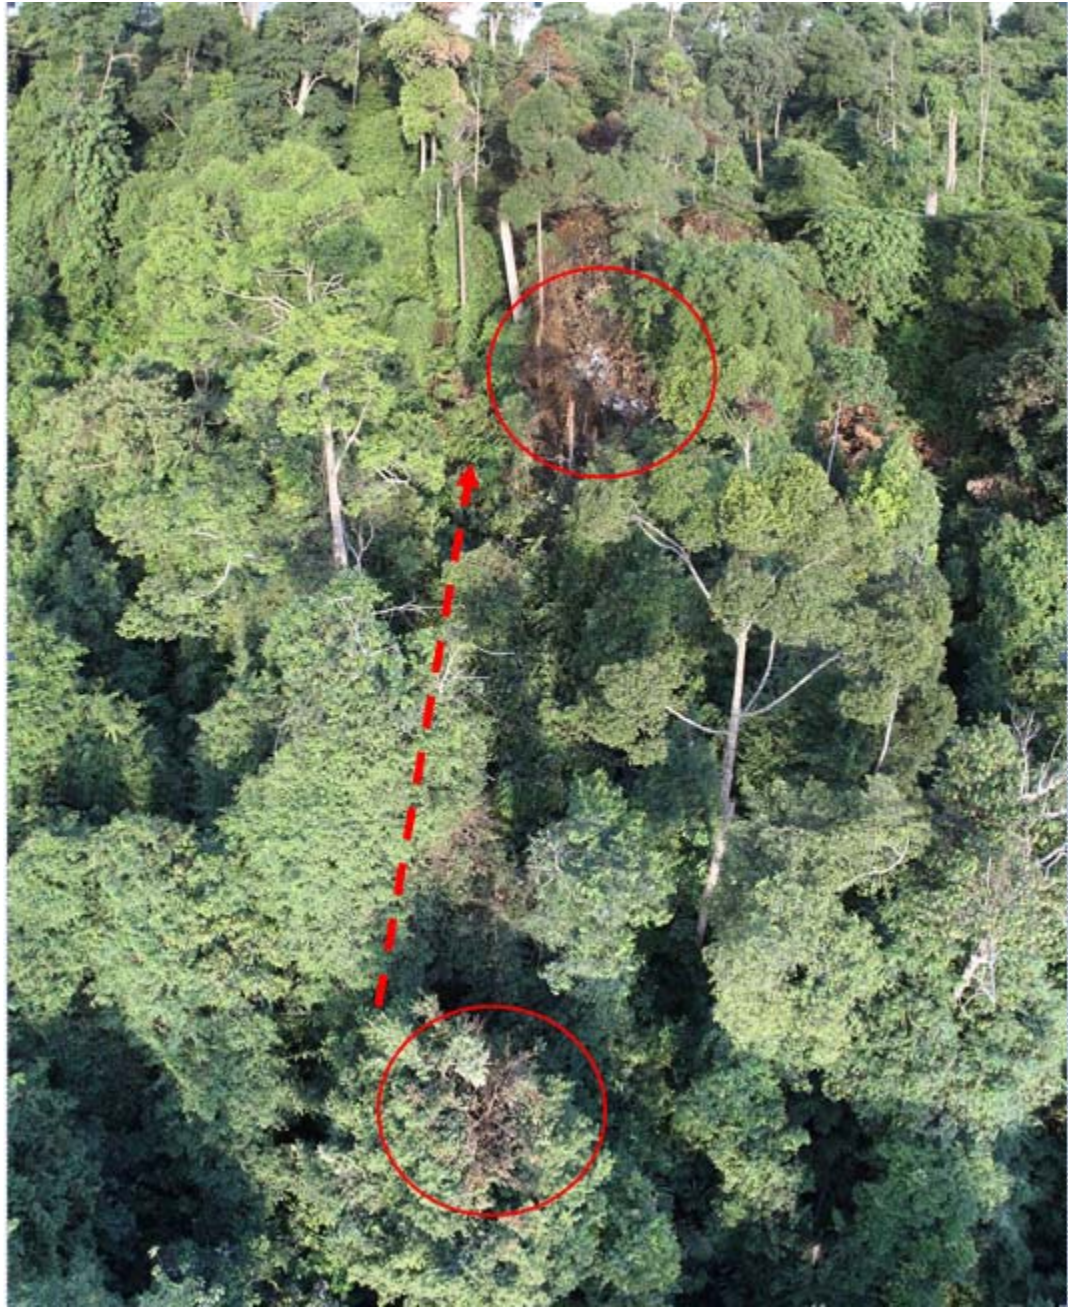
Figure 4: The final path of the flight

At approximately 100 meters elevation below the main wreckage were found dry leaves on the top of trees that indicated the flight path of the aircraft

At approximately 100 meters elevation below the main wreckage were found dry leaves on the top of trees that indicated the flight path of the aircraft. The last impact was approximately 1,200 feet AMSL. The flight path track on the tree tops indicated that the aircraft was climbing prior to impact.

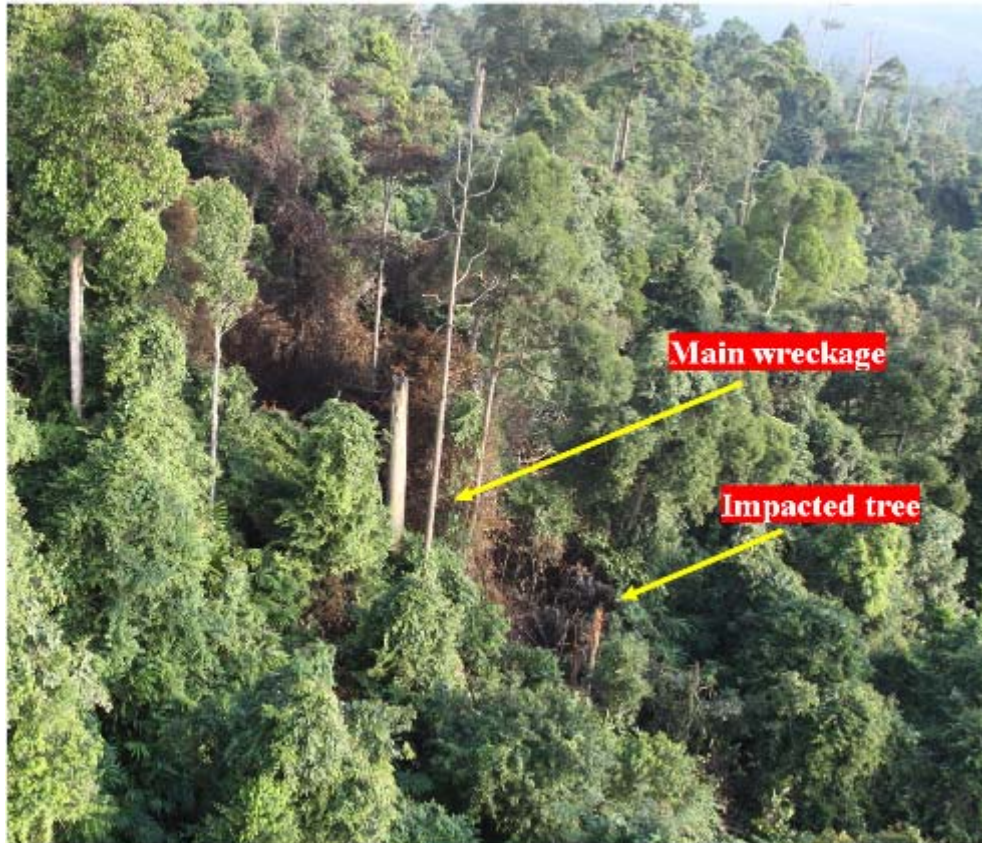
Figure 5: The impacted tree relative to the main wreckage

The aircraft impacted a significant sized tree before impacting terrain with the direction from the trees to last impact was approximately on a heading of 114°M. The distance from the tree to the last impact was 18 meters.

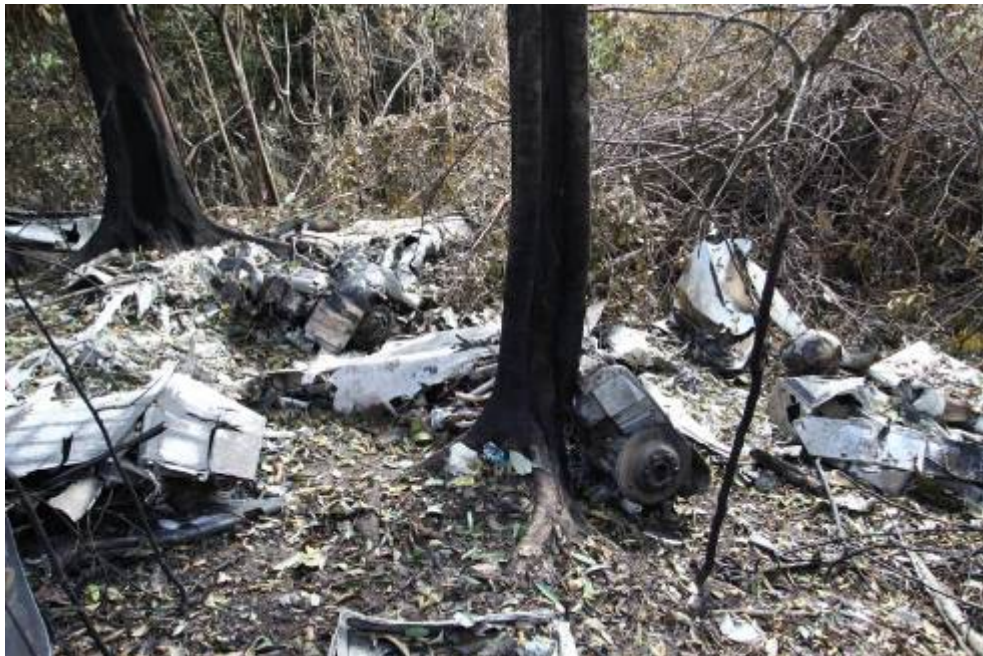
Figure 6: The main wreckage

The engines were found close to each other with the right engine in front of the left engine toward the direction of flight. The propellers were detached from the engines.

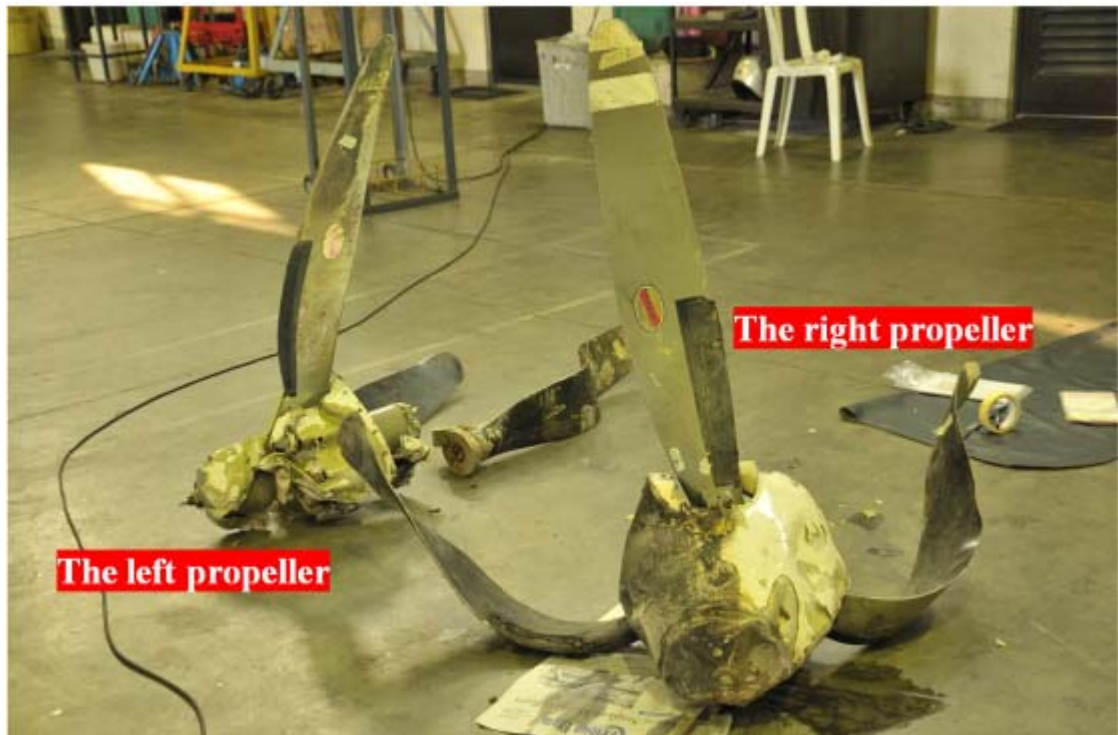
Figure 7: The propellers

Both engines sustained extensive impact damage. Both propellers were detached from each crank shaft. One blade of the left propeller assembly was detached from the hub. All blades of both propellers bent rearward and in rotational direction. The damage to the propellers was consistent with both engines operating at impact (Figure 7).

The propeller examinations showed that the engines were running at the time of impact.

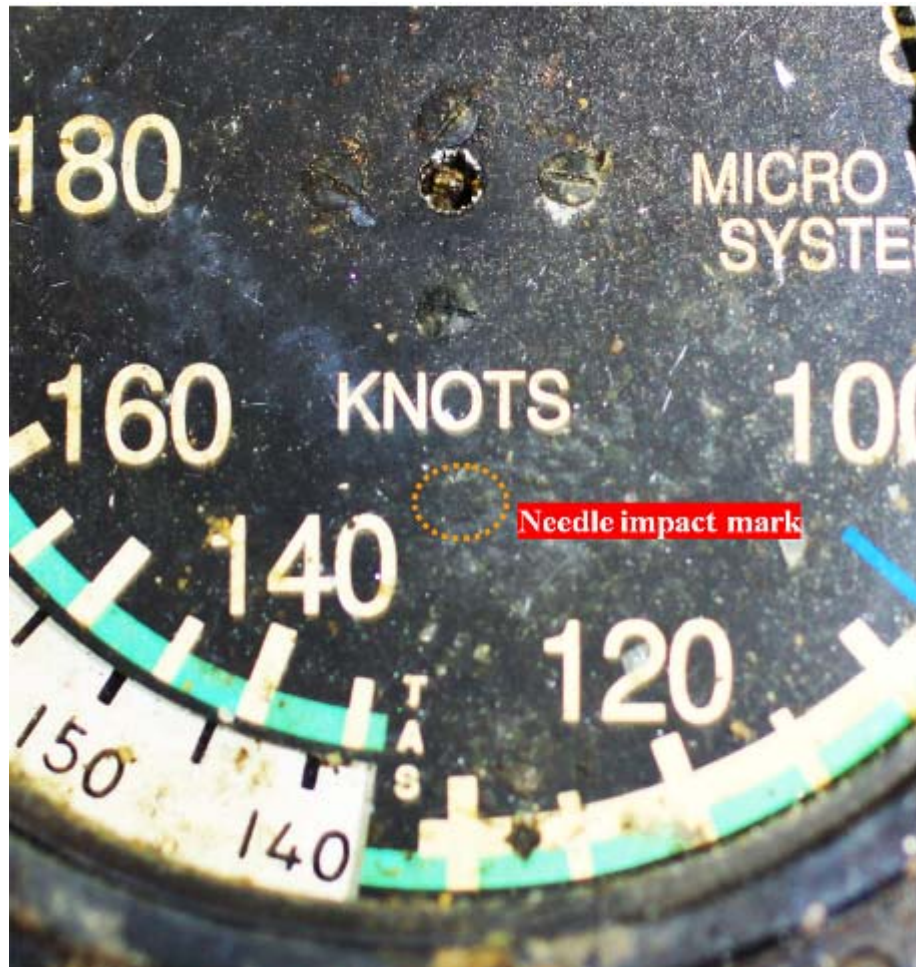
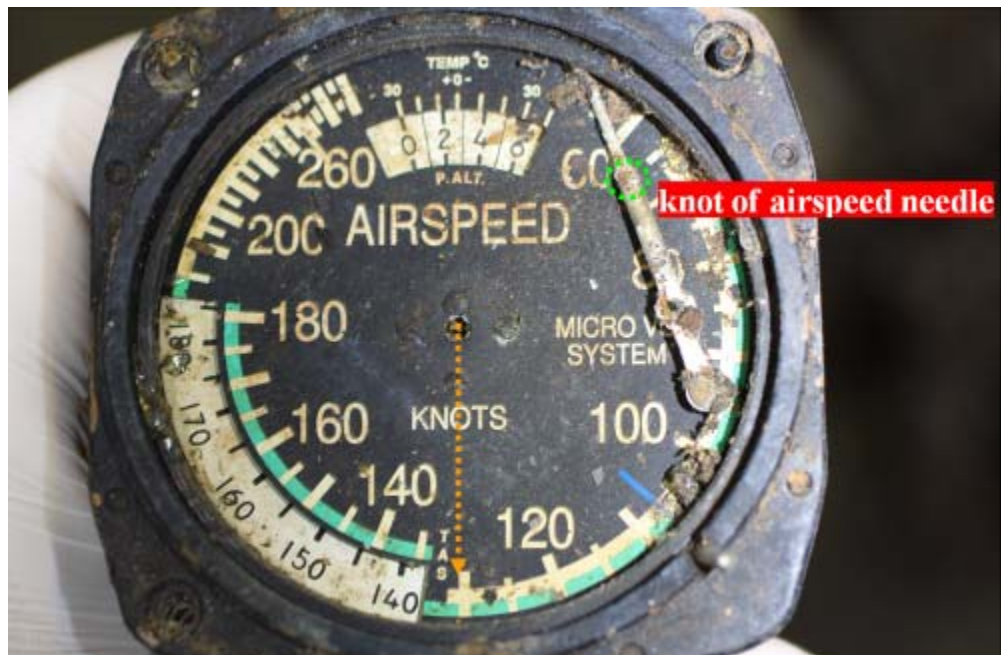
A circle impact mark was found on the face of the airspeed indicator. The mark matched to the diameter of a “knot” on underside of the indicator needle. The distance between needle base to the mark is identical to the “knot” distance on the needle.

Based on the impact mark from the “knot” on the needle on the instrument face, the needle was indicating approximately 130 knots at the time of impact (Figures 8 and 9).

The last Sure Track data recorded the aircraft speed of 138 knots. The examination of airspeed indicator concluded that the impact speed was at approximately 130 knots. The reducing speed might due to that the aircraft was climbing.

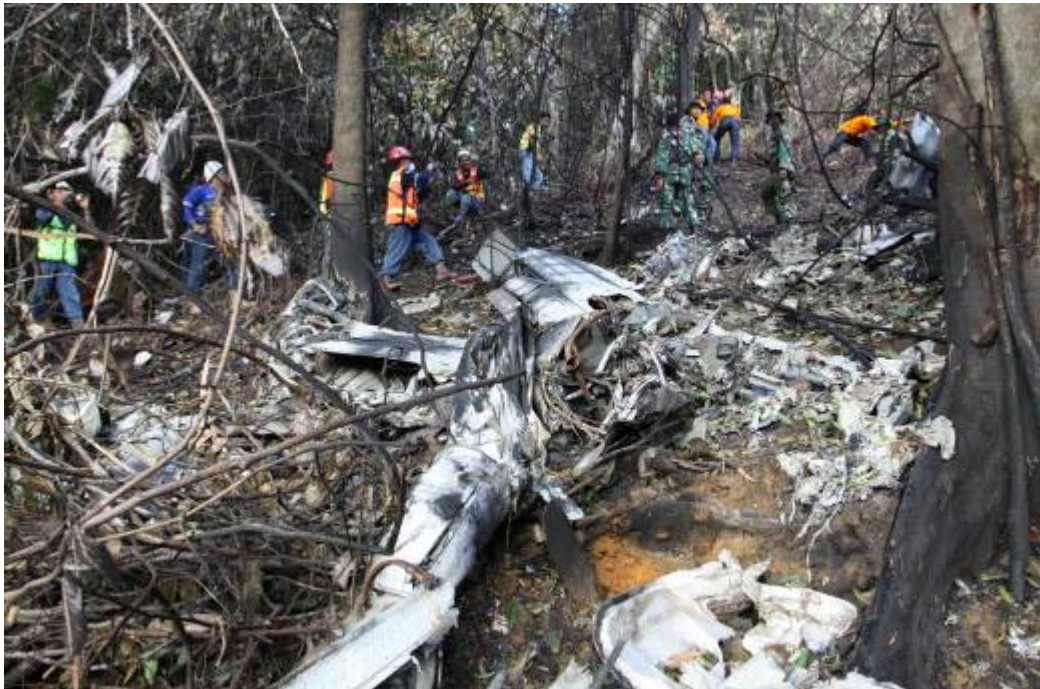
Figure 10: The main wreckage

There was no evidence of in-flight fire and the main wreckage was destroyed by a post impact fire (Figure 10).

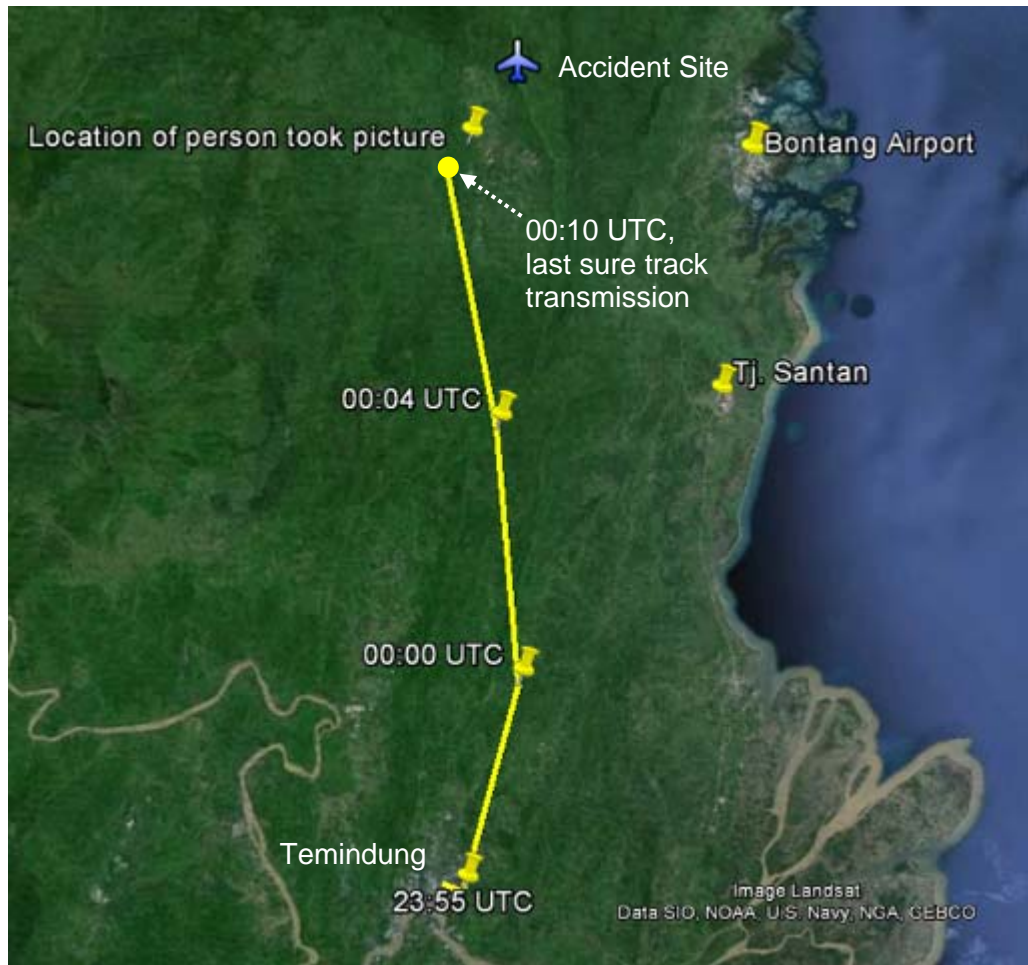
Figure 11: The flight path based on Sure Track

The last transmission of the accident flight to the server was at 0010 UTC and contained information of coordinate 00°8'33" N 117°12'54"E with aircraft speed 138 knots and heading of 152°.

The distance from the last transmission location to the accident site was approximately 6.4 NM in the straight line. With assumption of aircraft speed 138 knots, the distance would be travelled in 2 minutes 46 seconds (Figure 11).

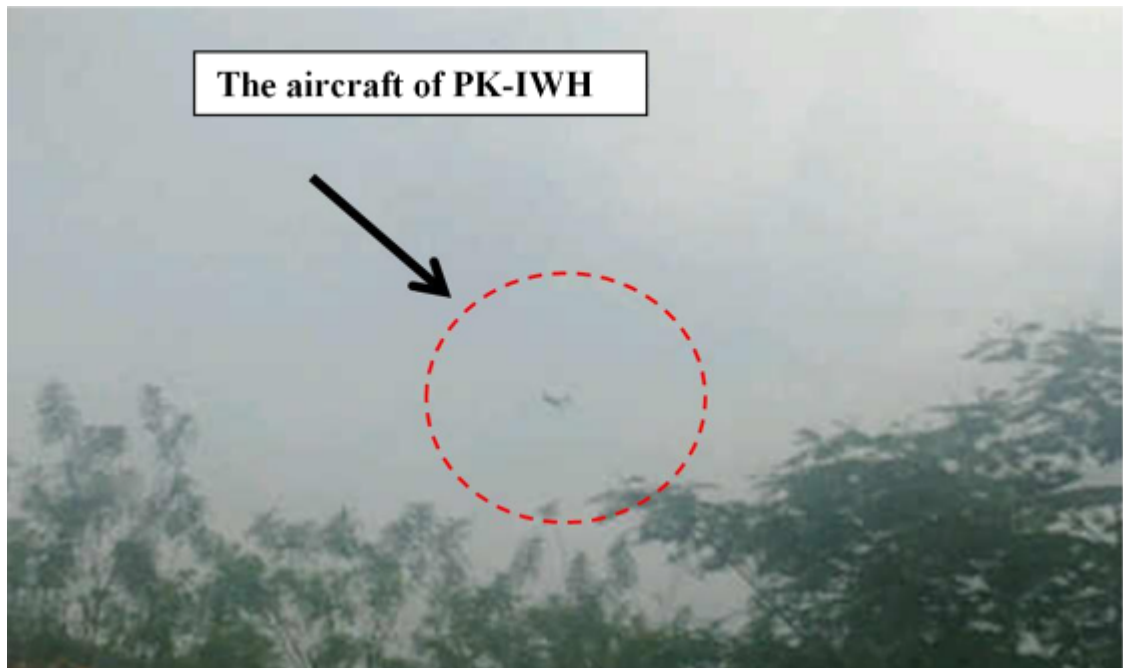
Figure 12: The picture of PK-IWH prior to the accident

There was a picture of the aircraft prior to the accident (Figure 12) taken from coordinate 00°9'35.93"N, 117°14'5.76"E. This position was between the last Sure Track transmission and the accident site (Figure 11).

The witness was interested to see an aircraft that was flying at low altitude and decided to take a picture. The witness also stated that the weather on that time was haze.

The last pilot report to Bontang Info at 0005 UTC indicated that the aircraft was flying at 300 feet AGL while the flight plan was 500 feet. The picture on figure 12 showed that the aircraft was conducting low flying.
