KNKT.12.08.15.04

# NATIONAL TRANSPORTATION SAFETY COMMITTEE

Aircraft Accident Investigation Report

**Bali International Flight Academy  
Cessna 172; PK-ROI  
Letnan Kolonel Wisnu Airport,  
Buleleng, Bali  
Republic of Indonesia  
5 August 2012**

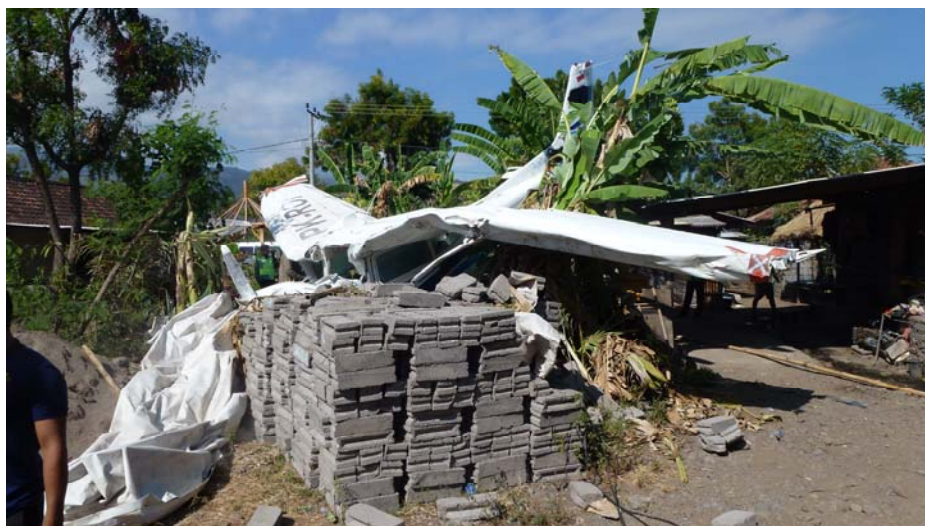
The occupants suffered minor injuries. The aircraft substantially damage. There was minor damage to a house.

Figure 1: The aircraft has substantial damaged

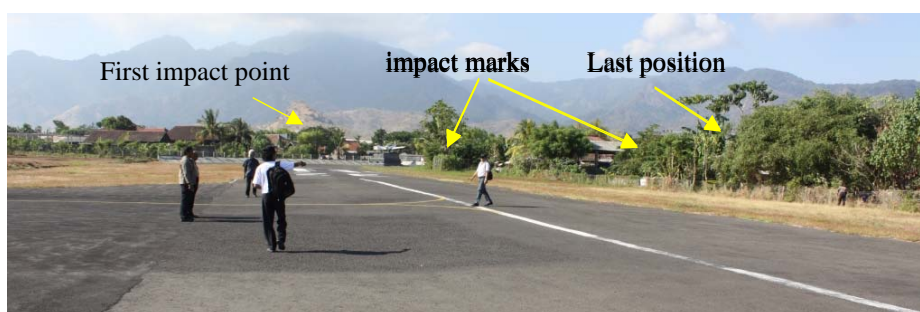
The first impact mark was found on the top of a tree on short final runway 32 with approximate height of 10 meters. Prior to rest at last position, two impact marks found on the airport fence and a tree. The aircraft stopped on the left runway 32 about 59 meter from centre line of runway.

Figure 2: Impact points founds on the accident site
