**KOMITE NASIONAL KESELAMATAN TRANSPORTASI
REPUBLIC OF INDONESIA**

Aircraft Serious Incident] Investigation Report

PT. Wings Abadi Airlines

ATR 72-212A; PK-WFK

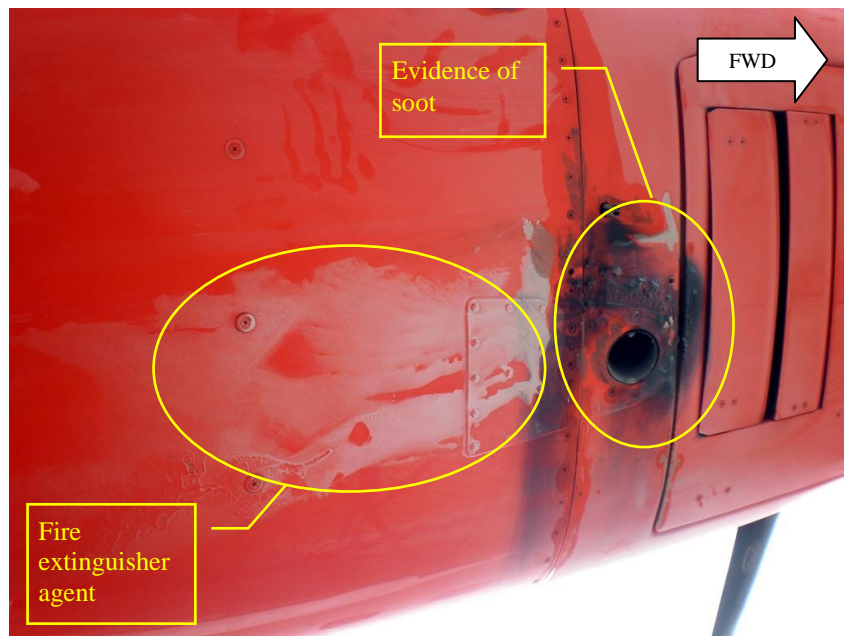
There was no evidence of aircraft damage. The right engine lower cowl exhibited soot consistent with the sign of fire as shown in figure below.

Figure 2: Sign of burn and fire extinguisher agent on the right engine lower cowl.

The soot at the lower part of right engine and thermal discoloration at the lower surface of nacelle indicated that the fuel was burn from the nacelle floor. The burned fuel most likely activated the fire detection sensing that triggered the right engine fire warning.

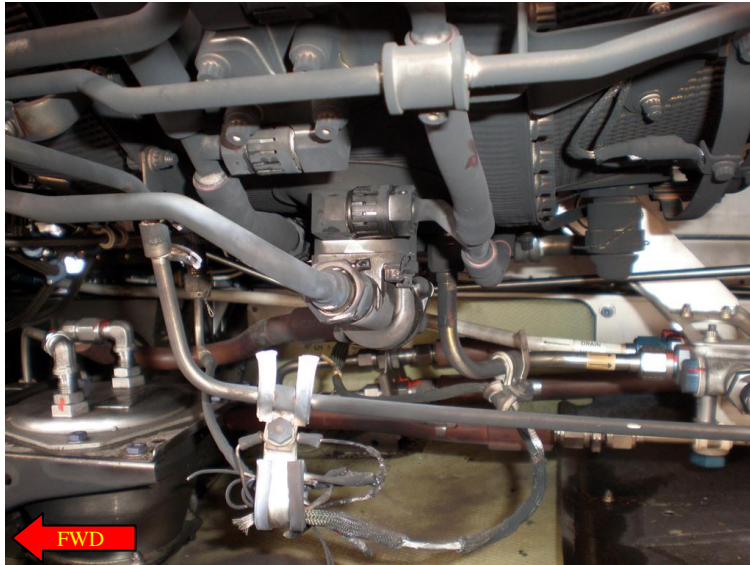
Inside of the right engine cowl there was evidence of soot on the lower engine as shown in the figure below.

Figure 3: Right engine lower part

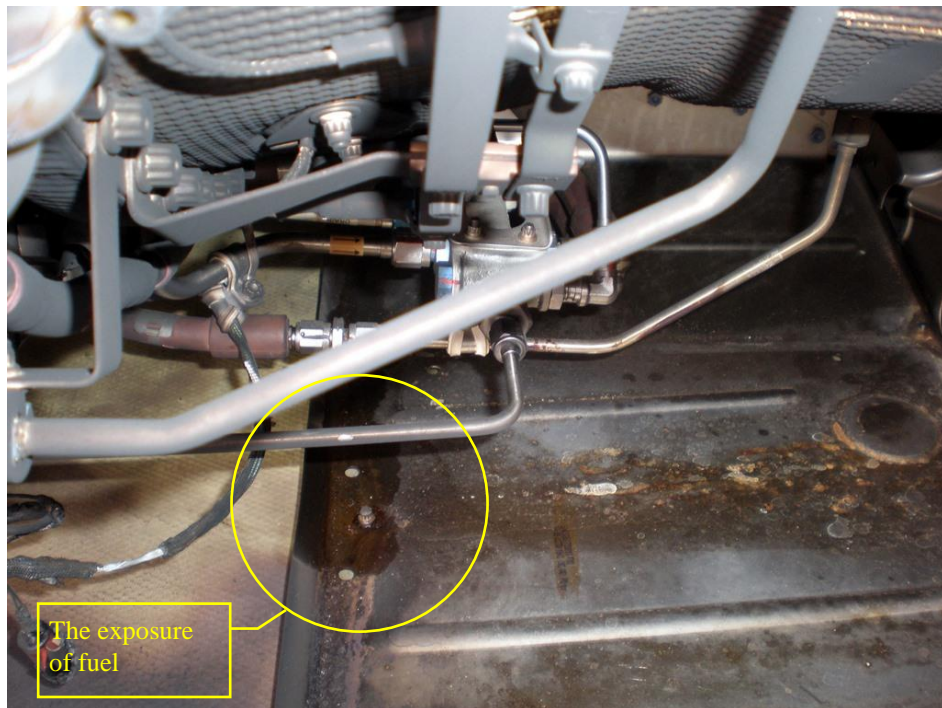
Several minutes after the occurrence, the engineer conducted motoring to the right engine in according Job Instruction Card (JIC) number 72-00-00 ERI 10020. There was evidence of fuel exposure on the engine cowling floor.

Figure 4: The evidence of fuel exposure on the right engine nacelle floor

During parking, the fuel leak accumulated on the nacelle and evaporated as the temperature inside the engine nacelle was above flash point. The engine was running with prop brake, which means the propeller was not rotating, therefore no air flow from propeller to wash the evaporated fuel overboard. The running engine was also radiated heat to the nacelle. The NAC 2 OVHT warning will active when temperature in the engine nacelle is more than 170°C. The evaporated fuel became auto ignited when the temperature reached 220°C.

The fire initiated from the significant amount of accumulated fuel on the engine nacelle floor which then evaporated and reached auto ignited condition due to the high temperature in the right engine nacelle.

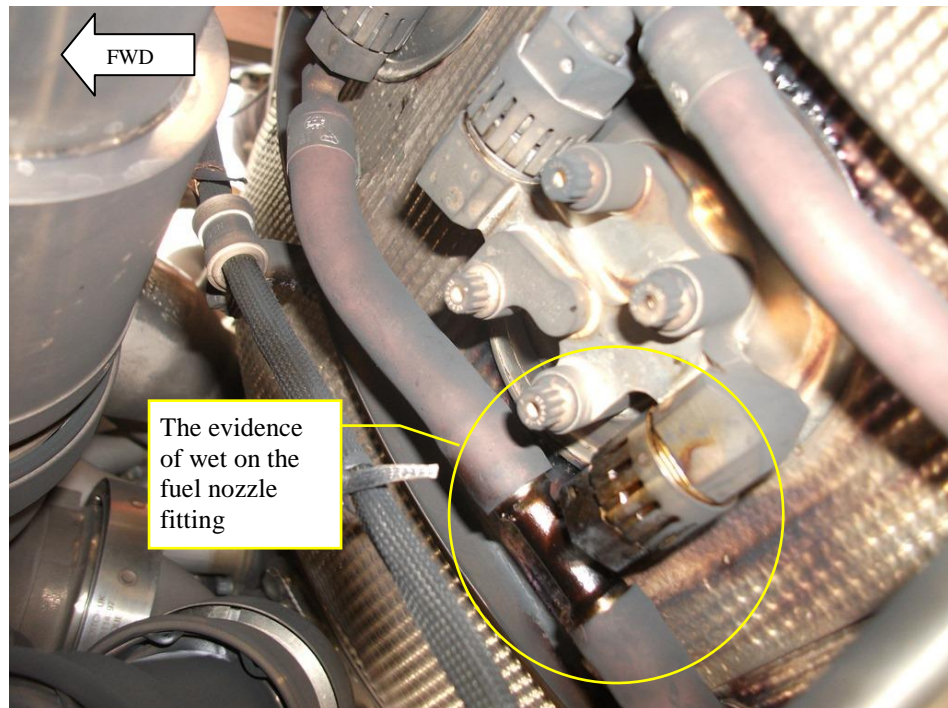
There was evidence of wetting on the fuel nozzle connector fitting at fuel nozzle on position 1 as shown in the figure below.

Figure 5: Wet on the fuel nozzle position 1

Several minutes after the occurrence, the engineer conducted motoring to the right engine and found fuel exposure on the engine cowling floor and wetting on the fuel nozzle connector fitting at fuel nozzle on position 1. It was most likely that the fuel exposure on the engine cowling floor was from the leak on the connector fitting of fuel nozzle on position 1.

nozzle which was conducted without recommended special tool. The installation without proper tool might cause by improper installation of the fuel nozzle. During the operation, the fuel nozzle might have become loosen due to the vibration. The visual inspection on 13 July 2012 did not identify the loosening fuel nozzle since there might be no wetting on the fuel nozzle or any other visual indication. The loosening fuel nozzle resulted in fuel leakage which then accumulated in the nacelle floor.

On 19 September 2012, Wings Air updated the Engineering Authorization No. ATR72-EA-73-013R3 to ATR72-EA-73-013R4 with subject “PW127M Engine Fuel Nozzle Adapters Periodic Restoration” that applied to ATR72-212A equipped with PW172M engine in their fleet and to ensure that the replacement of the fuel nozzles are utilize the special tools as required by the manufacture.

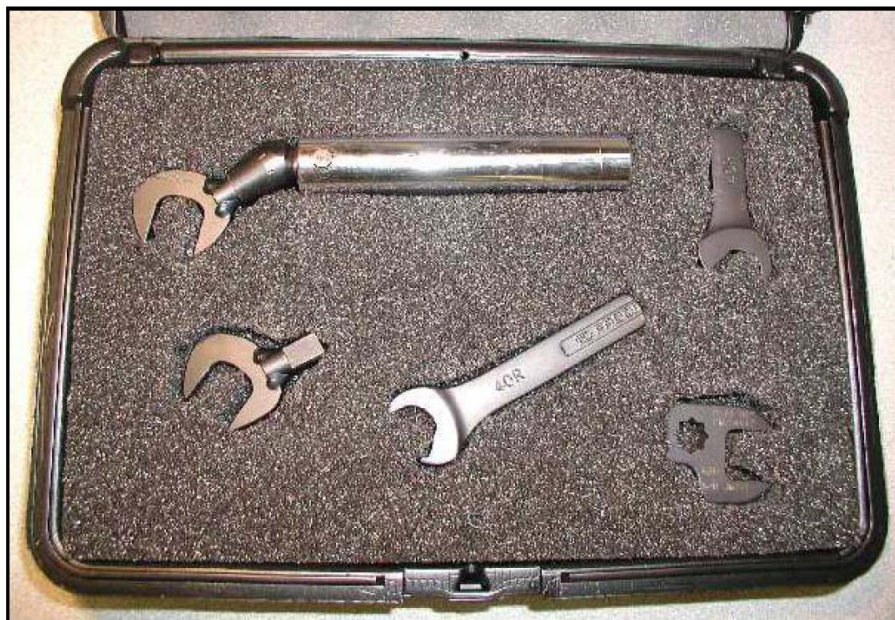
Figure 6: PWC Special Tool PWC56616

On 13 June 2012, the engineer replaced all of 14 fuel nozzles of the right engine as part of the Continuous Airworthiness Maintenance Program (CAMP) task number 731361-RAI-10000-1 to restore the fuel nozzle. The replacement of the fuel nozzles did not utilize the PWC special tool PWC56616. The special tool was required for accessing the fuel nozzle especially at the position 1 and 14. The special tool PWC56616 is shown in the figure below.

On 13 June 2012, all of 14 fuel nozzles of the right engine replaced as restoration program stated in the CAMP. The replacement of the fuel nozzles did not utilize special tool PWC56616 that is specified for the fuel nozzle replacement especially fuel nozzle position 1 and 14.

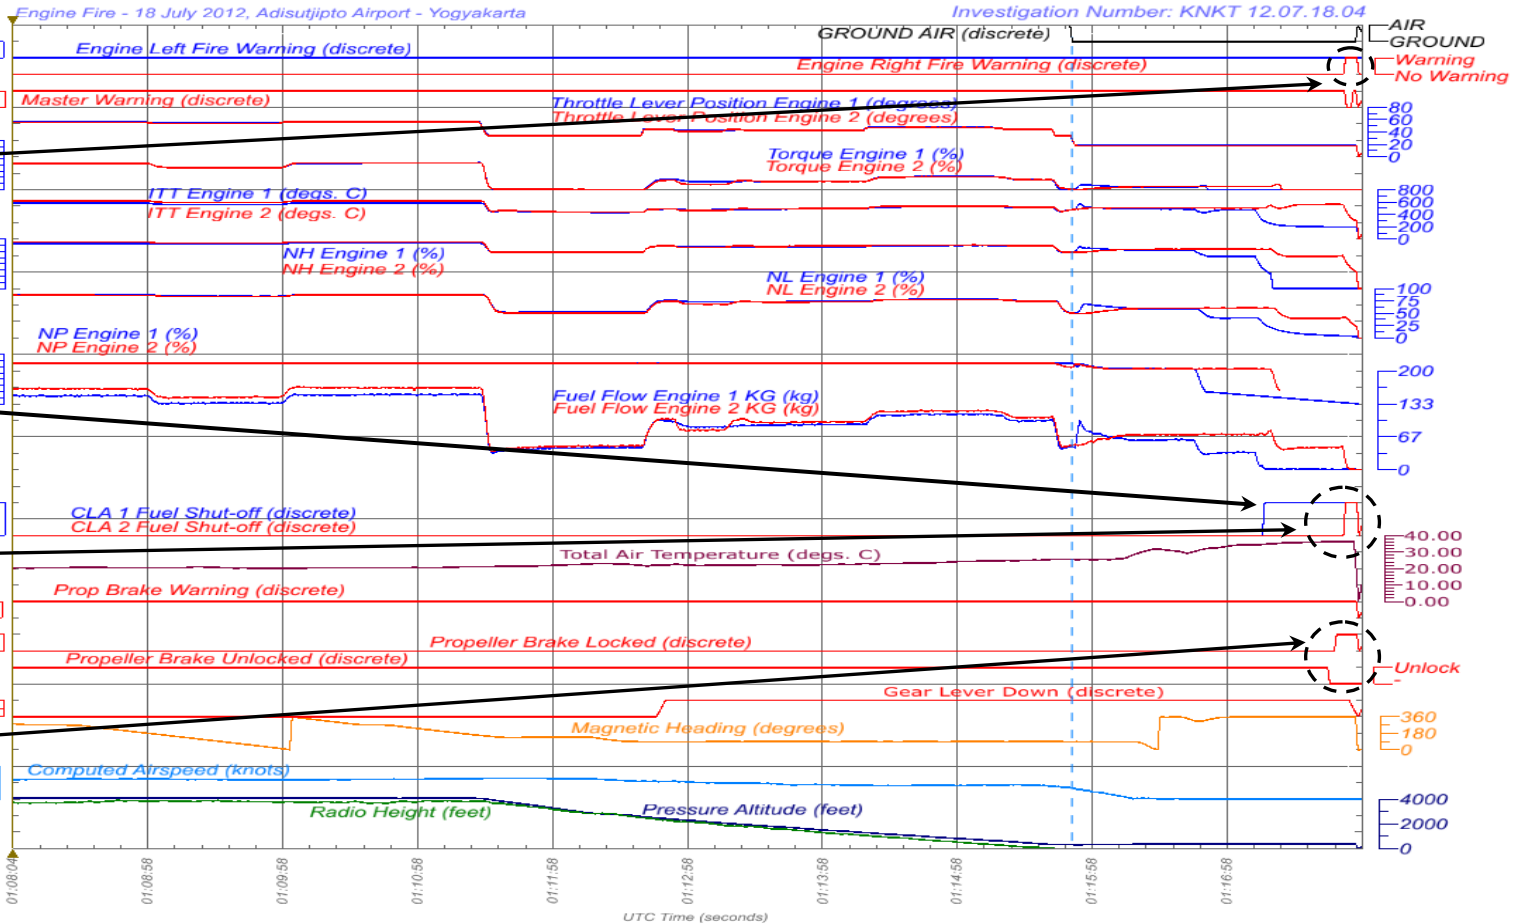
Figure 7: Significant FDR Parameters of the serious incident flight

The significant FDR events as shown on figure 3 are as follows:

1. The FDR shows that the right engine fuel flow was higher than the left engine, when the throttle lever position, torque, Inlet Turbine Temperature (ITT), NH and N1 were relatively equal.
2. At 1:15:56 UTC, the aircraft touch down.
3. At 1:17:21 UTC, the left engine shutdown.
4. At 1:17:53 UTC, the propeller brake at right engine was activated.
5. At 1:17:57 UTC, the right engine fire warning was activated and at the same time the right engine was shut-down. The Total Air Temperature (TAT) recorded 36° Celsius.

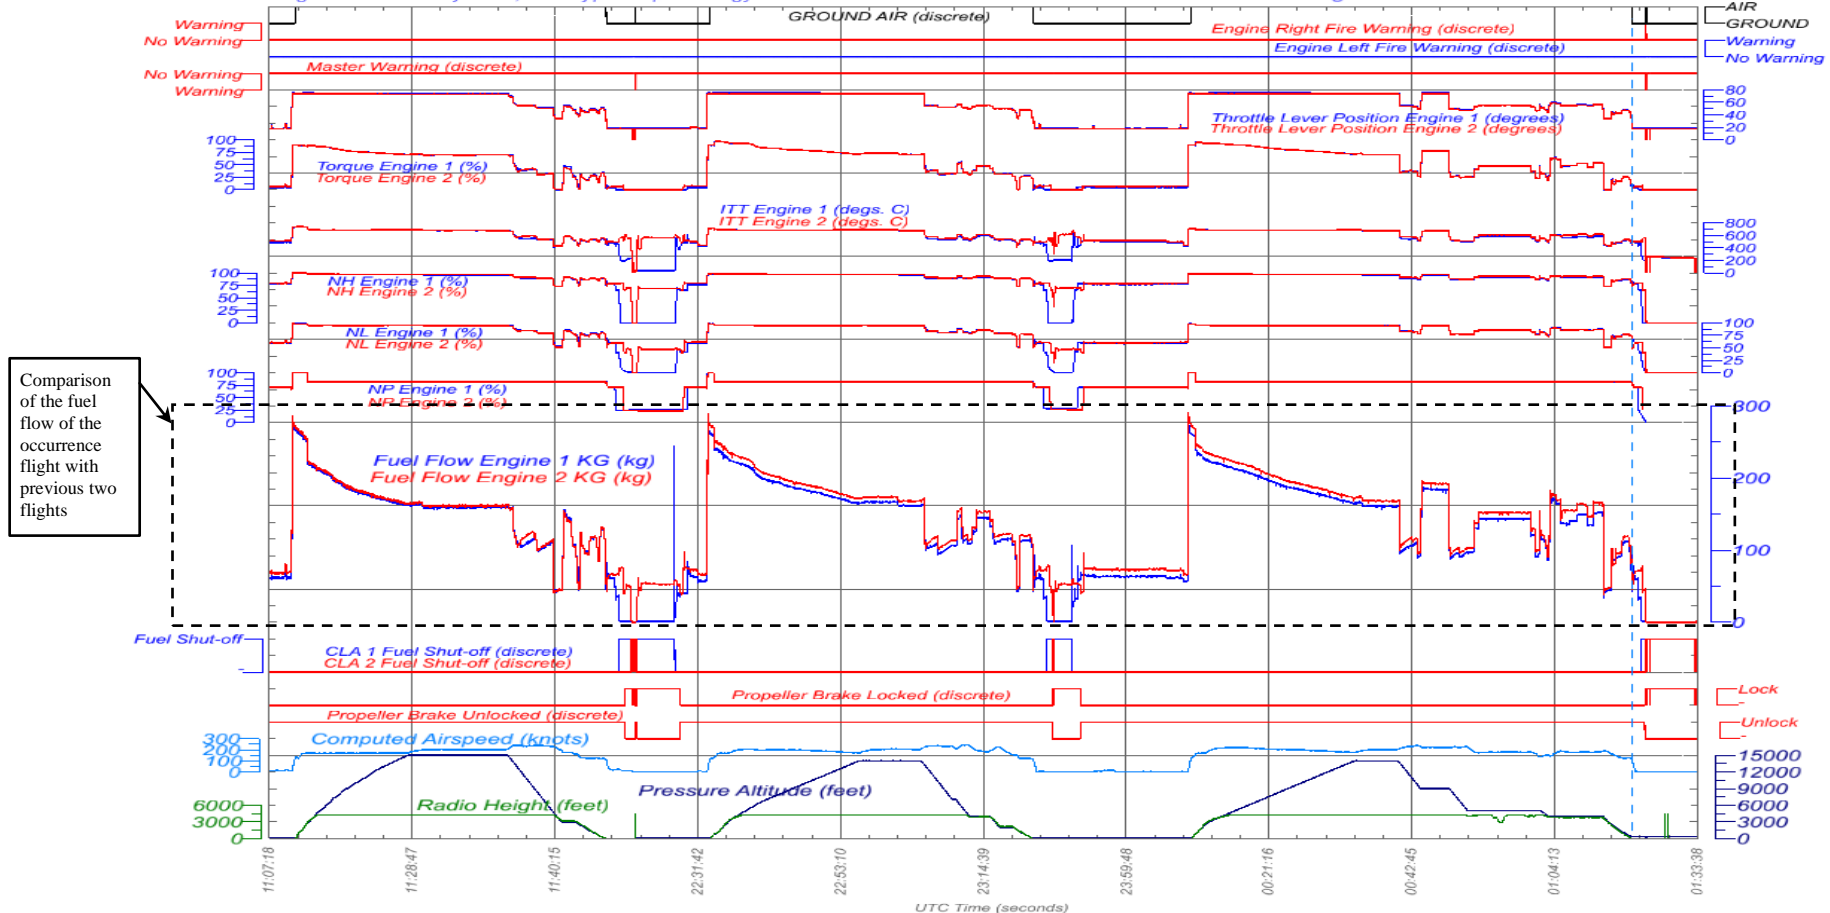
Figure 8: Comparison of the occurrence flight with two previous flights

Comparison of the fuel flow of the occurrence flight with previous two flights

The FDR data showed the differences of the fuel flow on both engines occurred since the last two flights prior to the serious incident flight. The fuel differences initiated on the last flight of 16 July 2012. The investigation calculated the differential fuel flow between left and right engines in these three flights. The differential fuel is shown in the table below.

On 16 July 2012, the FDR recorded fuel flow differences between left and right engines. The differential fuel flow was greater in the occurrence flight which was on 17 July 2012. The FDR recorded that the difference of fuel flow between left and right engine approximately up to 10 kg per hour while the other engine parameters relatively similar. The similarity of the engine parameters indicated that the amount of fuel burned to both engines was similar. Therefore, the difference of fuel flow most likely due to the leak of the fuel from the fuel nozzle position 1, that was found wet during the engine motoring.
