**PRELIMINARY**  
KNKT.12.11.25.04

**Aircraft Serious Incident Investigation Report**

**PT. Metro Batavia (Batavia Air)  
Boeing 737 - 300; PK-YVZ  
Supadio Airport, Pontianak, Kalimantan  
Republic of Indonesia  
22 November 2012**

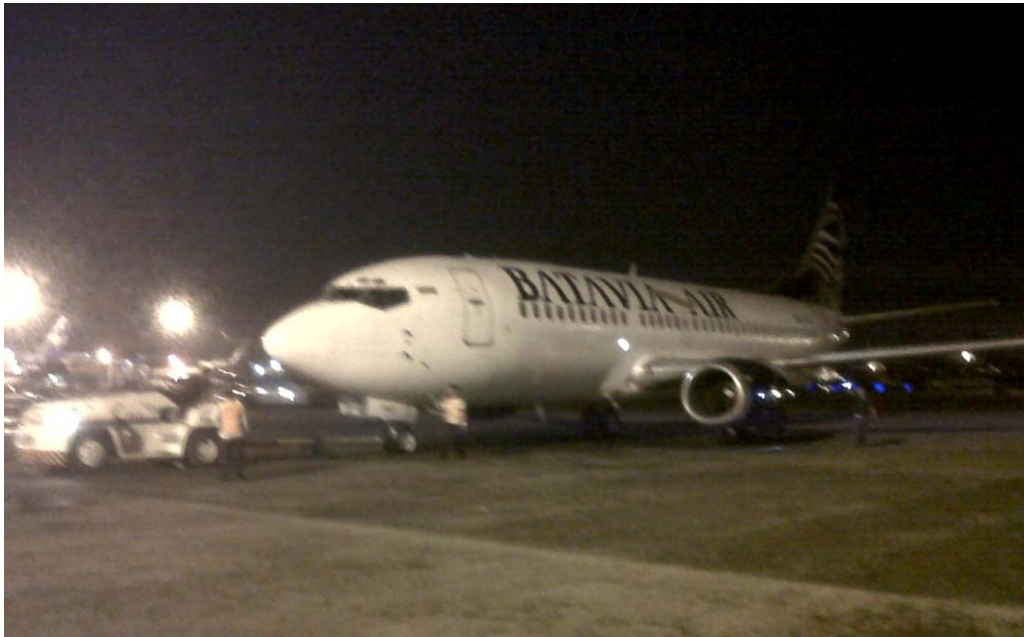
**Figure 1 Batavia Boeing 737-300 PK-YVZ Aircraft after the Serious Incident**

- Main wheel no. 1 and no. 2 damage;
- Left main gear shimmy damper broken;
- Left main gear lower torsion link broken;
- Left main gear inner door missing;
- Left main gear center broken;
- Left inboard spoiler dent
- Left main gear anti skid harness broken;
- Lower wing access panel and support panel broken.

The further inspection conducted by Batavia in their hangar facility found that main wheel no. 1 and no. 2 damage; left main gear shimmy damper broken; left main gear lower torsion link broken; left main gear inner door missing; left main gear center broken; left inboard spoiler dent; left main gear anti skid harness broken and lower wing access panel and support panel broken.

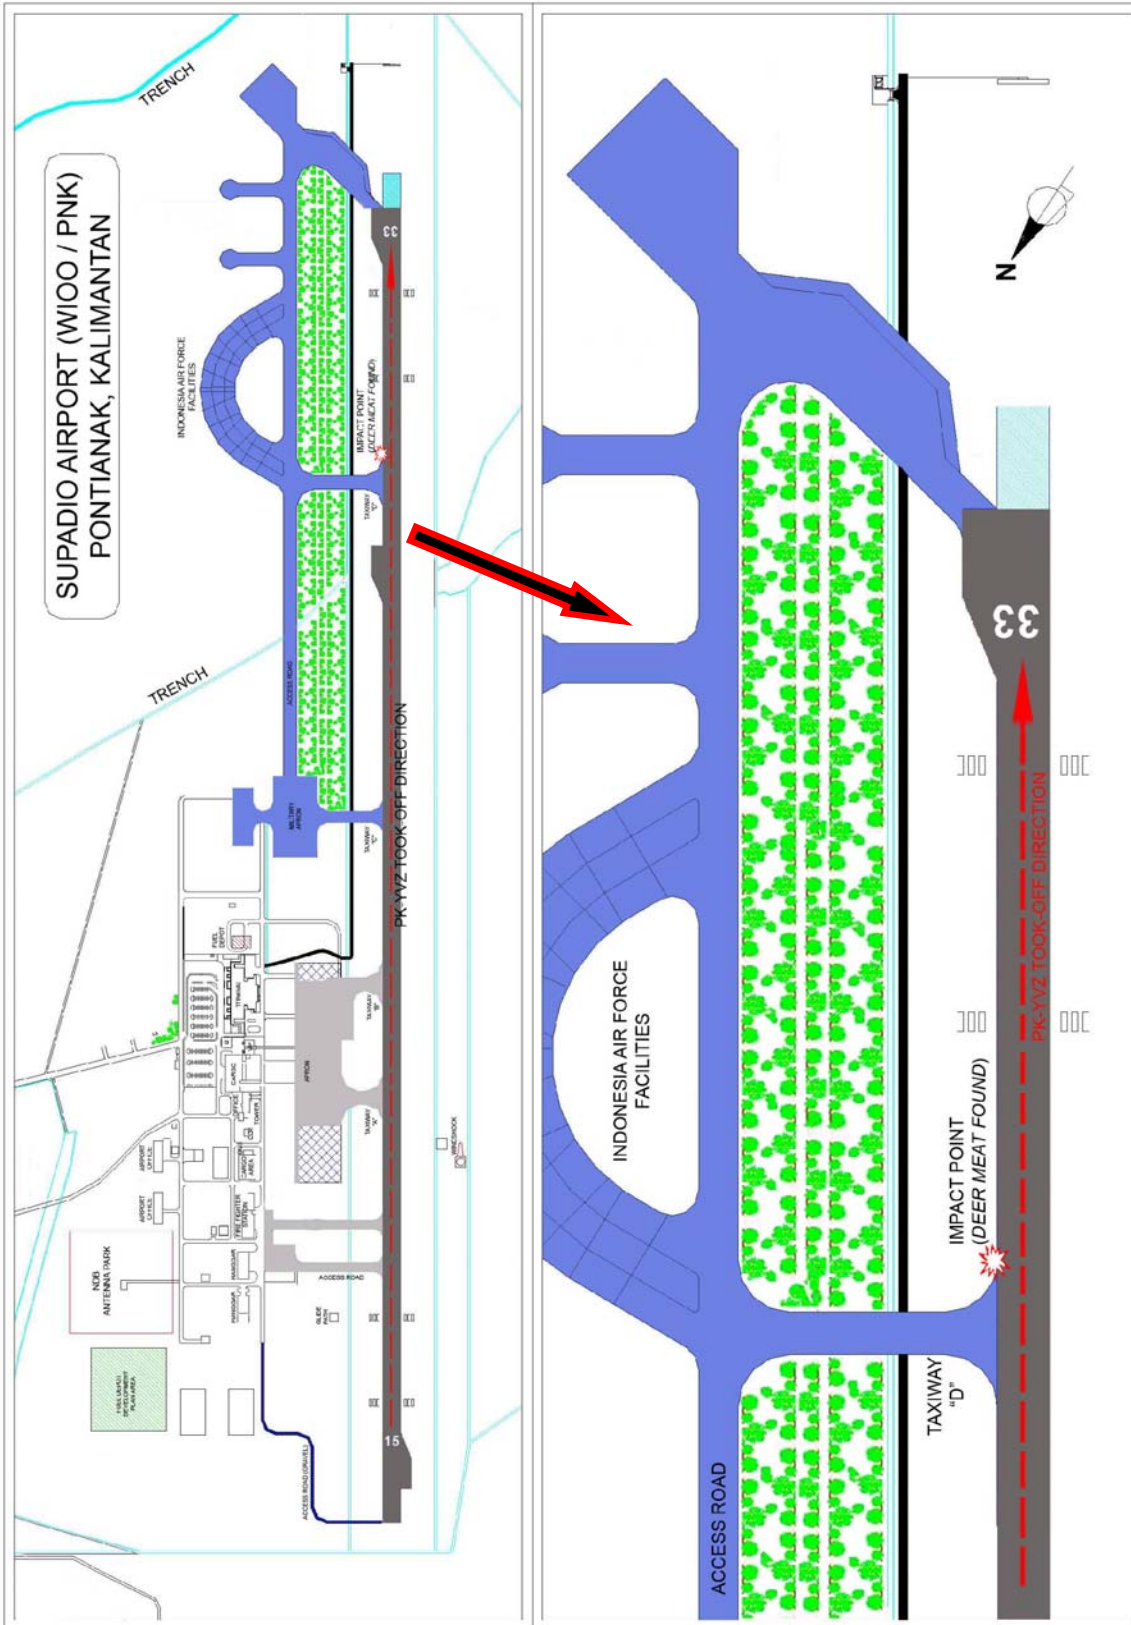
Figure 4 PK-YVZ Occurrence Sketch

There a deer's meat and head found by the airport safety officer near the Taxiway "D" of Runway15 Supadio Airport, after the Batavia Y6-206 PK-YVZ took off. The airport safety officers conducted a sweep and cleans operation. They found about 75% of deer body included deer head.

It likely the deer come from brushes between runway 15-33 and Indonesia Air Force Base (see Figure 4).

- To ensure the air side of the Supadio Airport is sterilize from any un-authorized personnel, foreign objects or wildlife.
