**KOMITE NASIONAL KESELAMATAN TRANSPORTASI
REPUBLIC OF INDONESIA**

Aircraft Accident Investigation Report

PT. Wings Abadi Airline

ATR 72-212A (500 Version); PK-WFV

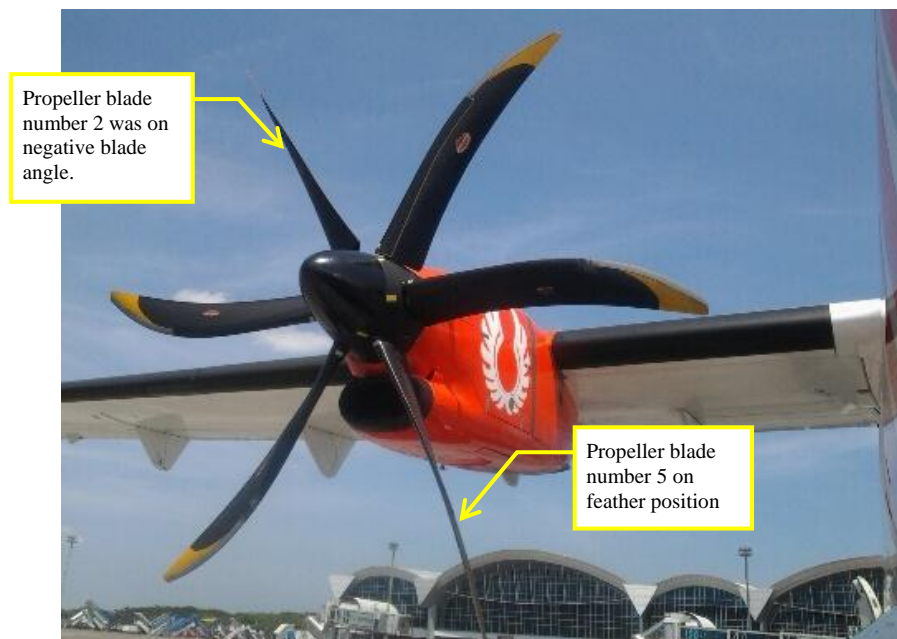
Figure 1: The right engine propellers condition after the aircraft parked

After the aircraft parked, the PIC inspected the right engine and found one of the propeller blades was in the feather position, one propeller blade was in the negative blade angle position and the rest of the blades were in the un-feathered position.

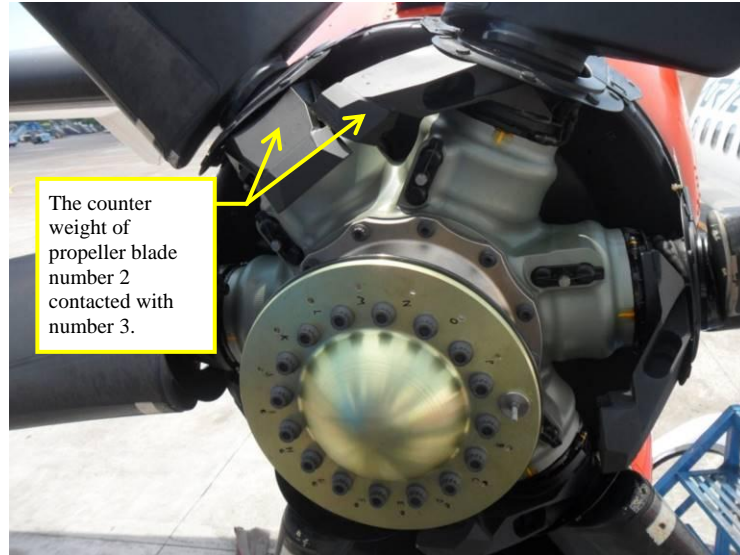
Figure 2: Propeller counter weight not in proper position

The propeller spinner was opened and found that the counter weight of propeller blade number 2 in contact with counter weight of propeller blade number 3 as shown in the figure below.

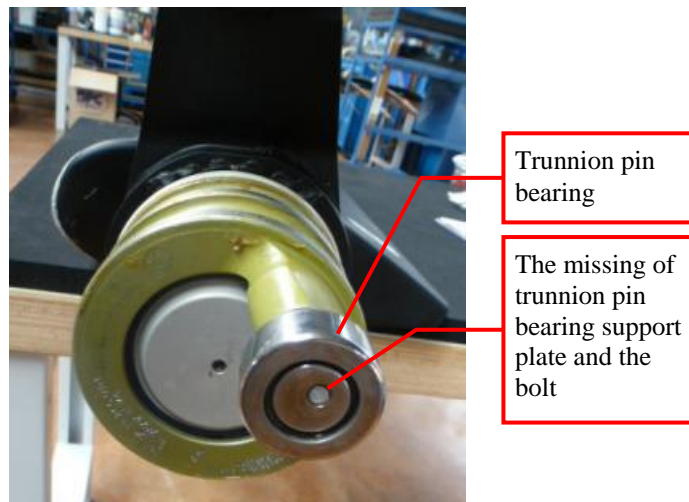
Figure 3: The trunnion pin of propeller blade number 2

For further inspection, all propeller blades were dismantled from the propeller hub. It was found that on the propeller blade number 2, the bolt to secure the trunnion pin bearing with the trunnion support plate was broken.

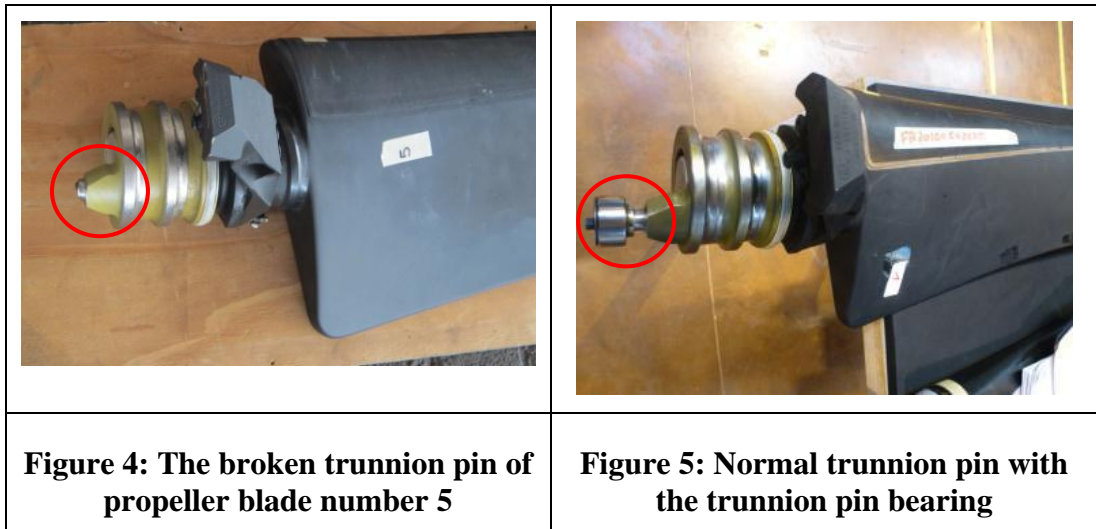
The trunnion pin of propeller blade number 5 was broken as shown in the figure 4 below. The normal trunnion pin with the trunnion pin bearing is shown in the figure 5.

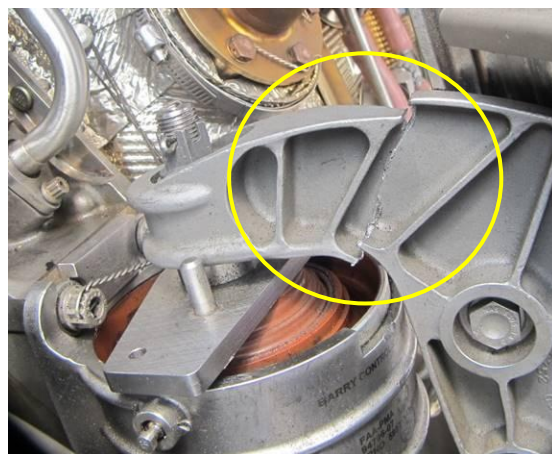
Figure 6: One of aft lateral engine mountings of right engine

The ATR 72-212A, each engine mounts comprises 2 forward lateral shockmounts, 1 forward upper shockmount and 2 aft lateral shockmounts. The engineer examined the right engine mounts condition and found the both aft lateral shockmount structure were broken as shown in the figure below.

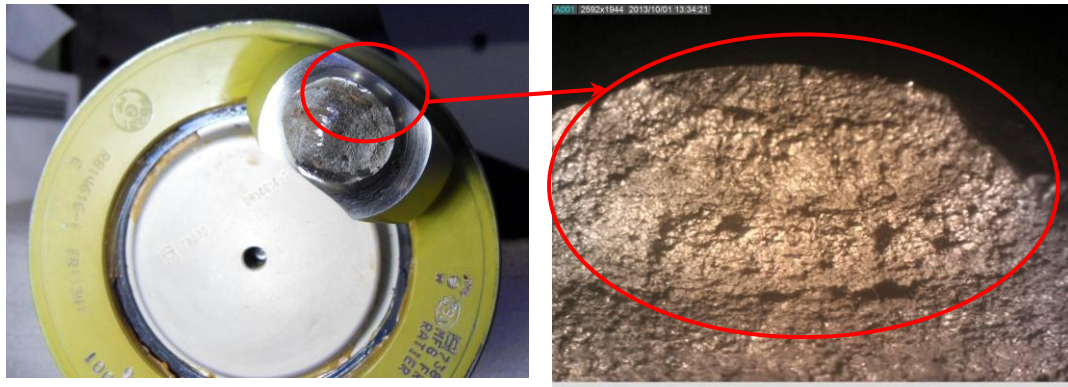
Figure 20: Crack initiation found on the trunnion pin of blade number 5

The stereo microscope visual inspection found indication of beach marks on the broken trunnion pin of the propeller blade number 5. The inspection by Scanning Electron Microscope (SEM) showed a dimpled rupture⁹ fracture as an indication of an overload (see chapter 1.7.2 point 5).

- c. The trunnion pin of propeller blade number 5 was found broken. The fracture analysis showed that the fracture was likely due to steady overload applied by the aft yoke plate.

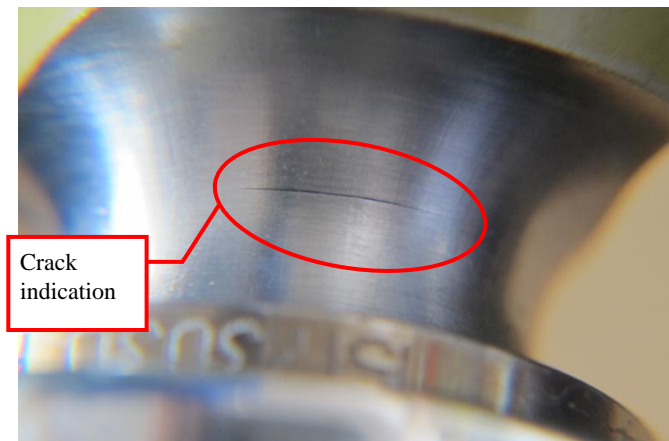
Figure 21: Crack indication on the trunnion pin of propeller blade number 2

The visual inspection of the propeller blade number 2 found crack on the trunnion pin and broken on the roller bearing bolt.

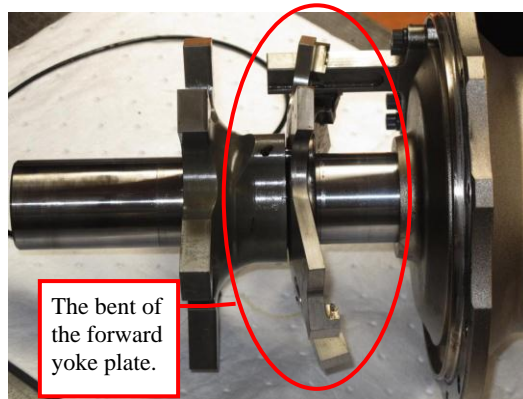
Figure 22: The bend of the forward yoke plate

The inspection of the actuator yoke found that all the forward yoke plate arms were deformed with estimated displacement of the yoke plate arms are between 4 and 15 millimeters from the original condition.

- d. All forward yoke plate arms bent between 3.01 millimeters (0.12 inch) to 14.40 millimeters (0.57 inch).

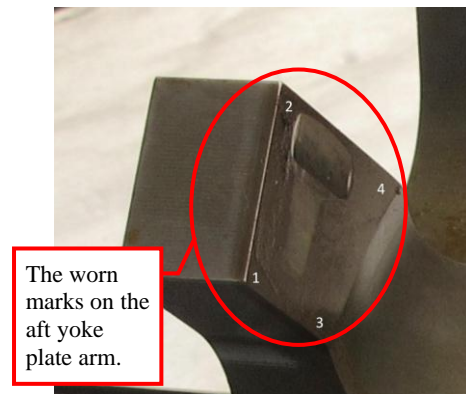
Figure 23: The worn mark on the one of the aft yoke plates

The forward and aft yoke plate exhibited functioning marks (worn marks) in all 6 yoke plate arms.

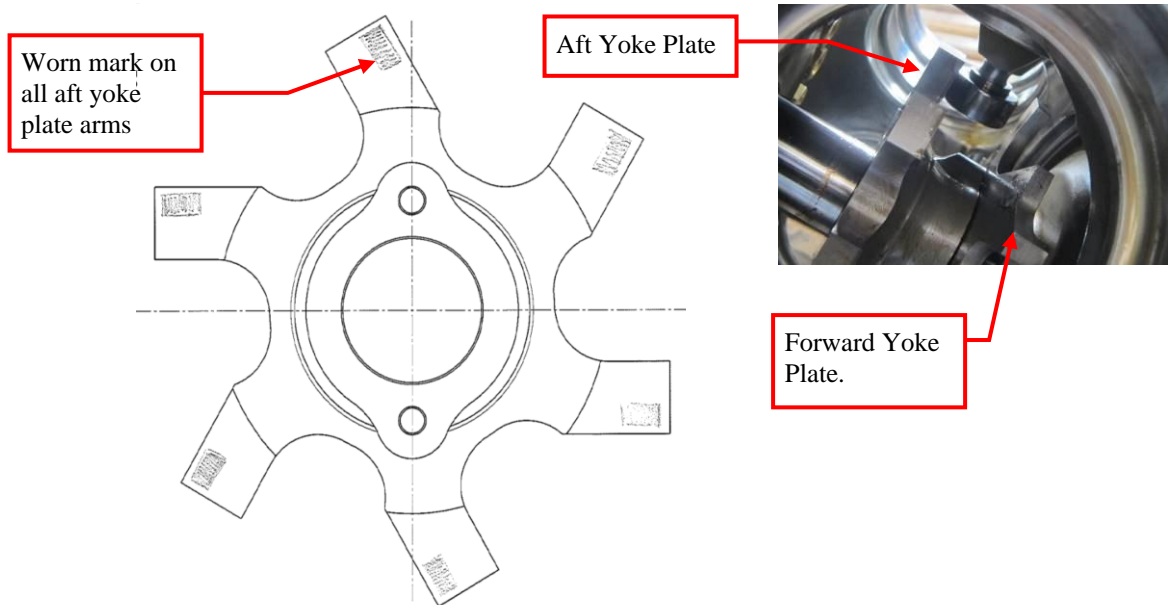
Figure 24: The worn marks on the surface of aft yoke plate

The examination on the yoke plates found that, the forward and aft yoke plates exhibited worn marks. In the normal operation, worn marks are considered normal as the bearing of the trunnion pin was in contact with the yoke plate arms.

In addition, the worn marks measurement revealed that the depth of the seized mark on the forward yoke plate arms between 0.16 to 0.24 millimeters and the depth of the seized mark on the aft yoke plate arms between 0.409 to 0.518 millimeters.

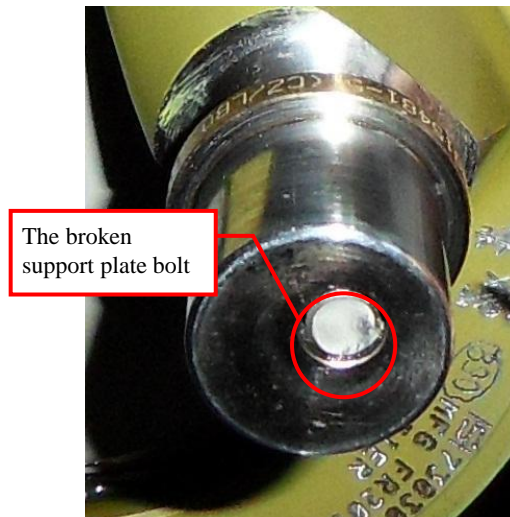
Figure 25: The broken bolt on the trunnion pin of propeller blade number 2

- b. The examination of the forward yoke plate arm number 2, found residual bending of 14.4 mm (0.567 in). With this amount of bending, the trunnion bearing support plate would have been in contact with the forward yoke plate when reverse power was commanded.

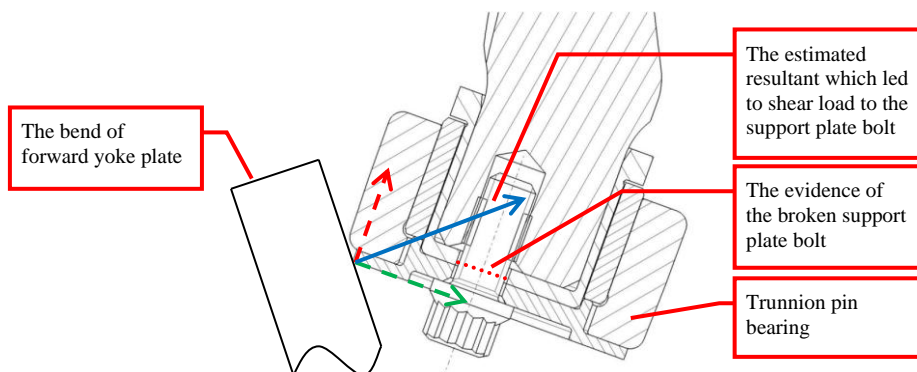
Figure 26: The illustration of the failure of support plate bolt of trunnion pin number 2

The estimated resultant of the trunnion bearing support plate which in contact with the forward yoke plate is shown with the blue arrow in the figure 26 below. The contact of the trunnion bearing support plate with the forward yoke plate created a shear load to the bolt which resulted in the broken of the support plate bolt.

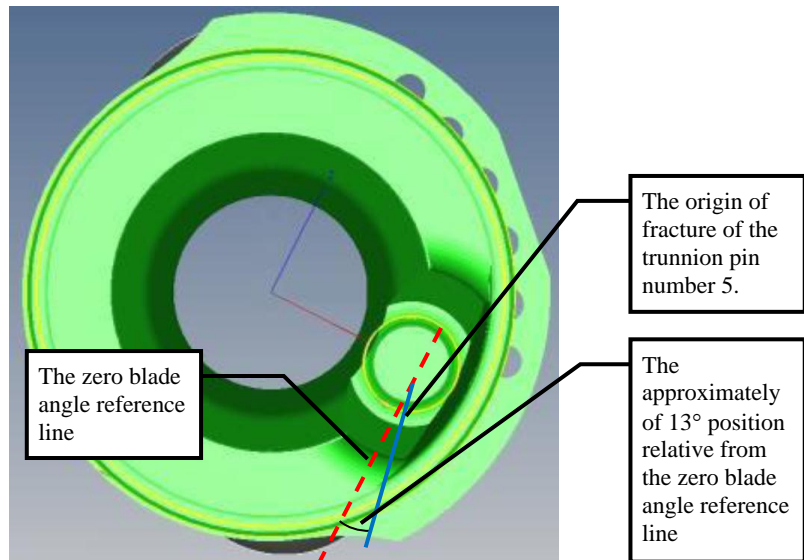
Figure 27: The estimated propeller blade angle corresponds to the origin of fracture trunnion pin

The detail examination of the fracture showed that the origin or the fracture was corresponding with the angle approximately of 13° relative to the red dashed line corresponding to a $\frac{3}{4}$ radius propeller blade angle of approximately 39° (minimum in-flight blade angle). The illustration of the fracture origin is shown in the figure below.

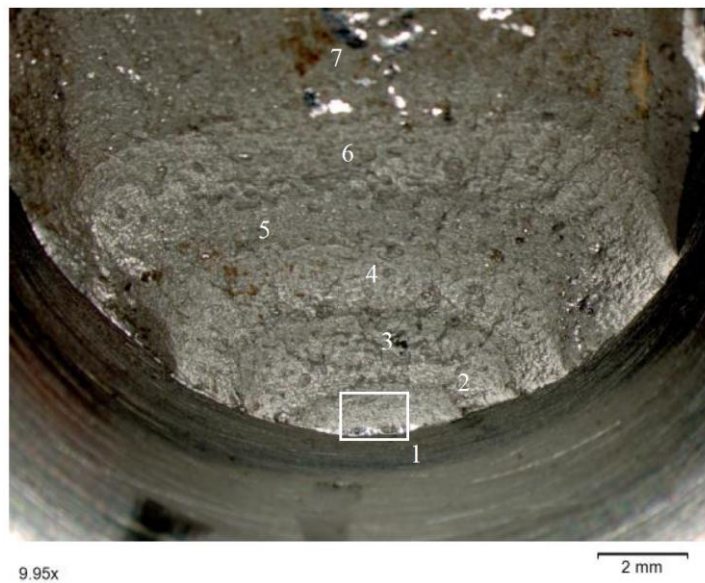
Figure 28: The SEM examination areas of 1 to 7
The detail SEM image of area 1 to 7 is shown in the figures below.

The fracture analysis was consistent with the SEM examination result which showed the dimple rupture (overload) fracture to the trunnion pin. The dimple rupture characterized with the appearance of microvoids. The SEM result is as follow:

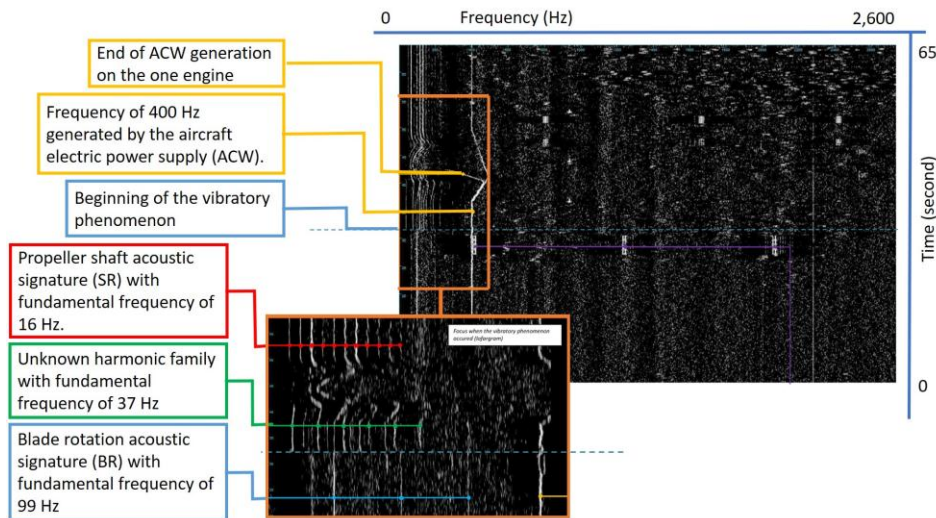
Figure 31: Spectrum analysis during the vibration

The spectrum analysis showed a harmonic family with a fundamental frequency of 99 Hz. This family was associated with the acoustic signature of the blade rotation (BR) and corresponds to an engine RPM of 82 % of the nominal rate.
