FINAL
KNKT.13.11.29.04

Runway Incursion Investigation Report

**Indonesia Air Asia and Batik Air
Airbus A 320 (PK-AXG) and
Boeing B 737-900ER (PK-LBH)
Adisutjipto International Airport, Yogyakarta
Republic of Indonesia
20 November 2013**

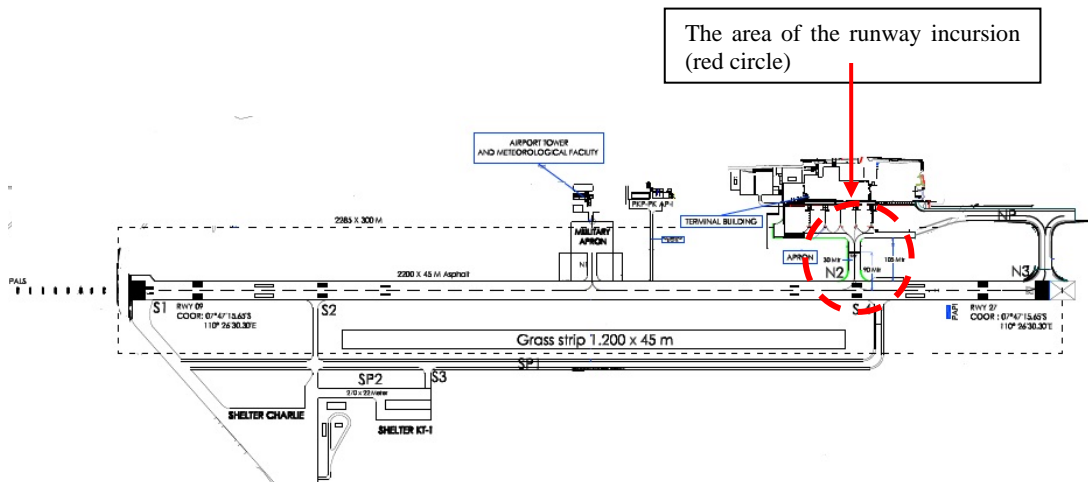
Figure 1: Adisutjipto airport layout the holding position on N2 and N3

According to the current AIP, the runway length was 2200 meter and the width was 45 meters. The distance from the beginning runway 09 to taxiway N2 was 1750 meters.

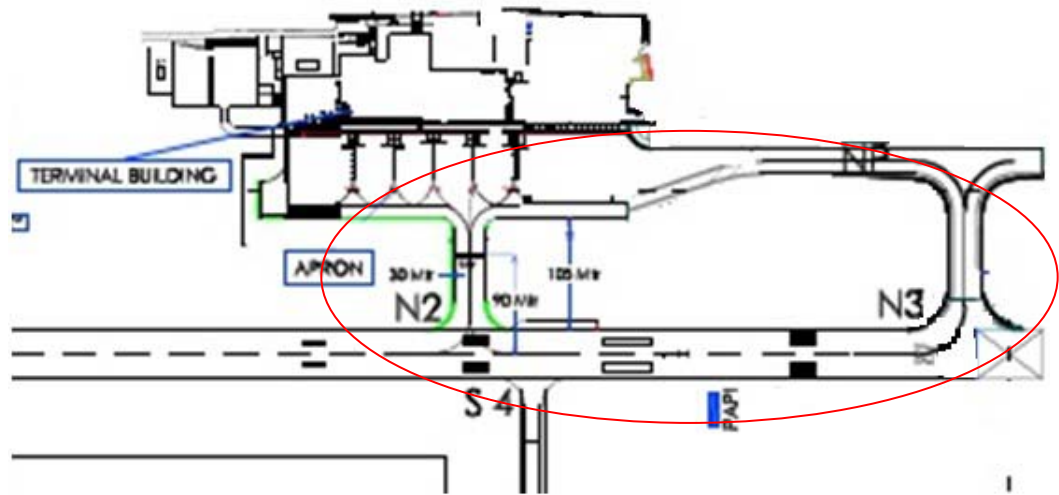
Figure 2: The taxiway N2 and N3 in the red circle

The November Three (N3) taxiway has been operated on trial condition since 27 September 2012 as stated in the notification to airmen (NOTAM) which was valid up to 14 November 2012.

On 13 September 2013 a NOTAM was issued contain information of renaming the taxiway and detail taxiway information refer to Aeronautical Information Publication (AIP) Indonesia volume II dated 13 December 2012. The AIP amendment 34, issued on 13 December 2012 included information of the taxiway N3 however, the airport lay out has not been amended to include taxiway NP and N3.

There was no revision of AIP Indonesia for taxiway N3 until the dated of the occurrence.

- a. To amendment of the AIP for Adisutjipto Airport to include the taxiway NP and N3 in the airport layout.
- b. To review the existing AIP publication system to ensure the amendment of the AIP to the current condition in timely manner.
- c. To review the controllers training program in order to enrich the knowledge of the controllers concerning to the aircraft performance and operation. This refer to the finding that the controller perceived that an aircraft go around from short final might jeopardize the safety of the flight while the aircraft procedure indicated that a go-around can be performed as long as the aircraft has not touched down.

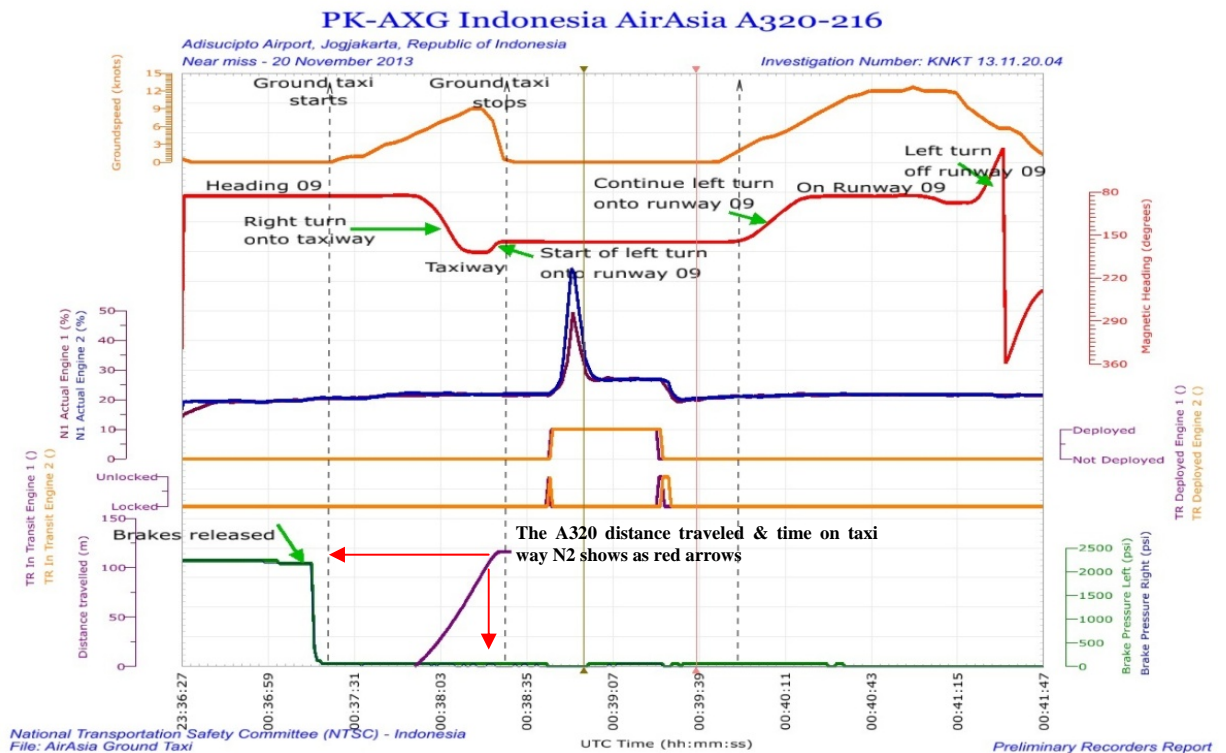
Figure 4: AXG aircraft distance travelled and time on taxi way N2 pointed by the red arrows

The FDR of the Air Bus PK-AXG was downloaded in the NTSC facility. The FDR data showed that the average taxi speed was of 6.4kts/hour when entering and on the taxi way N2 and was indicated stopped after 30 seconds of taxi period. The distance travelled during taxi on taxiway N2 was approximately 116 meters.

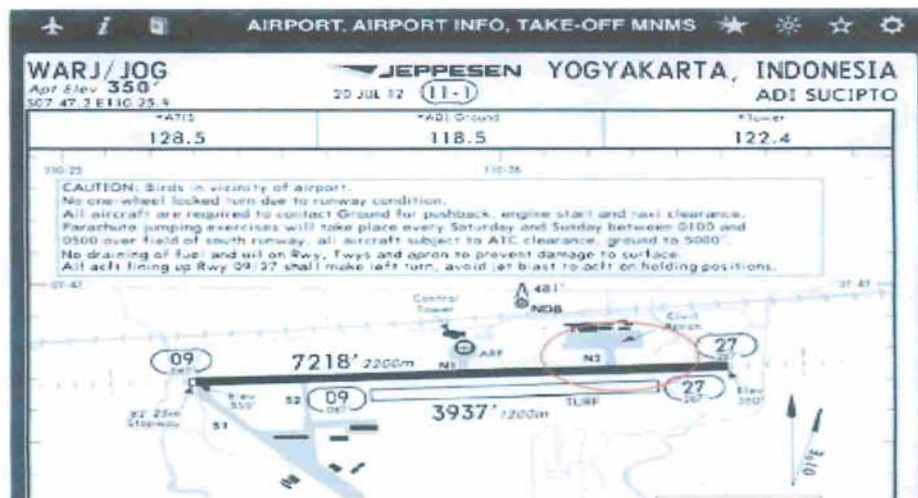
Pada data tersebut Taxiway N3 dan NP belum ada hal ini didasari oleh AIP issued 7 September 2009 sampai dengan saat kejadian data tersebut belum berubah.

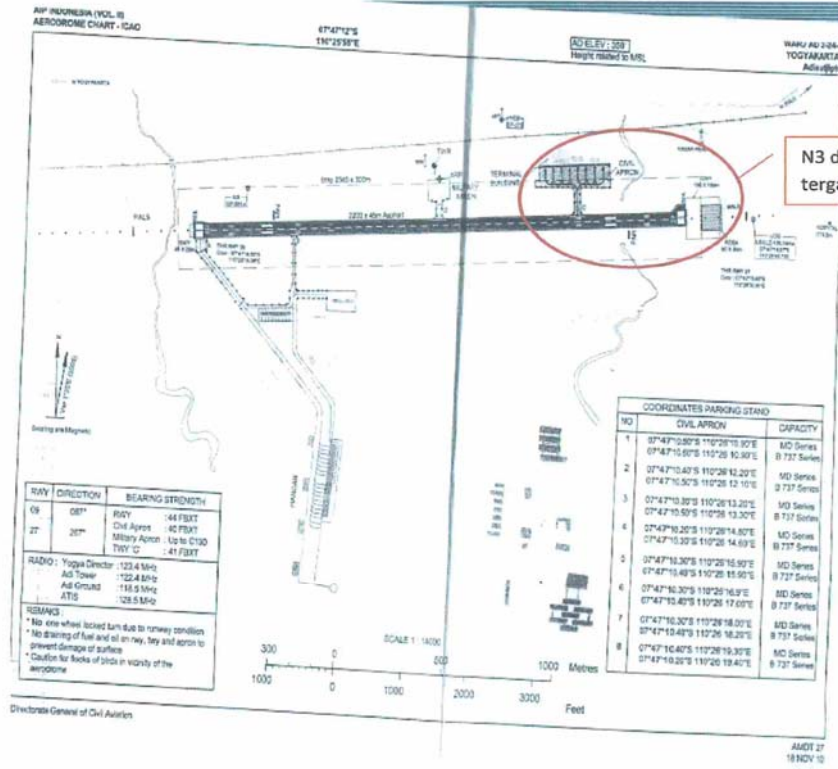
N3 dan NP belum tergambar

Perbedaan data tersebut yakni antara Amdt. 34 tanggal 13 Desember 2012 dan Amdt 27 tanggal 18 Nopember 2010 semestinya tidak terjadi di karenakan amandemen di AIP apabila terjadi perubahan data terkait data aerodrome semestinya juga akan merubah lay out aerodrome tersebut. Pihak yang dapat melakukan amandemen AIP adalah Kementerian Perhubungan dalam hal ini Direktorat Jenderal Perhubungan Udara, dari pihak bandara sudah menyampaikan data perubahan aerodrome tersebut berdasarkan surat Pts. General Manager Bandara Adisutjipto tanggal 27 Juni 2012, terlampir.
