FINAL
KNKT.13.03.07.04

Aircraft Serious Incident Investigation Report

**PT. Sriwijaya Air
Boeing 737-500;PK-CLJ
Minangkabau International Airport, Padang
West Sumatera
Republic of Indonesia
27 March 2013**

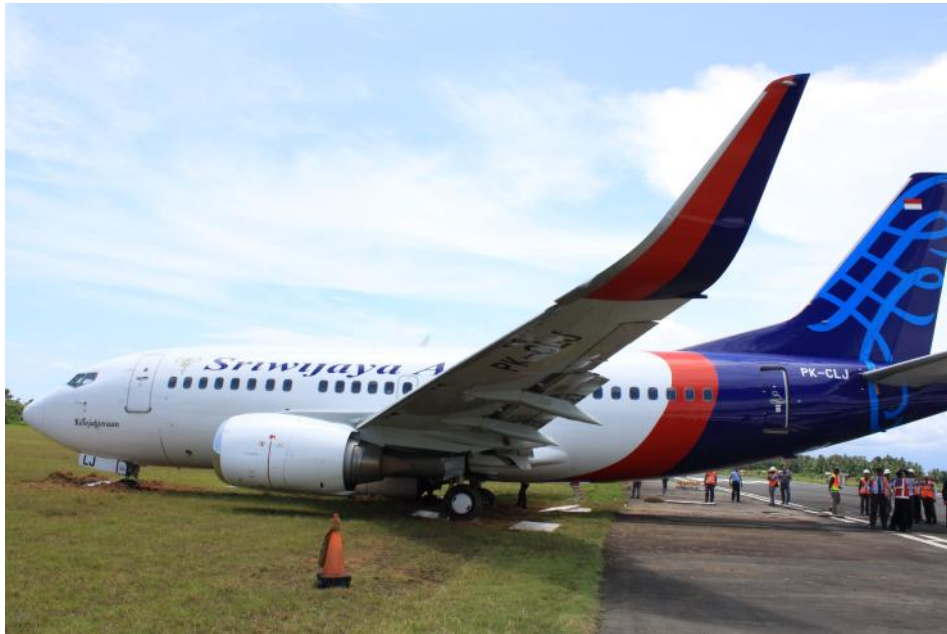
At 1142 UTC (1842 LT) the pilots received clearance to taxi out and enter back track runway 15. When approaching the threshold runway 15, the pilot turned the aircraft to the left. The aircraft stopped at 1155 UTC on approximate heading of 270° with the nose wheel out of the runway about 4.2 meters and in full deflection to the left.

On the runway was found 22 meters of rubber skid mark of the nose wheel beginning from the center guide until aircraft stopped.

Figure 2: The aircraft last position

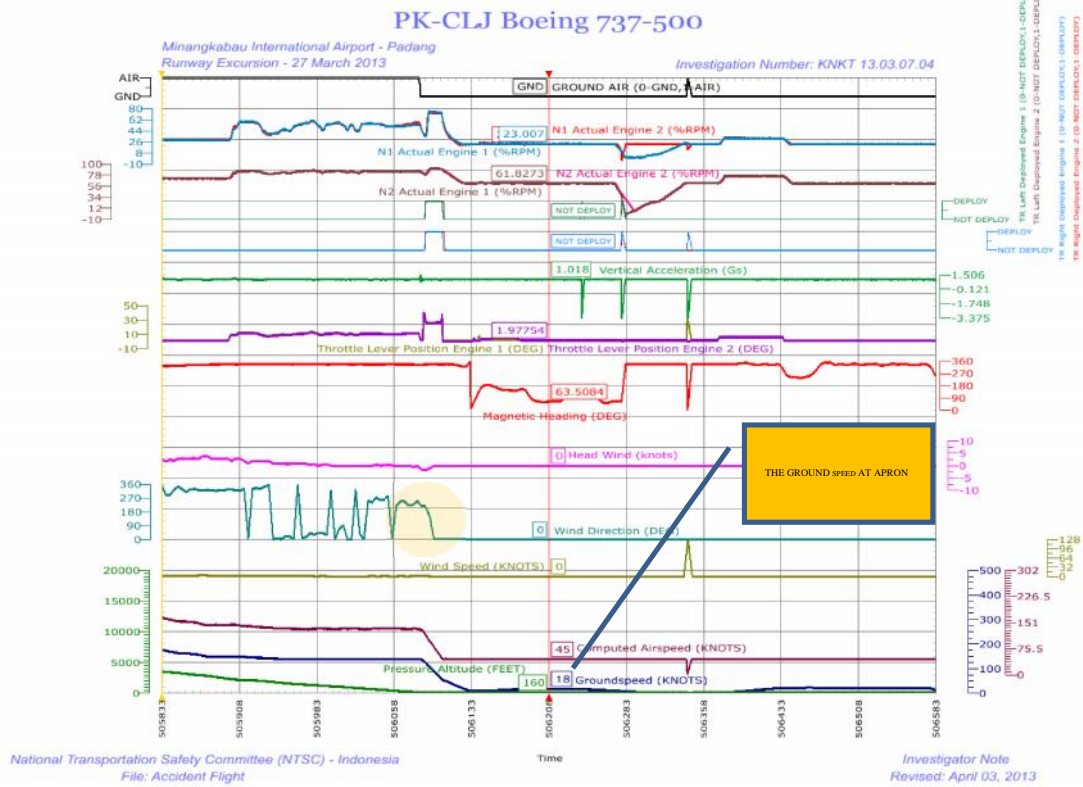
Figure 4: The FDR data shows the aircraft taxi speed at apron

The FDR recorded that the taxi speed when the aircraft entered the apron was 18 knots.

The FDR recorded that the taxi speed when the aircraft entered the apron was 18 knots and this mean that the aircraft taxi speed was 8 knots faster than the recommended in the FCTM.

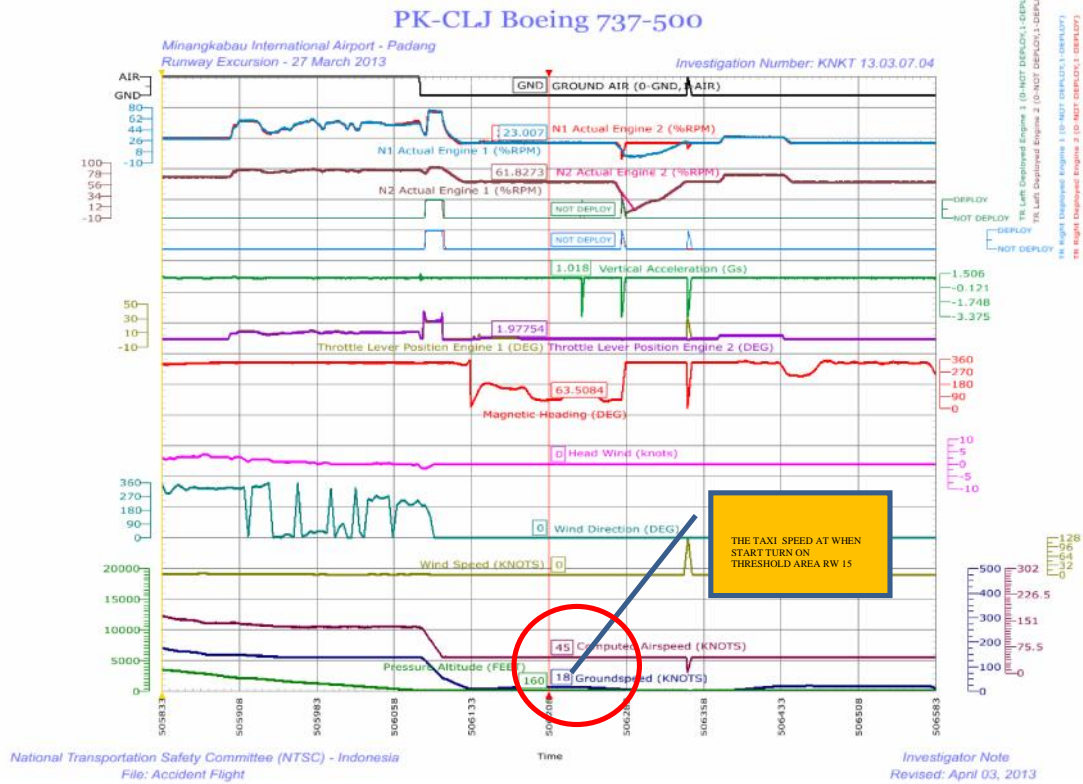
Figure 5: The FDR data shows the initial aircraft ground speed when start turning on the runway 15

The FDR was recorded that at the initial aircraft turn speed for a line up position on the runway 15 was 21 knots, this mean that the aircraft speed when turn was 11 knots faster than the recommended in the FCTM. The high speed most likely was the caused the nose wheel skid instead of turning.

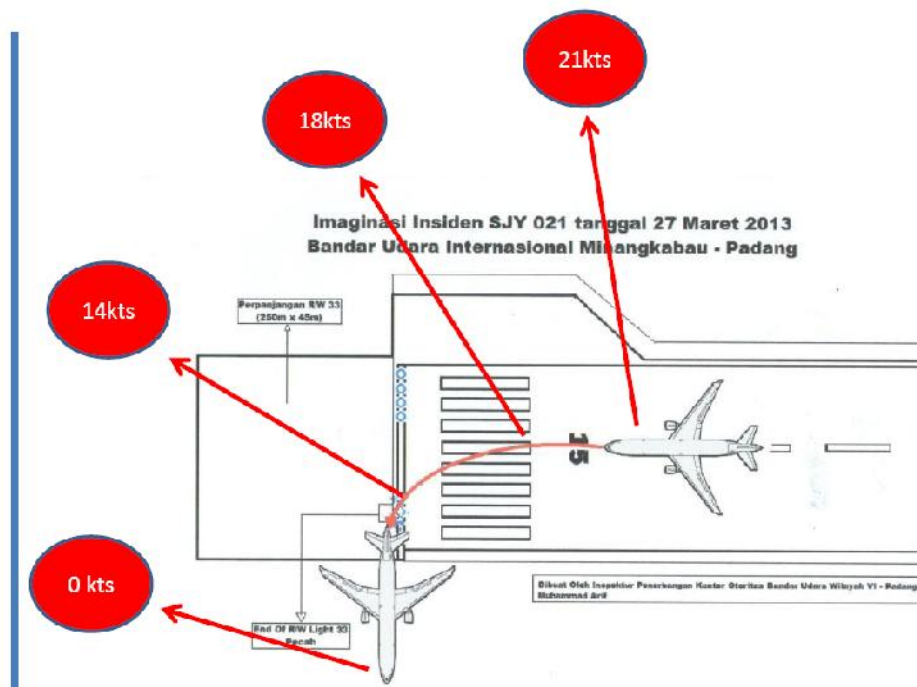
The aircraft speed illustration prior and after the aircraft veered off the runway shoulder end 15.

Figure 6: The aircraft speeds illustrates from the FDR data

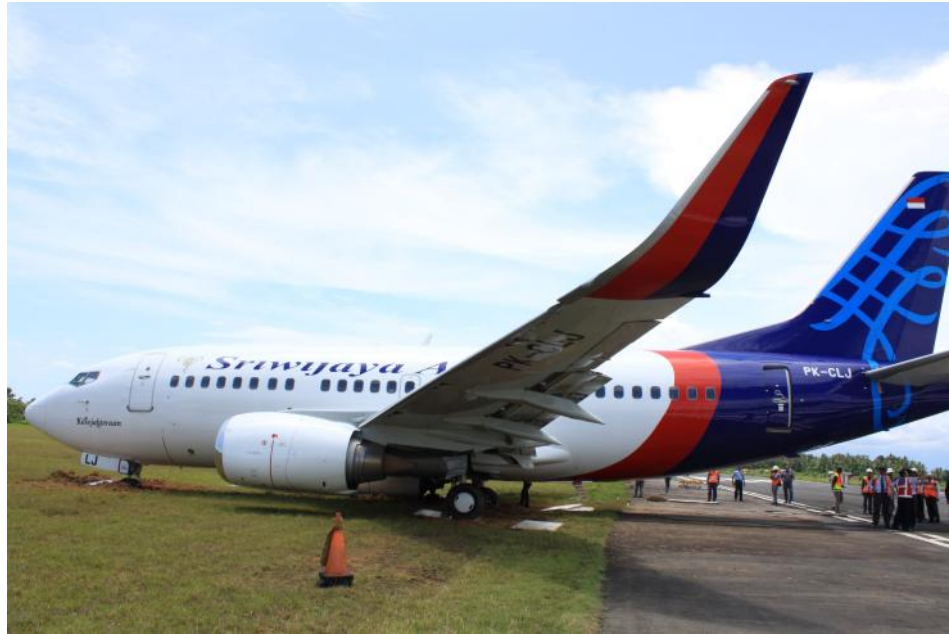
- The excavated lines of the nose wheels were marked on the surface along end of runway shoulder till its rest to stop showed both of nose wheels was skidding on the surface with approximate angle was 70 ° to the right.
- Visually checked found that no physical damage on the aircraft.

Figure 7: The aircraft last position prior evacuation process

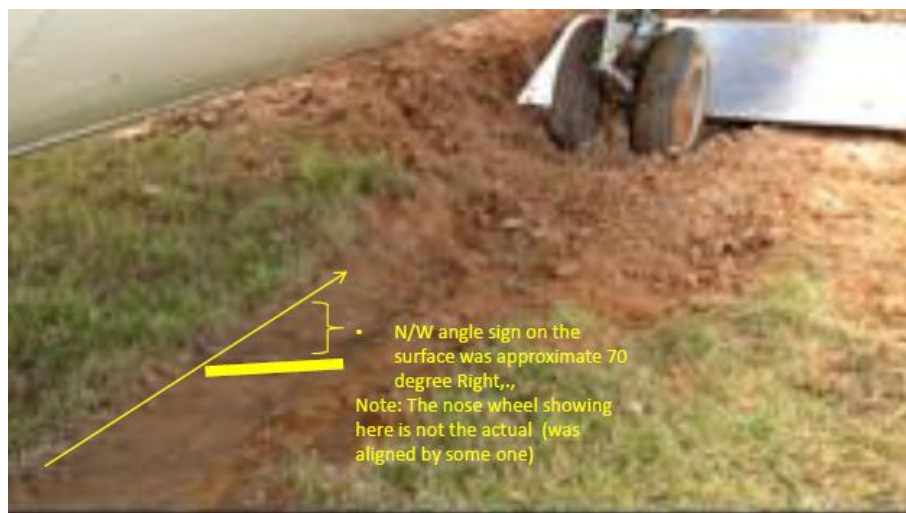
The excavated lines of the nose wheels were marked on the surface along end of runway shoulder till its rest to stop. Each excavated lines provide angles of approximately 70° on the surface.

- The figure below was not the actual nose wheel direction at the time of serious incident as the nose wheel has been turned to the center position for the evacuation purposes.

Figure 8: The excavated lines on the surface

- l. The excavated lines of the nose wheels marked on the runway surface showed that the nose wheel was skidding with approximate angle were 70 ° to the left.
