**KOMITE NASIONAL KESELAMATAN TRANSPORTASI  
REPUBLIC OF INDONESIA**

**Aircraft Accident Investigation Report**

**BAe ATP Freighter; PK -DGI**

**31 May 2013**

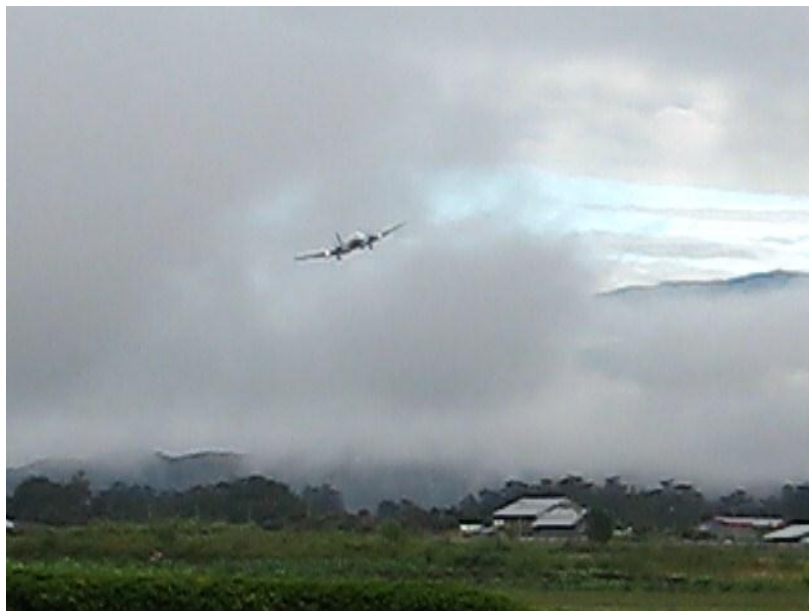
**Figure 1: When the aircraft on short final**

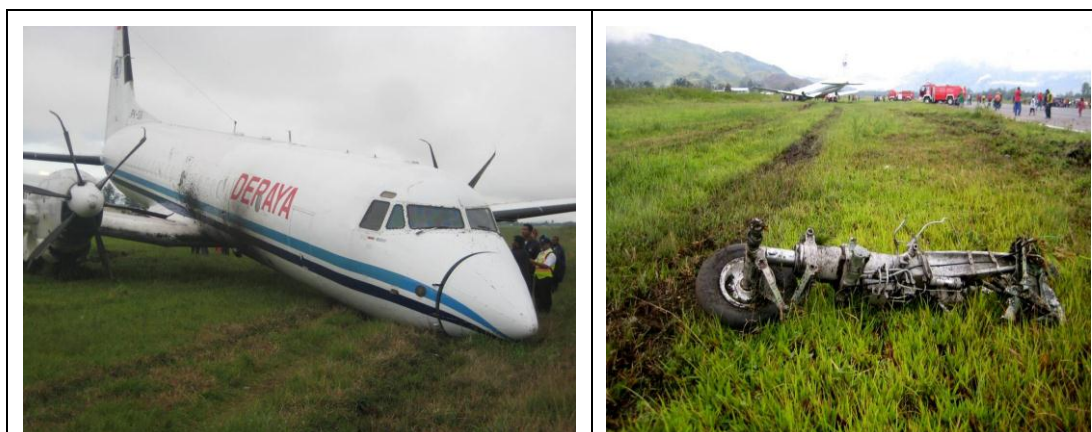
The damage of the aircraft were the nose and main landing gear broken, all the propeller blades bent.

**Figure 2: The aircraft final position and the nose landing gear detached**

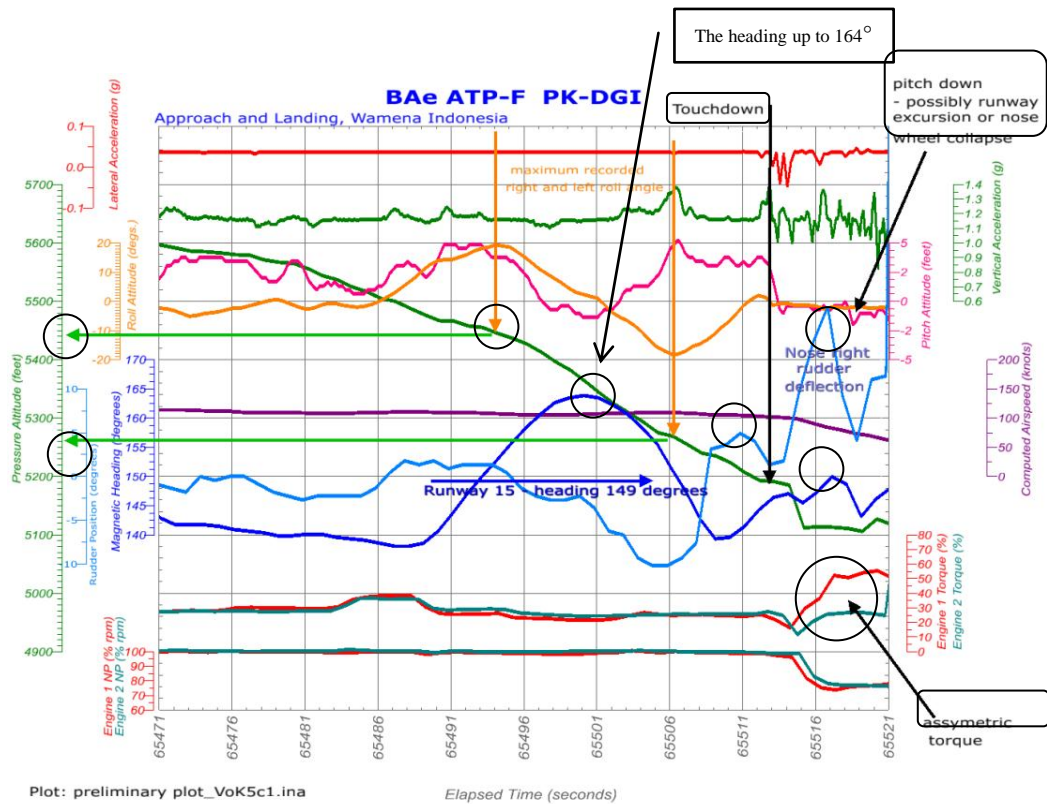
**Figure 4: The FDR graph data for several significant parameters**

- When at approximate 5,450 feet ( $\pm 400$  feet AGL) and 5,260 feet ( $\pm 200$  feet AGL) the pitch varied from  $1^\circ$  down to  $5^\circ$  up and the aircraft rolled to the right up to  $20^\circ$  and at aircraft heading  $164^\circ$  the aircraft rolled to the left up to  $20^\circ$ .
- The aircraft speed relatively constant from 105 kts until touchdown.
- The aircraft touchdown with roll angle approximately  $2^\circ$  to the left and heading of  $147^\circ$  while the runway heading was  $149^\circ$ .
- After touchdown the NP indicated drop from 100% to approximately 70% and maintained.
- The engine torques was asymmetric; it shows that the left engine torque was approximate 55% while the right engine torque was approximate 25%.

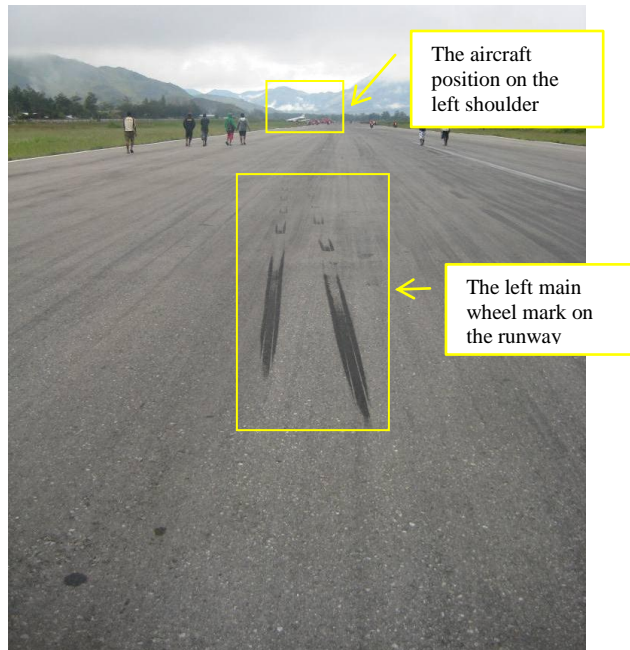
- The touchdown marks indicated that the aircraft movement misalign with the runway centerline
- The initial left main wheel out of the runway pavement found at 750 meters from the beginning runway 15.
- The aircraft travelled on the left runway shoulder parallel with the runway 15.
- The nose landing gear was detached and the aircraft last position was 1,073 meters from the beginning and 10 meters left side of runway 15.

**Figure 5: The mark of first touchdown found on the runway**

The FDR revealed that the aircraft touchdown with roll angle approximately 2° to the left and heading of 147 while the runway heading was 149°, this was confirmed by the evidence of touch down mark found on the runway.

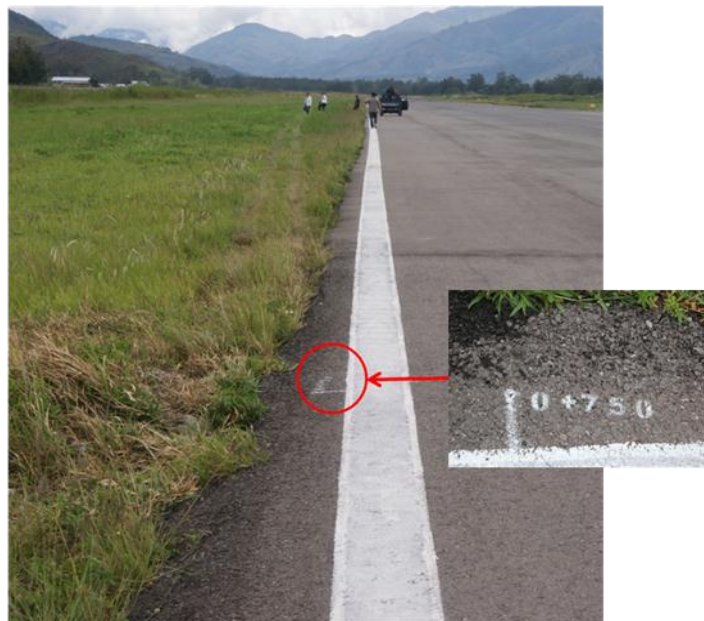
**Figure 6: The mark of left main wheel off the runway**

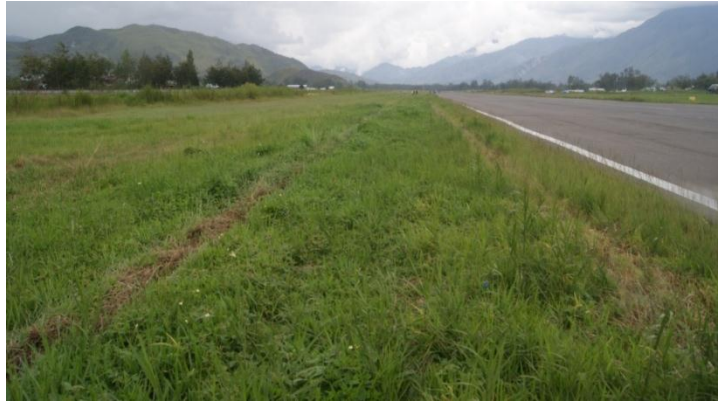
**Figure 7: The mark of both main wheels off the runway**

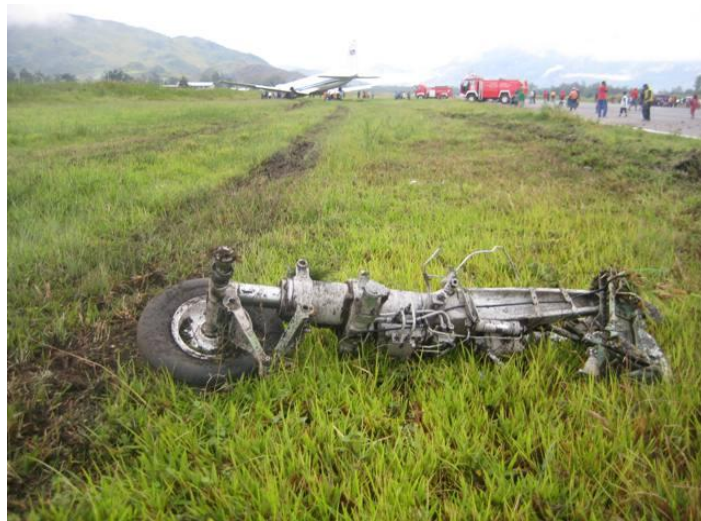
The nose landing gear detached and found on the shoulder at about 250 meter from the aircraft final position. The main landing gears broken and all the propellers bent.

**Figure 8: The aircraft final position and the nose wheel detached**
