FINAL  
KNKT.13.12.32.04

Runway Excursion Investigation Report

**PT. Garuda Indonesia**  
**Airbus A330-200; PK-GPN**  
**Soekarno-Hatta International Airport,**  
**Tangerang**  
**Republic of Indonesia**  
**13 December 2013**

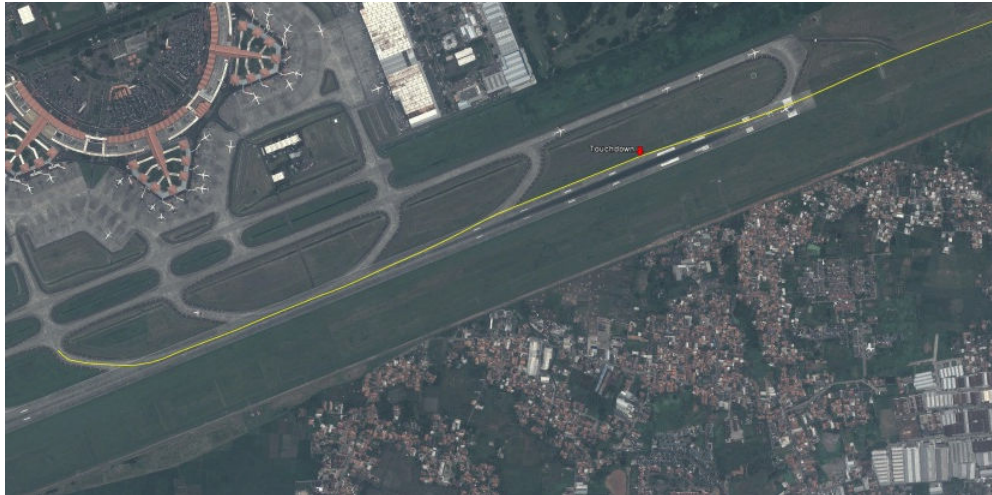
**Figure 1: The flight trajectory and touchdown point revealed from the FDR and superimposed to Google Earth.**

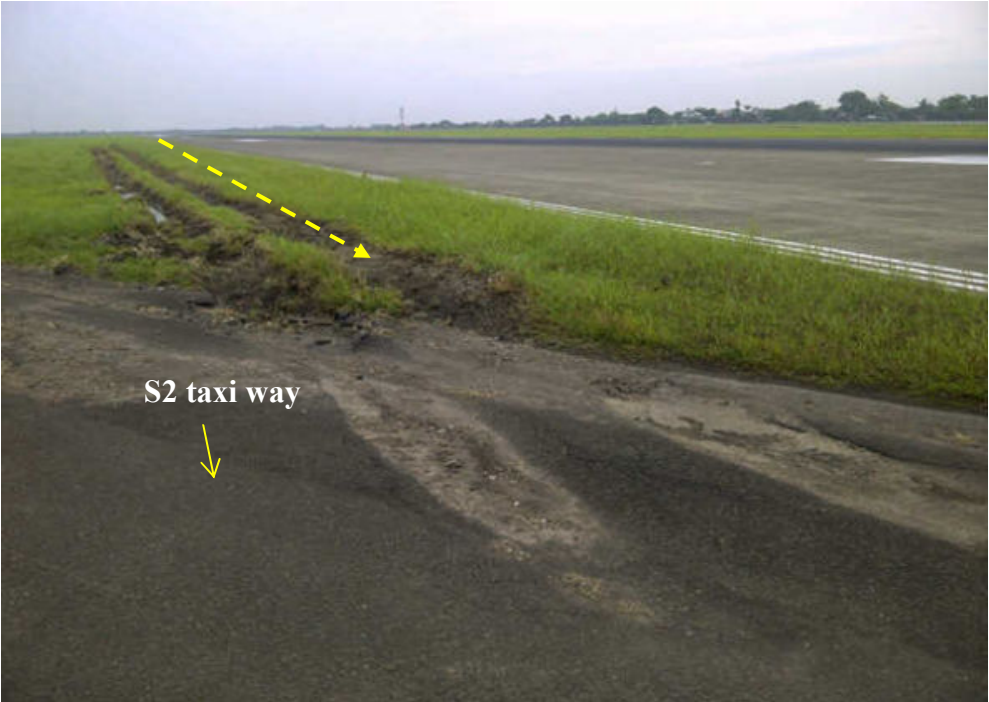
**Figure 2: The right main wheel mark on runway shoulder**

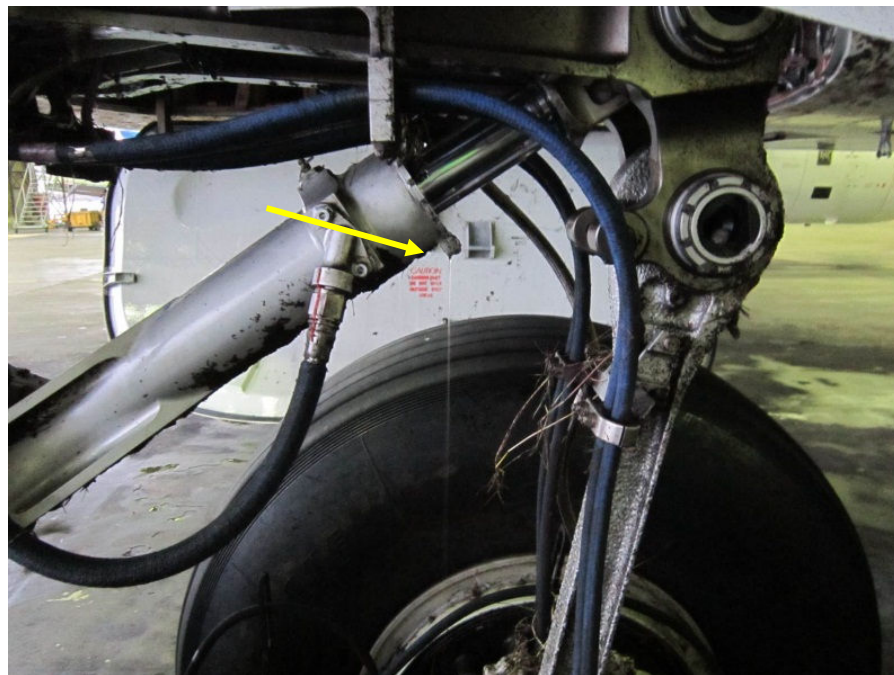
Observation of the aircraft after the serious incident at the Garuda Maintenance Facility AeroAsia (GMF-AeroAsia) found the hydraulic leak on the right landing gear actuator and one of the tires torn and cut.

Figure 3: Leak on the right main landing gear actuator (yellow arrow).

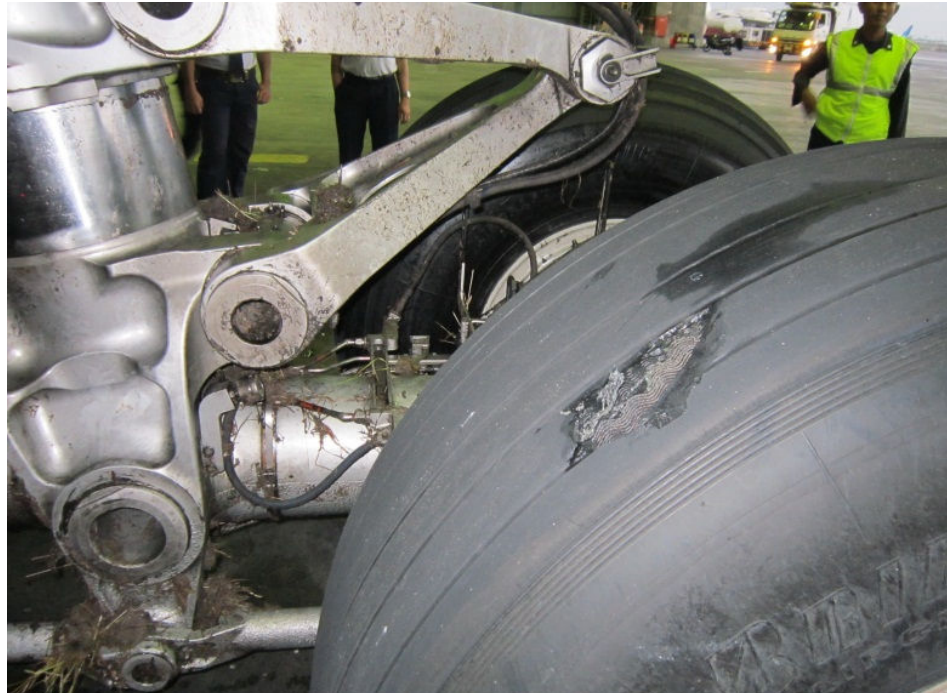
**Figure 4: One of the tires torn and cut**

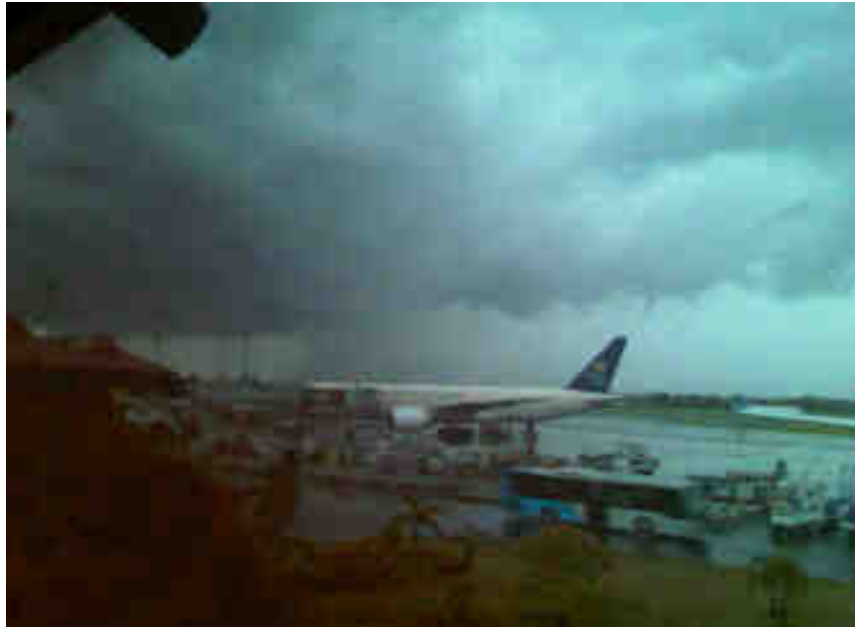
A picture taken 22 minutes after the serious incidents indicated a heavy rain and low clouds on the area of Soekarno-Hatta Airport.

**Figure 5: Picture taken at terminal two, 22 minutes after the serious incident**

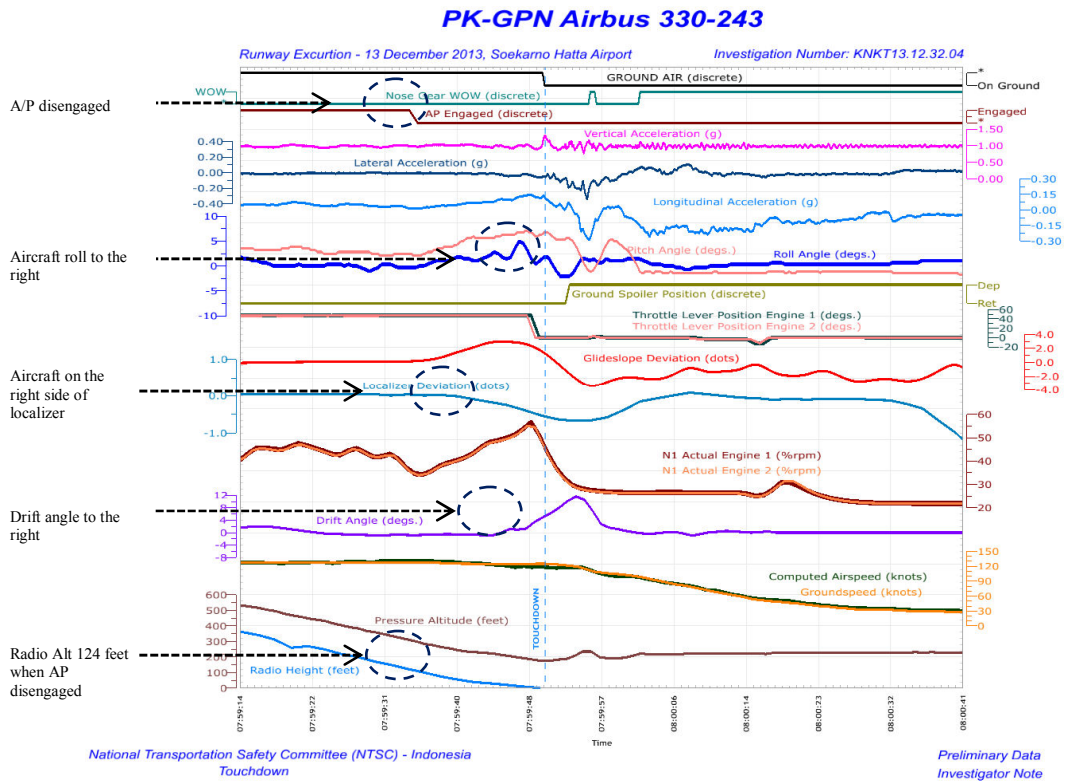
The FDR data was downloaded at NTSC facility. The significant parameters were marked with circles on figure 6.7 and 8.

**Figure 6:** The FDR data on approach from 350 feet of Radio Altimeter

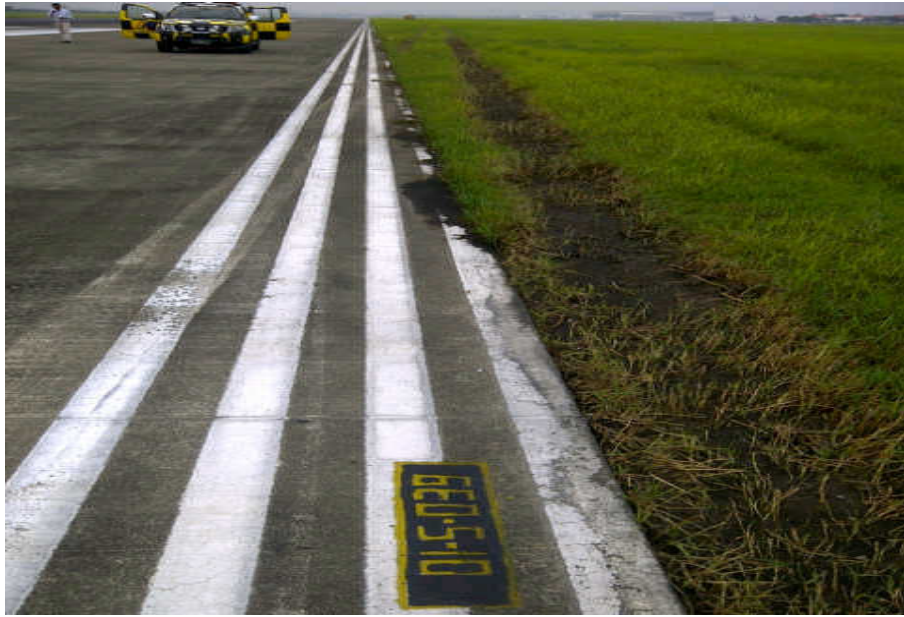
The mark of the right main wheels found on the right runway shoulder about 500 m before re-entered the runway. Refer to the interview, the pilot stated that the initial touched down, the right main wheels were on the right unpaved of the runway 25L.

**Figure 9:** The mark of initial touch down
