FINAL
KNKT.13.05.11.04

Aircraft Accident Investigation Report

**Bandung Pilot Academy
Cessna 172 S; PK-IUA
Nusawiru Airport
Pangandaran, Jawa Barat
Republic of Indonesia
03 May 2013**

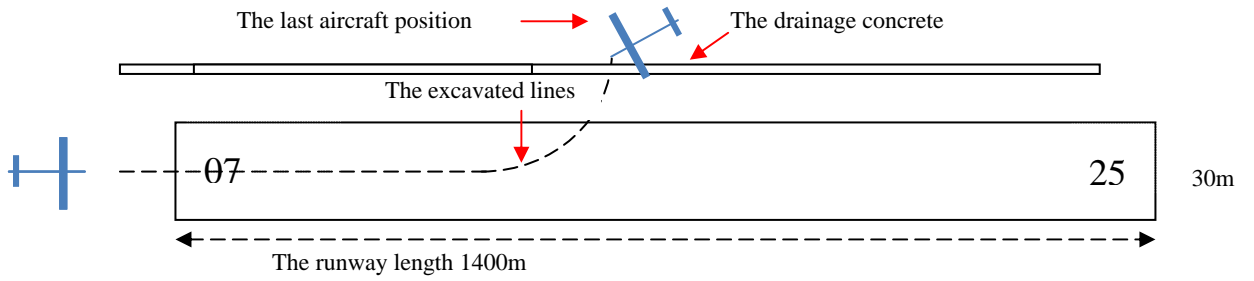
Figure 1: Illustration of accident aircraft trajectory

At 01.12 UTC the aircraft touch down on runway 07 normally. During rolling the pilot prepared all things for re takeoff. While opening the power at approximately 600 meter from the end of runway 07, the aircraft veered to the left, crossed the runway shoulder then hit the drainage concrete and stop into rest on upside down position.

An observation on site, found excavated lines along the surface on the runway shoulder in approximate 50 meter.

The figure 1; show an illustration of accident aircraft trajectory and wreckage information.

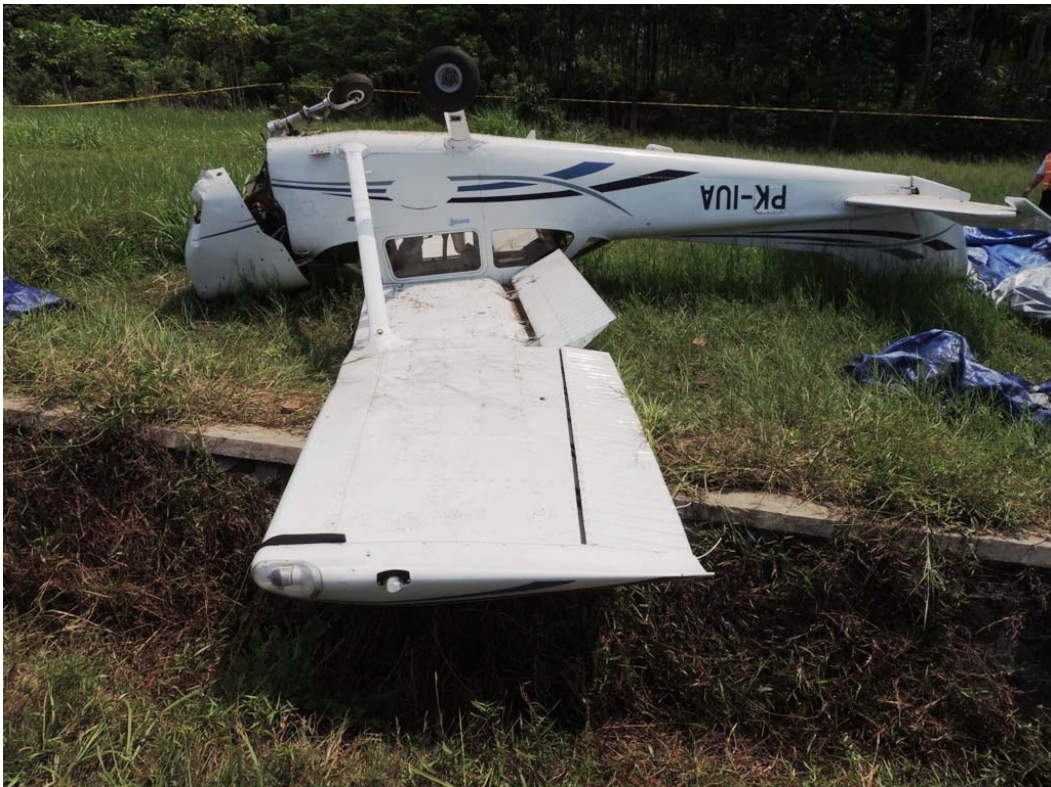
Figure 2: Aircraft position

The aircraft nose section, engine, propeller and most of the flight control parts were damaged. The flaps position was found at full down position. The wreckage was secured by the local security until the NTSC team arrived one day after.

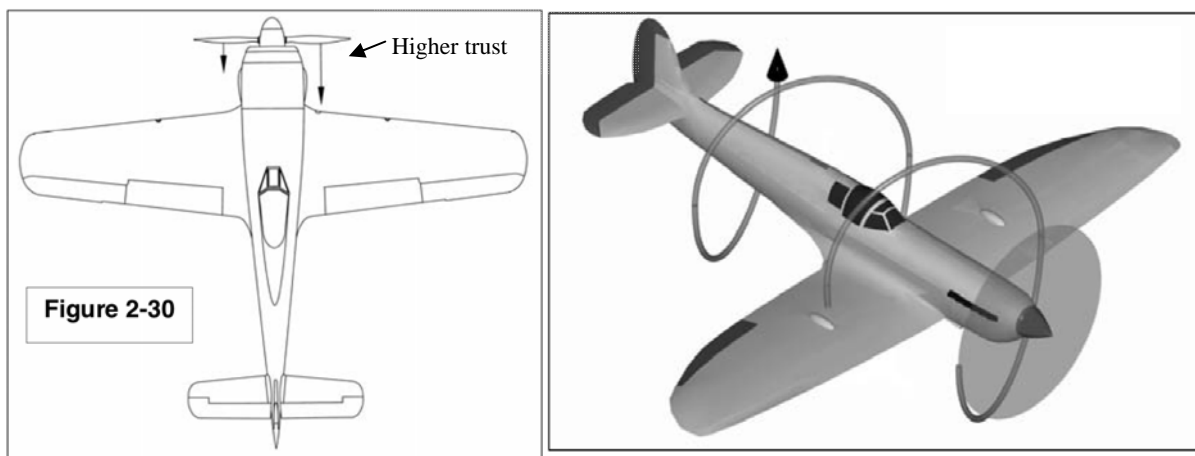
Figure 3: The Yawing Moment

The reaction to this is a left yaw of the aircraft (for a prop which rotates clockwise as viewed from the rear) because the thrust being produced on the right side of the aircraft (down going blade) is about twice as much as the up going blade on the left side (Figure 2-30)

Much rudder is often needed to compensate in some flight conditions, so much so that very little is available for maneuvering (less control authority). Although spiraling slipstream occurs constantly, it imparts more influence to the airflow at slow speed and higher power settings.

During rolling the student pilot opened the power then suddenly the aircraft veered to the left. This was consistent with the theory dynamic effect aforesaid above.
