FINAL
KNKT.13.09.24.04

Aircraft Accident Investigation Report

PT. Aviasi Solusi Prima (Flybest Flight Academy)
Cessna 152; PK- KFC
8 Miles Radial 153 BTM VOR;
Batam, Riau Island
Republic of Indonesia
12 September 2013

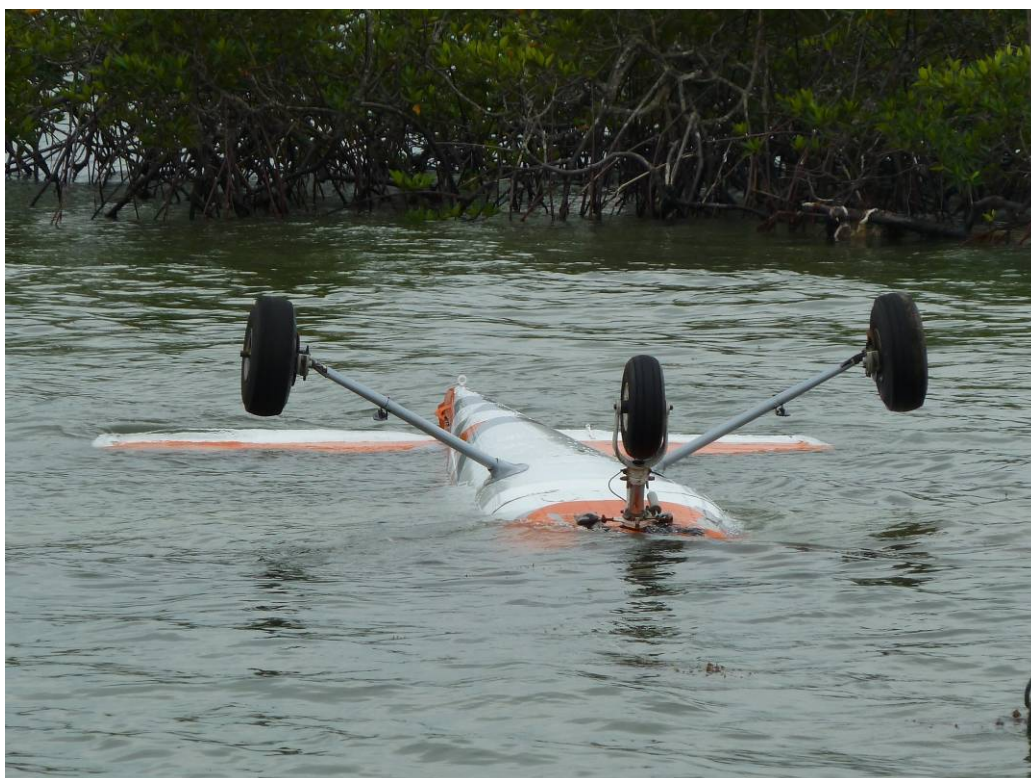
The pilots were minor injured and the aircraft was up-side down floated on the sea.

Figure 2: The aircraft up-side down floated on the sea

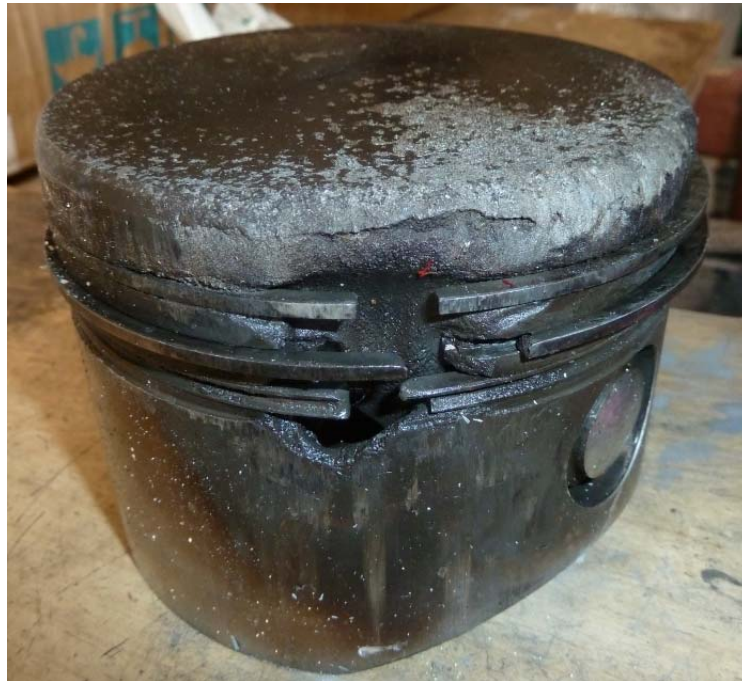
The post-accident engine examination was performed by KNKT investigators and found that the pistons burn and melt, and the exhaust valve damage.

Figure 3: One of the melted and scratched pistons

The metallurgy observation on the damage piston concluded that the failure of the piston was due to the overheating which occurred at relatively short period of time (few days).

The overheated engine could expand the piston resulted to the loss of power and even damaging the power section, piston heads and exhaust valves burn or melt, and exhaust valves seat damage. Engine overheat or excessive temperature caused by detonation.

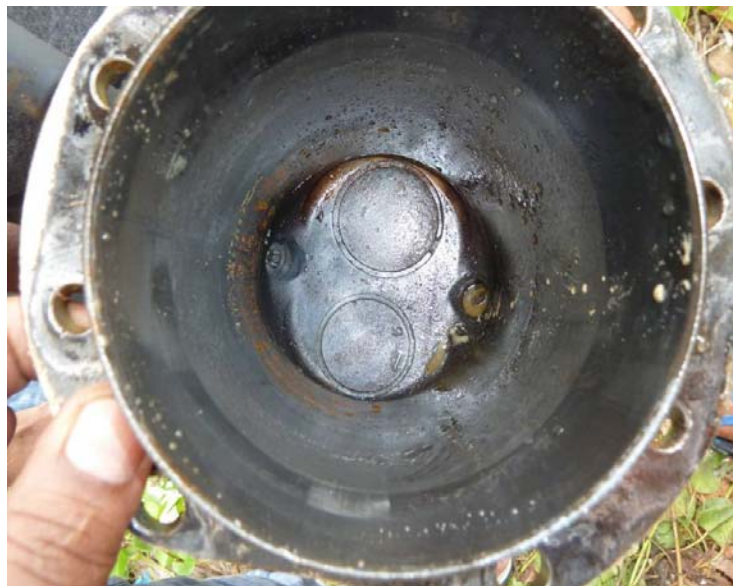
Figure 4: The damage found on the exhaust valve

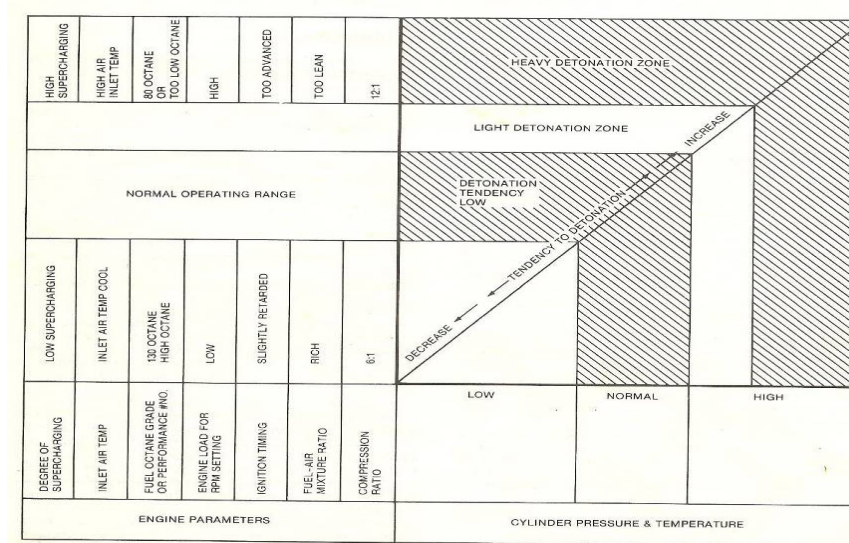
Figure 6: Factor that effect of detonation

Refer to the table above: the combination of MOGAS with octane of 91, lean air mixture on takeoff (high engine load for RPM setting) condition will go into the envelope of heavy detonation zone.

Refer to the factors that effect of detonation table, the condition of MOGAS fuel (with octane of 91) with RICH fuel air mixture in the high engine load would be in the envelope of LIGHT DETONATION ZONE.

The condition of AVGAS fuel (lean mixture performance rating is 100 and the rich mixture rating is 130) was used and lean air mixture in high engine load would be in the envelope of LIGHT DETONATION ZONE. The POH recommended for takeoff below 3000 feet with lean air mixture, the power limited to 75% power. The limited power would reduce the engine load and would be in the NORMAL OPERATING CONDITION, according to the factors that effect of detonation table.

Refer to the factors that effect of detonation table: The condition in the accident flight, of lean fuel air mixture, combined with lower octane fuel of MOGAS with octane of 91 (compare to AVGAS of lean mixture performance rating is 100 and the rich mixture rating is 130), has made improper fuel air ratio. The combination of these two conditions on high engine load (takeoff power of 2500 RPM) was in the envelope of HEAVY DETONATION ZONE.

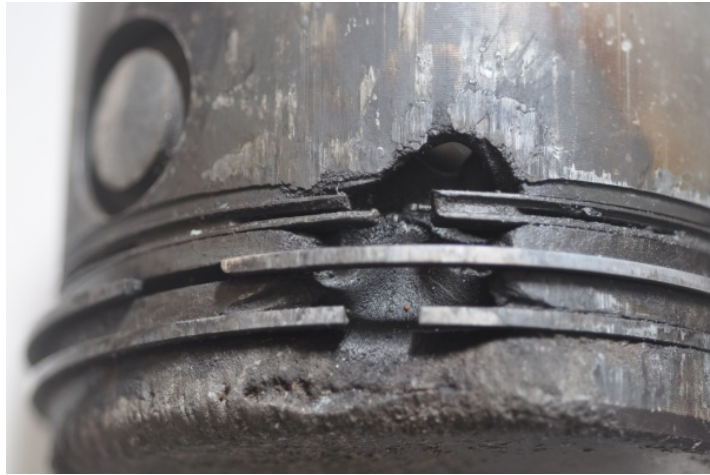
Figure 8: Burned and punctured area

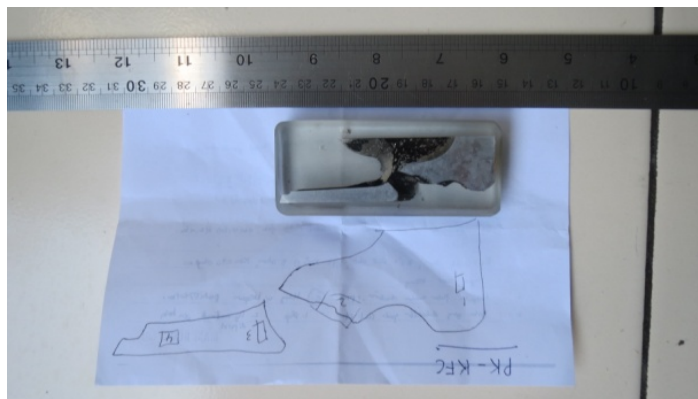
Figure 7: Sectioned sample for metallographic examination

Observation was performed by metallographic method. A sample was sectioned from the damaged piston. The cut was taken from the burned / punctured location, as well as the intact location. The idea was to compare the microstructures between the locations near the punctured hole and about two centimetres away.

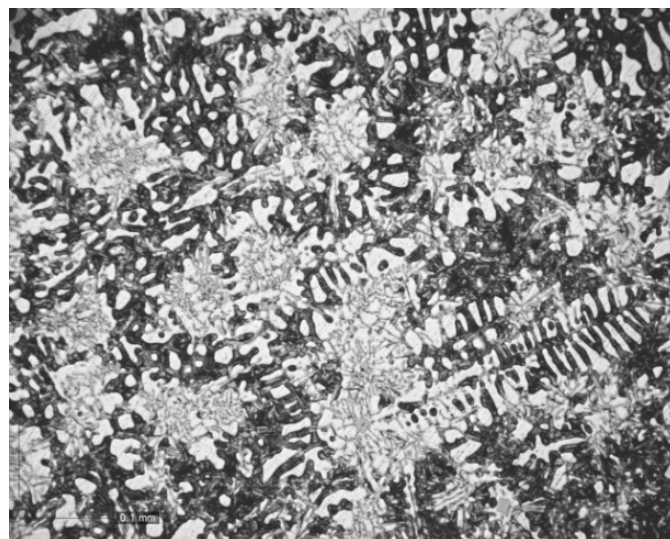
Figure 8: Microstructure at the piston wall, approximately 3 cm from the hole: original microstructure (i.e. the dendrites)

The area adjacent to the burned / hole area is typical a melted structure. The structure shows melted and solidified structure showing also free silicon grains. The original structure still existed, that is dendrites as a result of casting process, even at a distance of 2 cm from the burned hole.
