FINAL
KNKT.13.04.09.04

Aircraft Accident Investigation Report

**PT. Lion Mentari Airlines (Lion Air)
Boeing 737 - 800; PK-LKS
Ngurah Rai International Airport, Bali
Republic of Indonesia
13 April 2013**

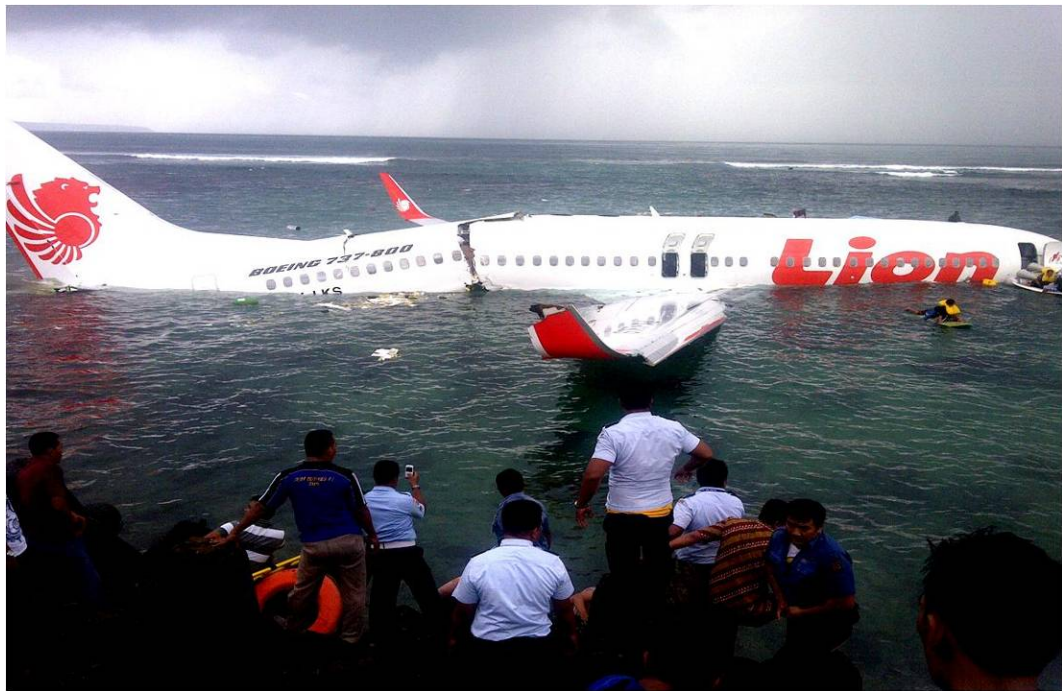
Figure 2: The aircraft after the accident

The aircraft was substantially damaged and submerged in shallow water.

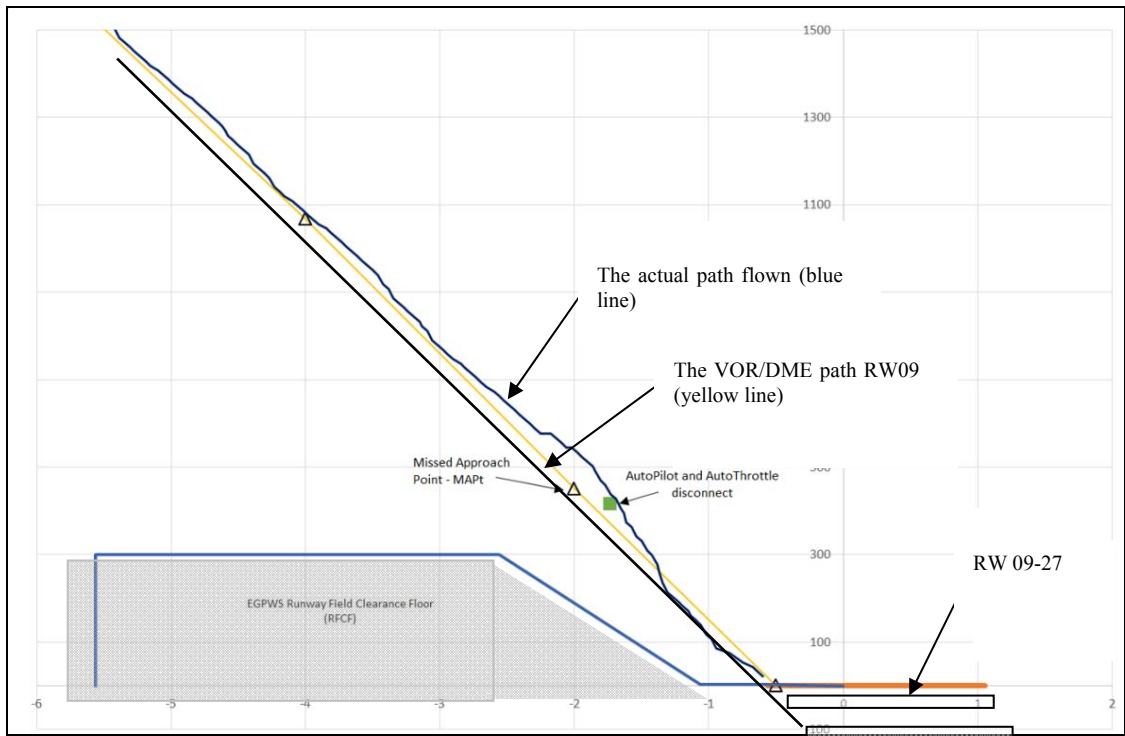
Figure 3: Aircraft flight path with respect to EGPWS envelope

Examination of the FDR and CVR information indicated that no EGPWS warnings occurred during the accident sequence. Further examination of FDR data indicated that the aircraft did not enter the EGPWS alert/ warning envelope during the approach (Figure 3).

The final approach phase of the flight profile was outside the envelope. Therefore there was no EGPWS terrain warning.

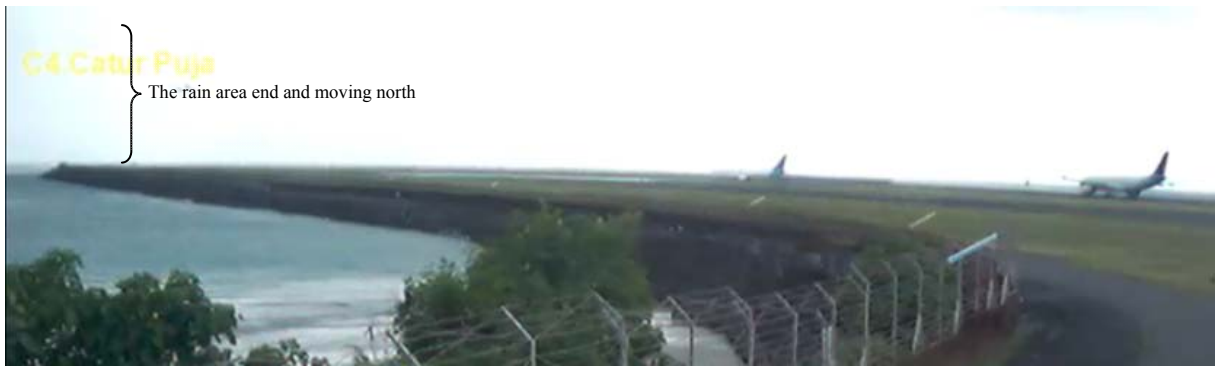
Figure 6: The weather 4 minutes prior to the accident

The airport Closed Circuit Television (CCTV) camera located on the south side of the runway recorded the changing weather. The rain showed as a grey area on the left corner, and moving across the short-final area. The weather 4 minutes before the accident (Figure 5) showed the final area was clear.

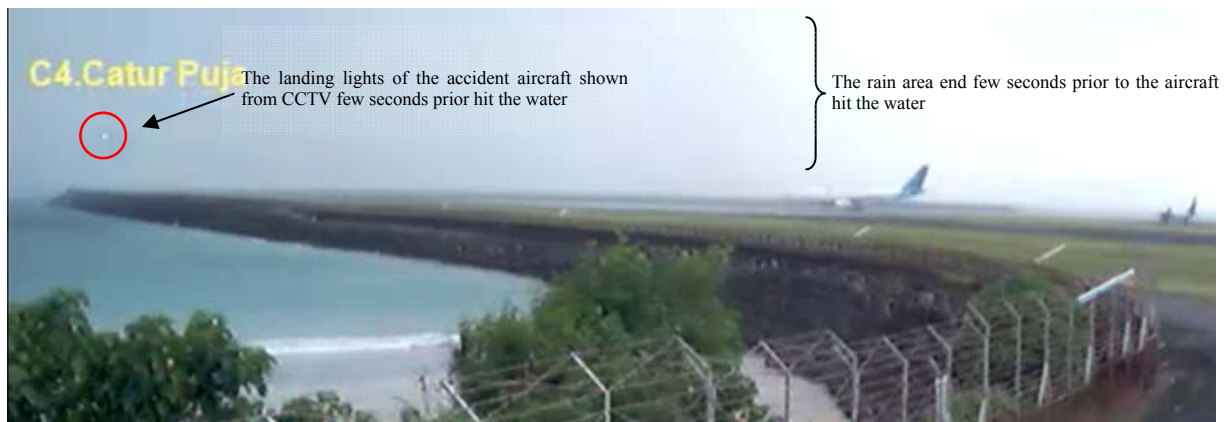
Figure 7: The weather few seconds prior to the accident

The weather a few seconds prior to the accident on figure 6 shows that the final area was raining as seen from the CCTV camera.

Four minutes prior to the accident, the airport CCTV recorded that the final approach area was clear. During the final approach of the aircraft, the CCTV recorded that the final approach area was raining. This indicated that the dark side that was initially observed by the PIC to the right of the aircraft had moved across the final approach path.

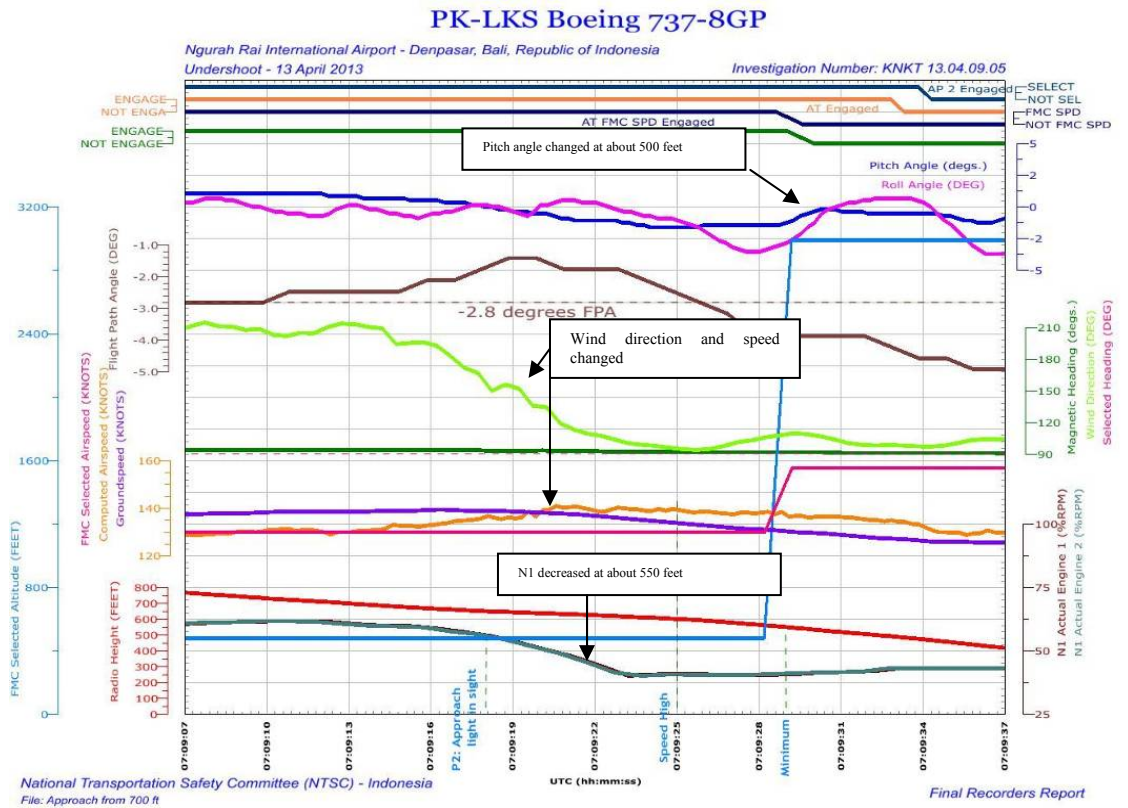
Figure 12: FDR data pitch, wind and N1

No aircraft systems malfunction were recorded on FDR after the aircraft departed from Bandung on the last flight.

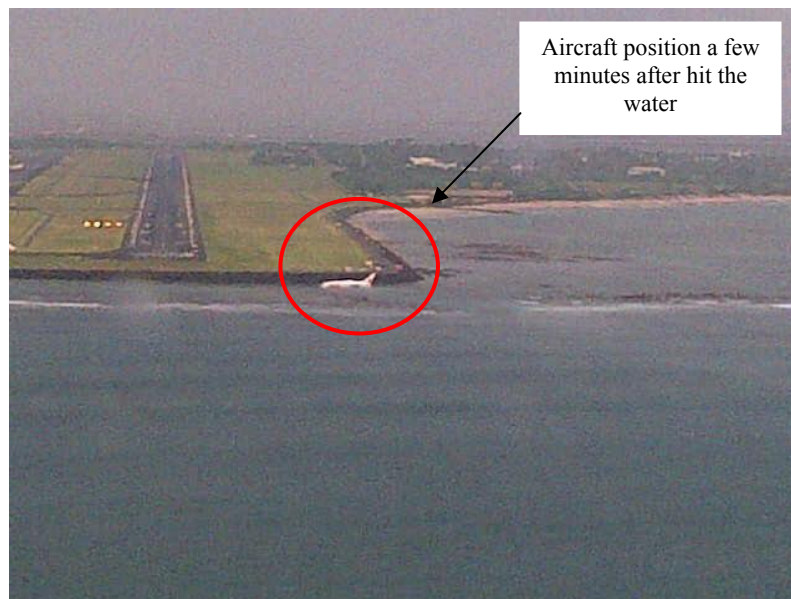
Figure 16: Final aircraft resting position

The main landing gears broke and detached. It was found about 300 meters from the last position of the main wreckage. The engines detached from the wing pylon. Those components detached most likely due to impact with rock of the shallow sea bed. After they detached, the aircraft swung to the left at its final position.

The aircraft came to a stop facing north about 20 meters from the shore and approximately 300 meters west of the runway 09 threshold.

The wreckage was submerged in shallow water between 2 to 5 meters in depth.

The initial photographs revealed that the vertical stabilizer, right stabilizer, wings and control surfaces were in good condition with minimal damage. The right engine and both main landing gears had detached from the main wreckage.

All of the observed damages were due to impact to the sea floor, coral reef and sea wall.
