FINAL
KNKT.13.11.28.04

Aircraft Serious Incident Investigation Report

**PT. Enggang Air Services
Grand Caravan C208B; PK-RSP
Nalca Airstrip, Papua
Republic of Indonesia
14 November 2013**

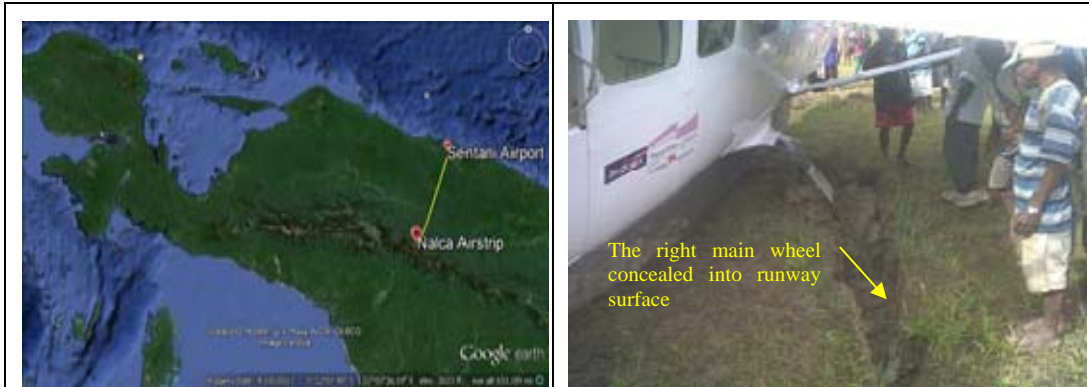
At 2256 UTC (0756 LT) the aircraft touched down runway 24 on landing speed about 78 knots and rolled normal with slightly right of the center runway. At approximately 20 meters before the parking area which was located on the right of the runway, the right main wheel trapped and the aircraft stopped with right wing slightly down and right wheel concealed on the ground.

Figure 2: Shows the flight track and the right wheel concealed on the runway

Therefore the investigation concludes that inadequate information including the runway surface status had contributed to pilot awareness to the condition of the runway and led to the right wheel concealed into the runway soft surface.

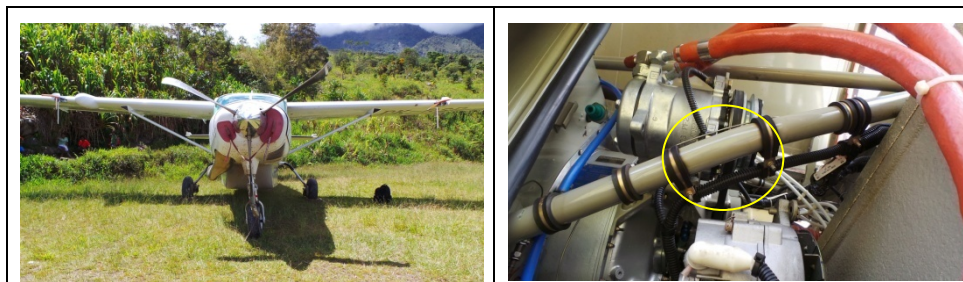
Damages found on the aircraft were the propeller blades were bent, nose landing gear misalign, the engine cowling bottom shifted and the left engine mounting bent.

Figure 3: Shows the aircraft and the bend of engine mount in the circle

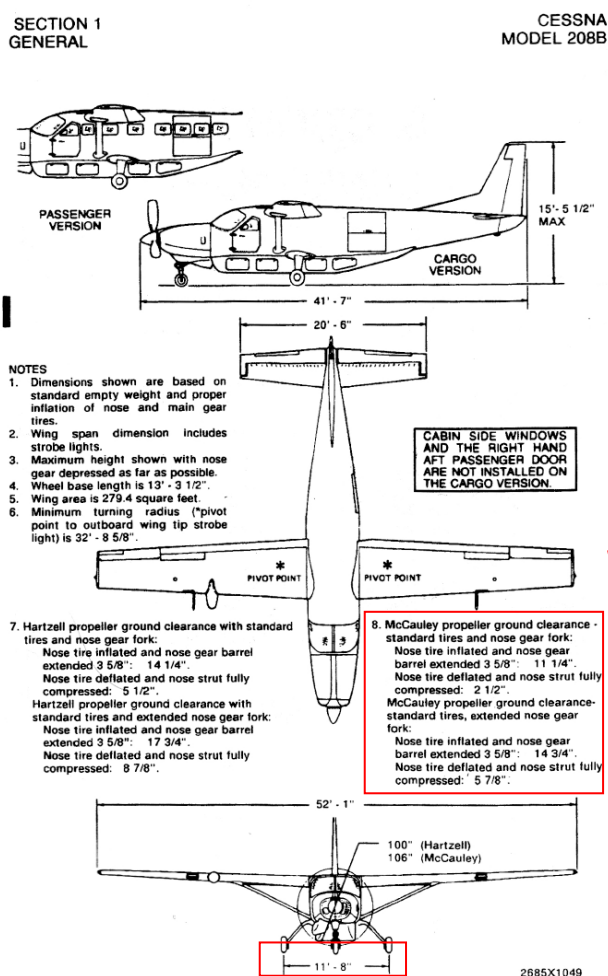
Figure 1-1. Three View

- McCauley Propeller Ground Clearance**
- The propeller ground clearance standard tires and nose gear fork: nose tire inflated and nose gear barrel extended 3 5/8": 11 1/4 "
 - Nose tire deflated and nose strut fully compressed: 2 1/2 "
 - propeller ground clearance standard tires, extended nose gear fork: Nose tire inflated 3 5/8 ": 14 3/4 "
 - Nose tire deflated and nose strut fully compressed: 5 7/8 "

Figure 4: Shows the aircraft dimension based on empty weight and proper inflation of nose and main gear tires (taken from Cessna 208B manual)

The propeller ground clearance and distance between main wheels is specified on the red boxes.

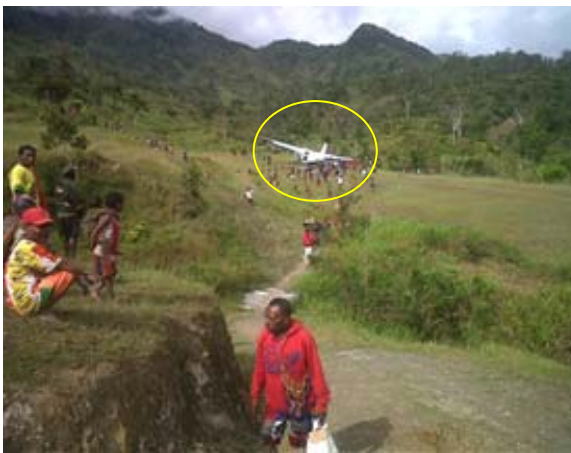
The photographic evidences as shown in the figures below indicated the right wheel mark found on the runway and the aircraft after evacuated (figure 6) and also shows the left wings slightly up (figure 5).

Figure 5: Shows the last position

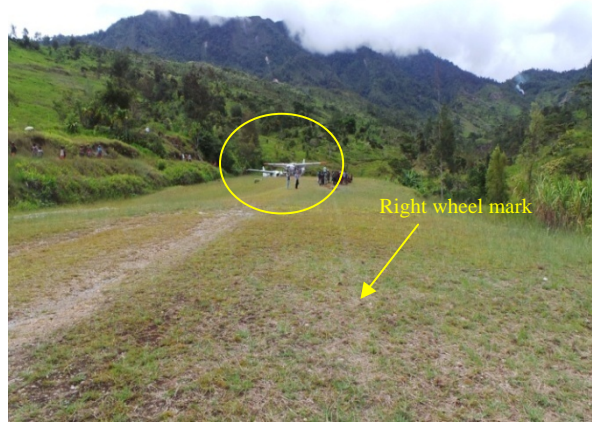
Figure 6: Aircraft position after evacuated

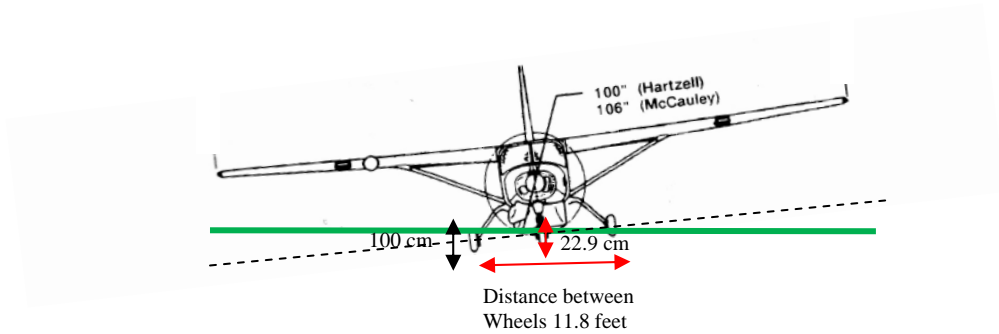
The observation found that the right main wheel concealed into ground in about one meter and the right wing slightly bank to the right.

The calculation of the propeller ground clearance using the highest propeller ground clearance of $14 \frac{3}{4}$ "(Inch) or 22.9 cm and distance between wheels is 360 cm. The propeller blade will hit the runway surface when any wheel concealed at least of 22.9 cm into the surface or the wing of the aircraft roll at least 17° on the ground. In fact the whole right main wheel had concealed into the runway surface which more than 22.9 cm.
