**FINAL**  
KNKT.13.05.13.04

**Aircraft Accident Investigation Report**

**PT. Nusantara Buana Air  
Casa 212-200; PK - TLG  
Sultan Babullah Airport; Ternate  
Republic of Indonesia  
10 May 2013**

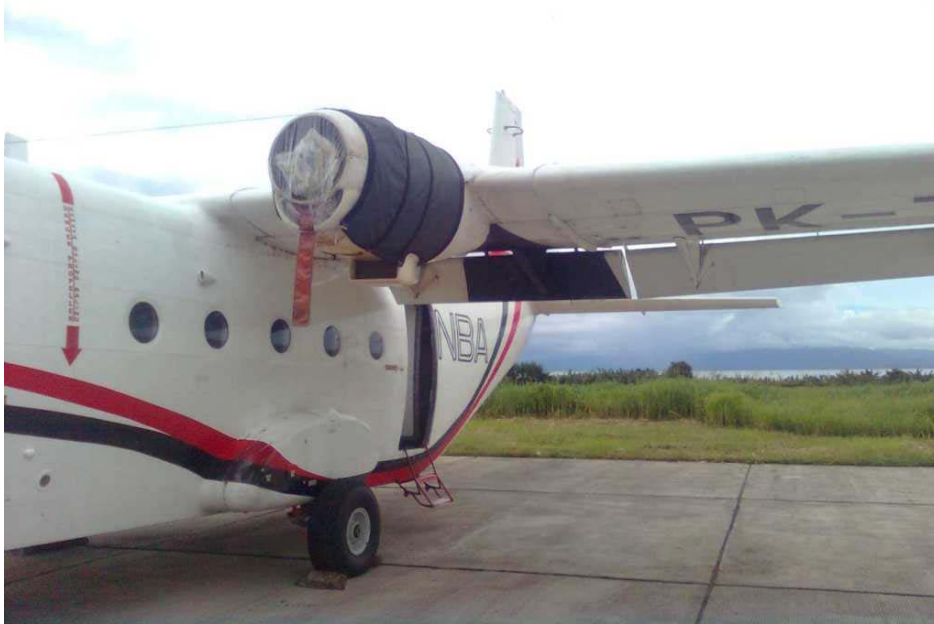
**Figure 2: The aircraft after incident**

There was no other damaged to the aircraft other than the left propeller assembly which detached.

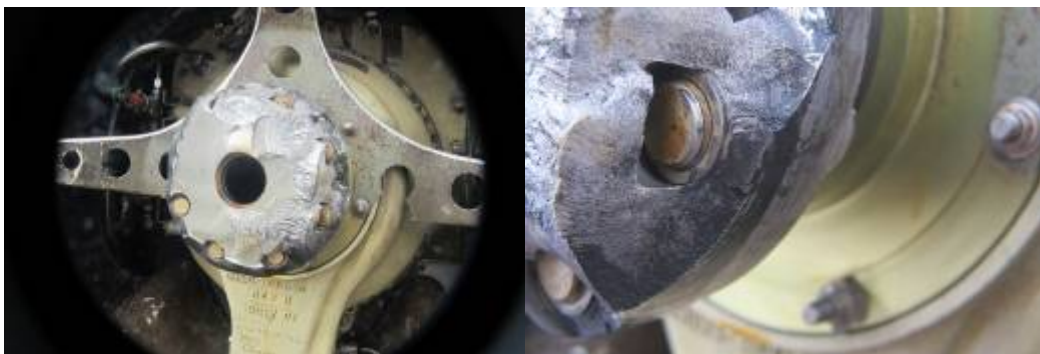
Parts of rear hub half was still intake to the propeller flange of the left engine while the detach parts of the hub half and the propeller were not recover.

Further examination of the left rear propeller hub half was found crack about 70%.

**Figure 9: Remaining left propeller hub half attached at the propeller flange**

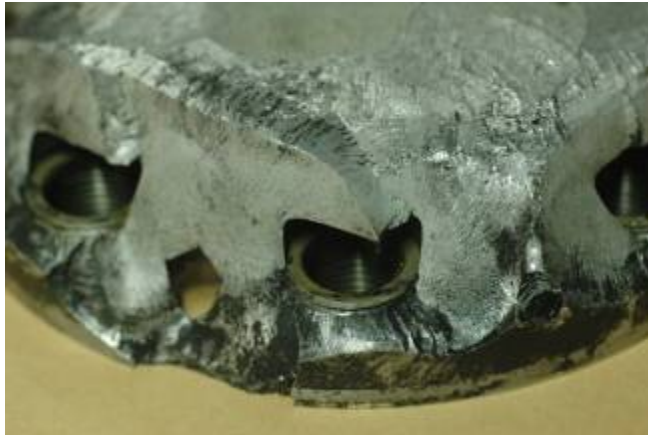
Observation on the fracture surface revealed that fatigue cracks (area with beach-marks) had propagated / progressed to a large area, so that the remaining area of the final failure (area with-out beach-marks) is approximately 30% of the original area. The dark colored surface indicates that fatigue cracks developed much earlier than the cracks shown at the bright fracture surface. Dark color was due to exposure to exhaust gas during propeller reverse operation.

**Figure 11: Fatigue cracks: darker surface shows earlier crack development while the lighter surface shows cracks developed somewhat later**

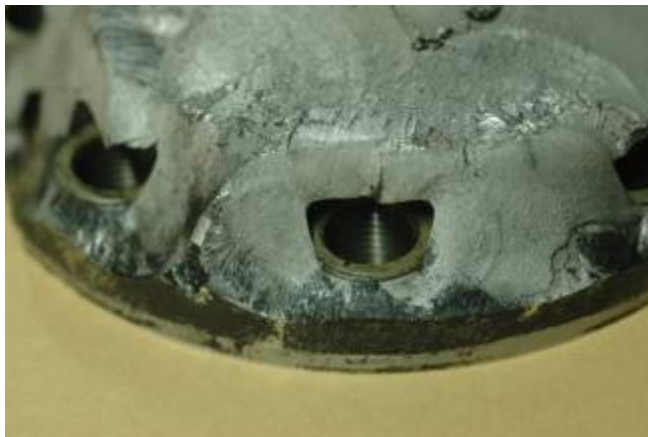
The fatigue cracks originated from the edges of the fastening holes. (See figure 11 and figure 12).

**Figure 12: Fatigue cracks started from edges of fastening hole**

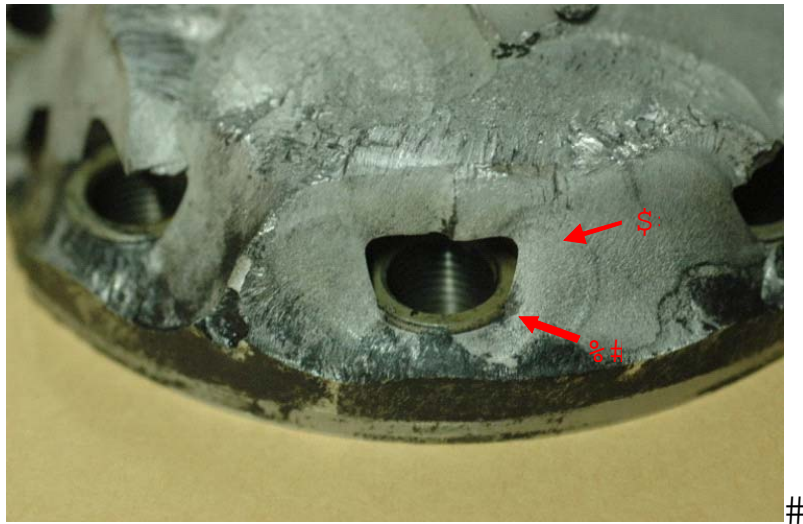
Further SEM (Scanning Electron Microscope) observation was performed on two nearby points close to the fastening hole, which were identified as the initiation of the fatigue crack propagation.

**Figure 13: Two points of observations, which were identified as the initiation of the fatigue crack propagation**

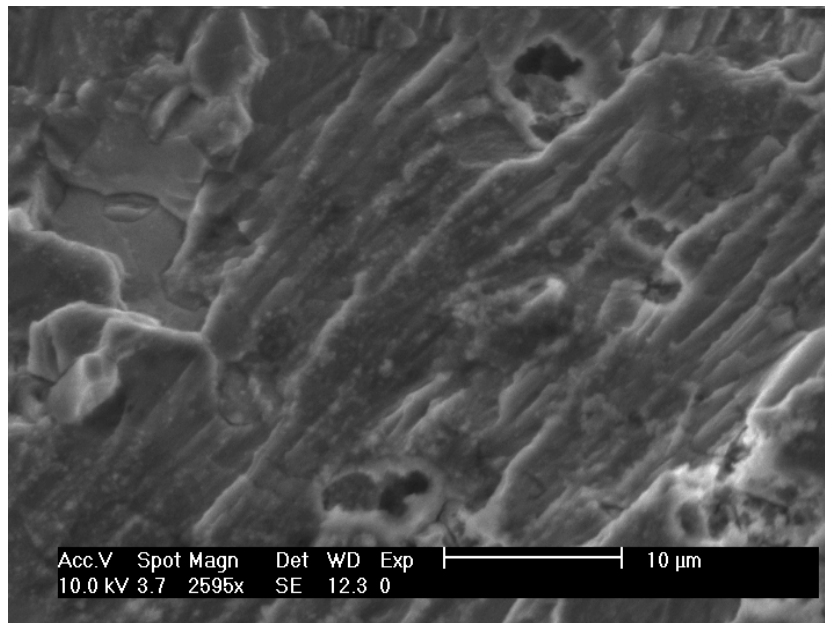
**Figure 14: Striations found on the point B with the gap between lines  
Approximately 5 µm**

Refer to the gaps between striations, it can be predicted that the rate of fatigue crack propagation approximately 100 – 200  $\mu\text{m}$  /load cycle.

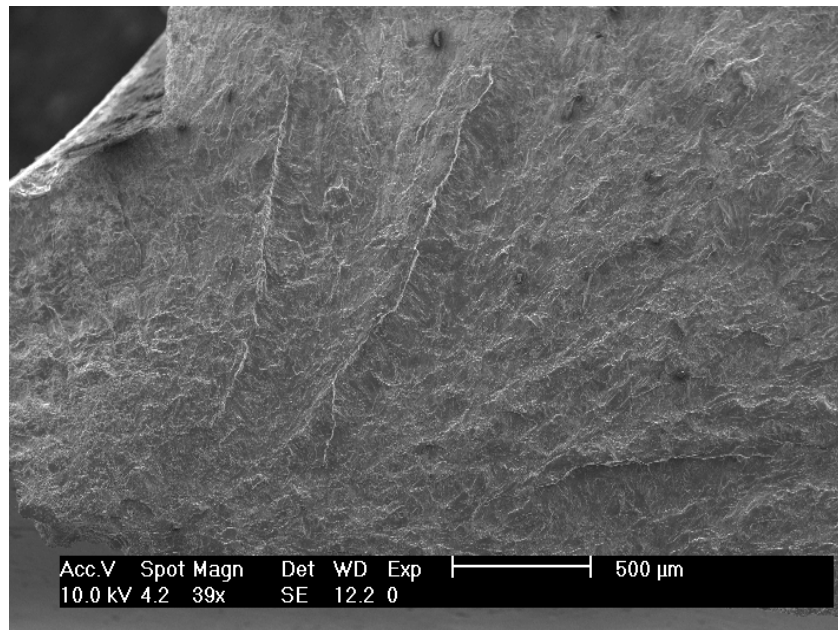
**Figure 15: Striation on point A with gap between lines approximately 500  $\mu\text{m}$**

Assuming that the fastening hole was the initial point of the fatigue crack and the distance of the fastening hole to the middle of the propeller hub was 8 cm. The rate of propagation was 100-200  $\mu\text{m}$  /load cycle. The fatigue crack would reach to the middle of the propeller hub after 400-800 load cycles. 400 – 800 load cycles has exceeded the inspection interval.
