**NATIONAL
TRANSPORTATION
SAFETY
COMMITTEE**

Aircraft Serious Incident Investigation Report

Pilatus Porter PC-6 ; PK-UCJ

Wamena Airport, Wamena, Papua

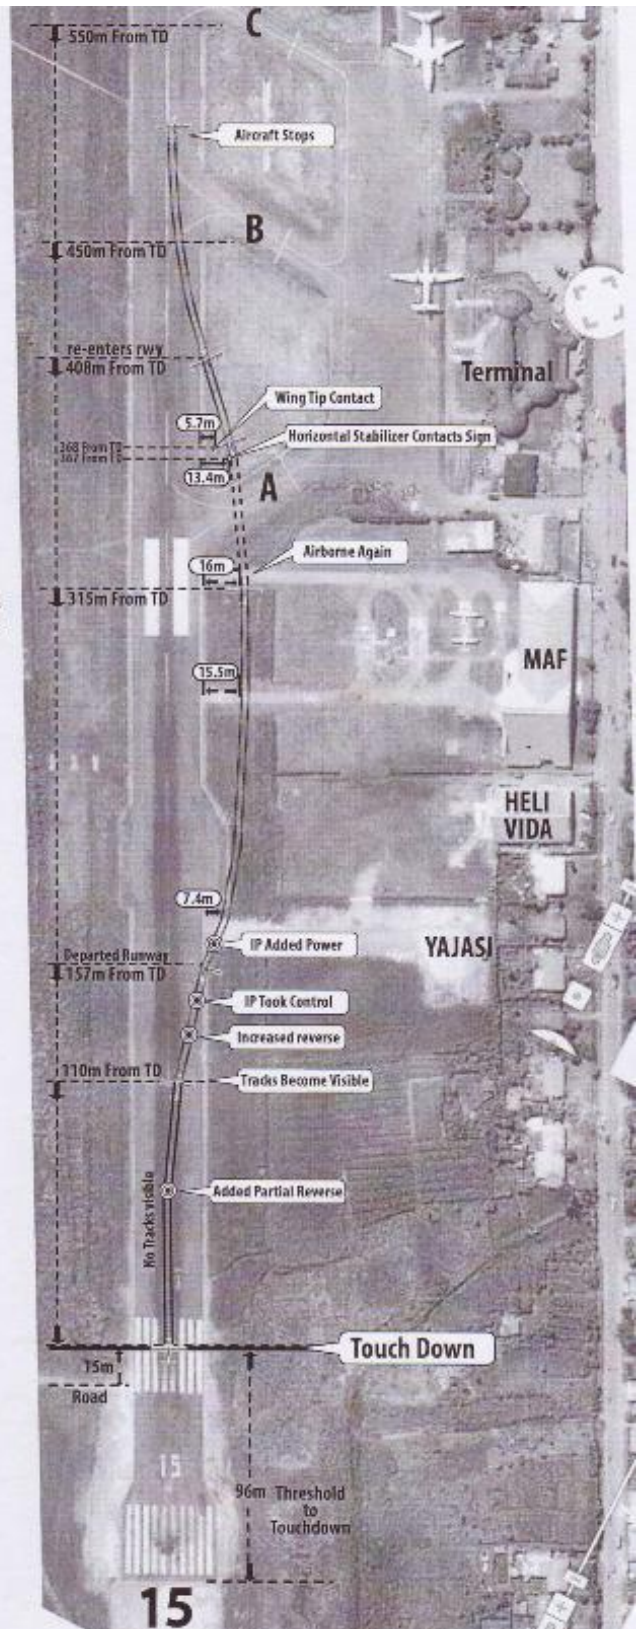
Figure 1: Schematic diagram landing accident PK-UCJ on 17 January 2013

At approximately 157 meters from first touchdown the aircraft veered off to the right of the runway and continued rolling over the runway shoulder, approximate 15 meters align to the runway.

The aircraft hit taxiway Alpha marking board, and airborne again at a distance of 315 meters from touchdown and continues rolling until approximately 408 meters from the first touchdown. The aircraft re-entered the runway and taxied. The damage found were the horizontal stabilizer, left wing tip and left aileron detached from the wing. The aircraft has been taxied with those damage conditions and parked at the Yajasi apron.

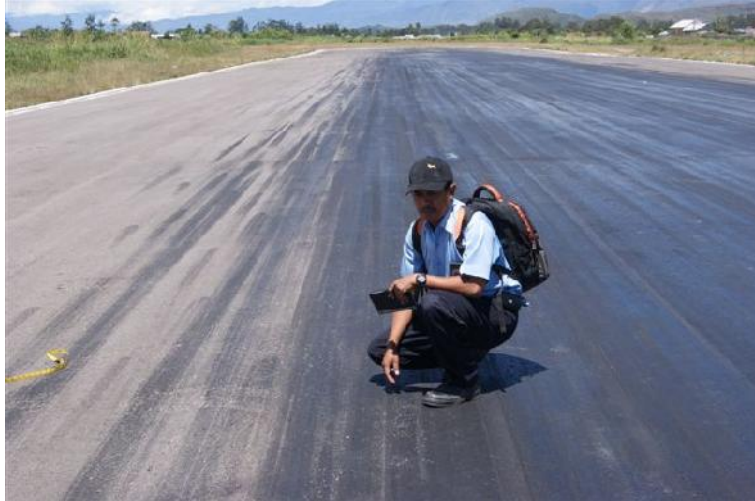
Figure 2: Surface condition on runway 33

The rubber deposit about half of the runway from the beginning of the threshold runway 15 was observed.

- a) The rubber deposit in about half of the runway 15 at Wamena Airport might have a part of the contributing factors in this runway excursion. as such, it is strongly required that the authority has to consider a regular runway decontamination schedule, not only in Wamena Airport but it could be extended to the other airports in a regular basis.
- b) Consider to the recommendations address to PT. Yayasan Jasa Aviasi Indonesia, the National Transportation Safety Committee recommends to the DGCA has to ensure that the aforesaid recommendations are well implemented.

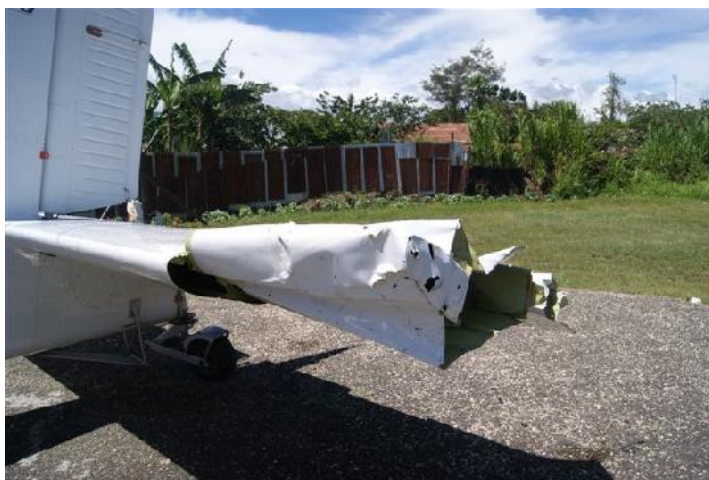
Figure 3: Left horizontal stabilizer

- a. Left horizontal and left elevator broken;
- b. Left wing damage and Aileron detached;
- c. Right rear fuselage deformed;
- d. Right windshield cracked and the fairing deformed.

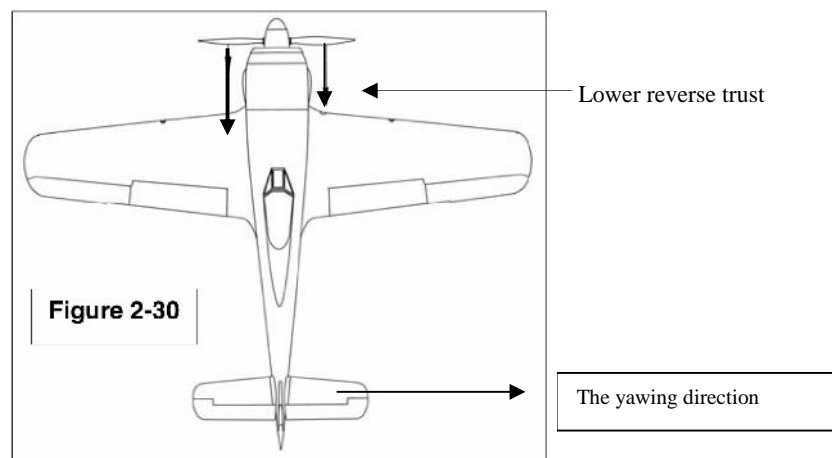
Figure 6: The reaction of the yawing moments

- When reverse being applied the aircraft start veer off to the right. It most likely that, this was due to the yawing moments produced by the propeller are mainly caused by the spiralling slipstream striking the fuselage aft of the Centre of Gravity (CG), and the other half is from the slipstream striking the vertical stabilizer.

The reaction to these moments yawed the lateral axis of the aircraft to the left (propellers rotates anti-clockwise as viewed from the rear) because of the asymmetry reverses thrust being produced, the left side of the aircraft (down going blade) is about twice as much as the up going blade on the left side (Figure 2-30). In fact, the aircraft move to the right of the runway.

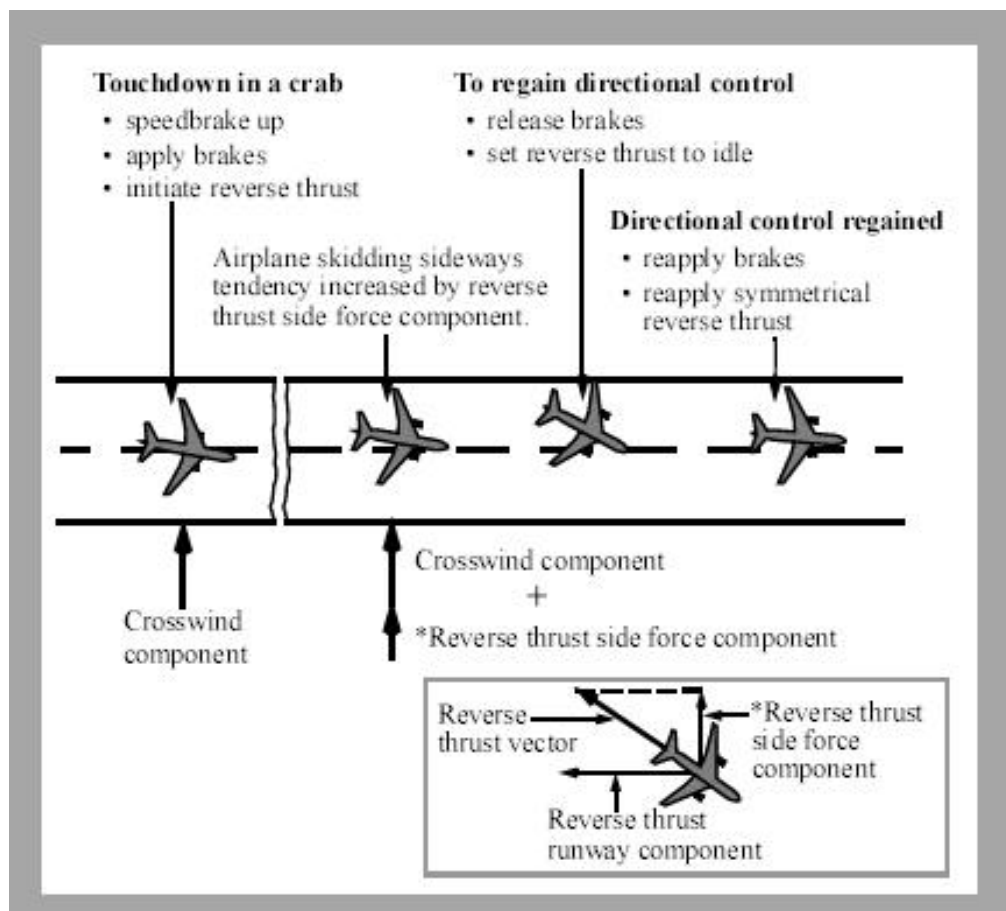
Figure 7: Recovery technique for landing on slippery runway

The aircraft experienced skid on the slippery runway. The technique to counter this condition is states as follows:

As the aircraft starts to skid, the reverse thrust side force component adds to the skid inertia and will drift the aircraft to the side of the runway. High braking force reduces the capability of the tires to corner.

To correct back to centre line, release the brakes and reduce the reverse thrust. Release the brake increases the tire cornering capability and contributes to maintaining or regaining the directional control. Reducing the reverse thrust will reduces the reverse side force component. Use rudder pedal and/or differential braking as required to regain the centre line. Avoid over correction not to pass the runway centre line. When the directional control is regained and the aircraft is correcting toward the runway centerline, apply maximum braking and symmetrical reverse thrust to stop the aircraft. This technique will increase the required landing distance.
