FINAL
KNKT13.02.03.04

Aircraft Serious Incident Investigation Report

PT. Trigana Air Service
DHC 6-300; PK-YRF
Apalapsili Aerodrome, Papua
Republic of Indonesia
5 February 2013

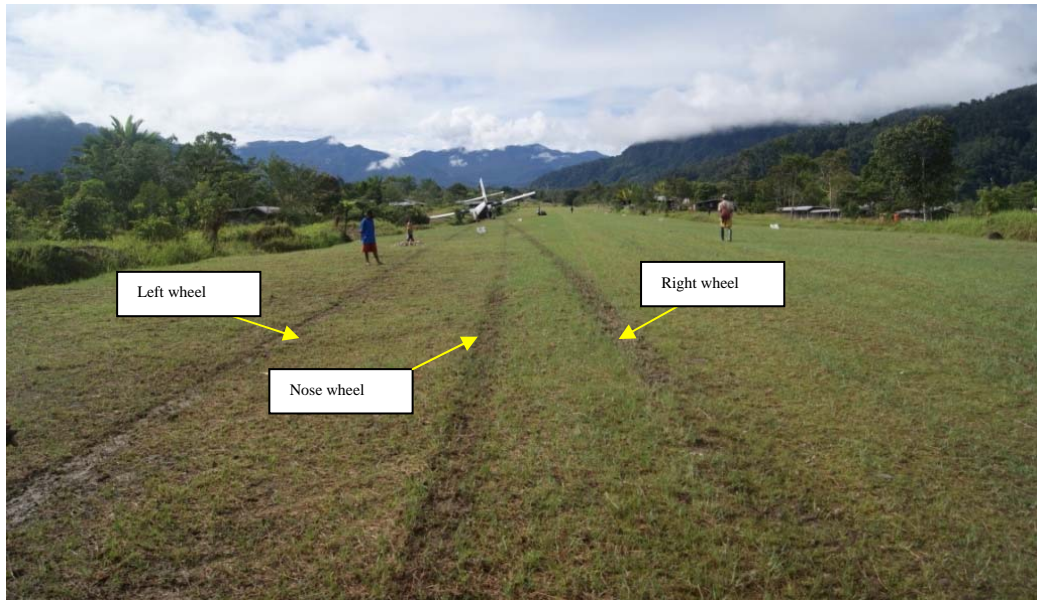
The marks on the runway found that the aircraft touched down on not align with the runway bearing the centre of the runway. The marks indicated that the aircraft constantly moved to the left as indicated by straight lines and did not parallel with the runway bearing.

Figure 1. Wheel marks found on the runway

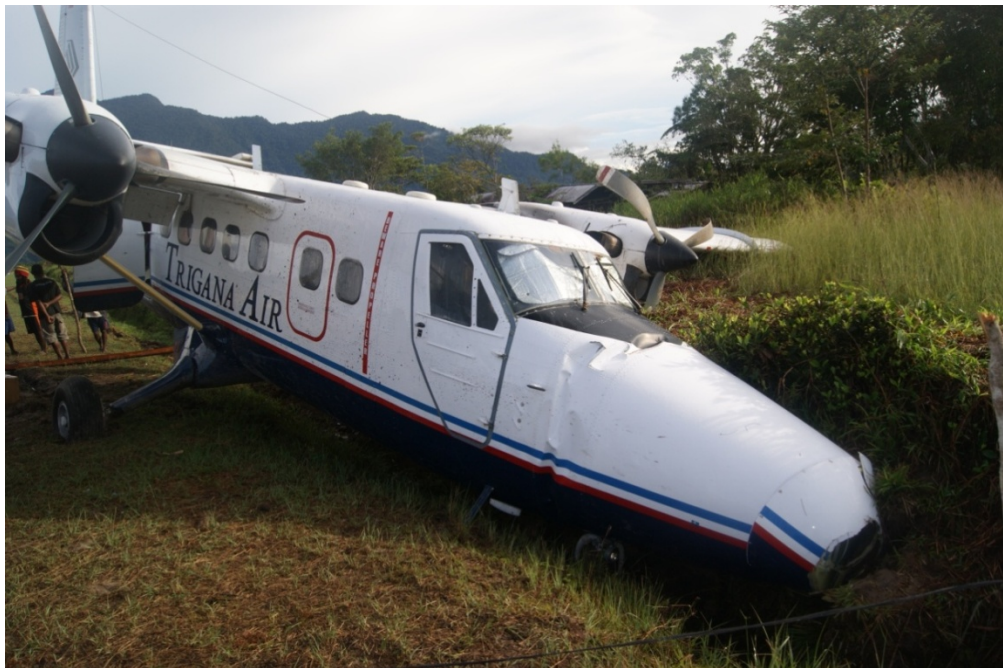
The aircraft stopped on the left of runway 15 about 500 meters from the beginning of runway 15, the nose wheel and Left main wheels trapped on the drainage line.

Figure 2. The last aircraft position

The aircraft out of the runway at approximately 400 meters from the beginning runway crossed the runway shoulder and stopped on the left side at approximately 500 meters from the beginning of the runway. The nose section and left main landing gear trapped on the drainage line.

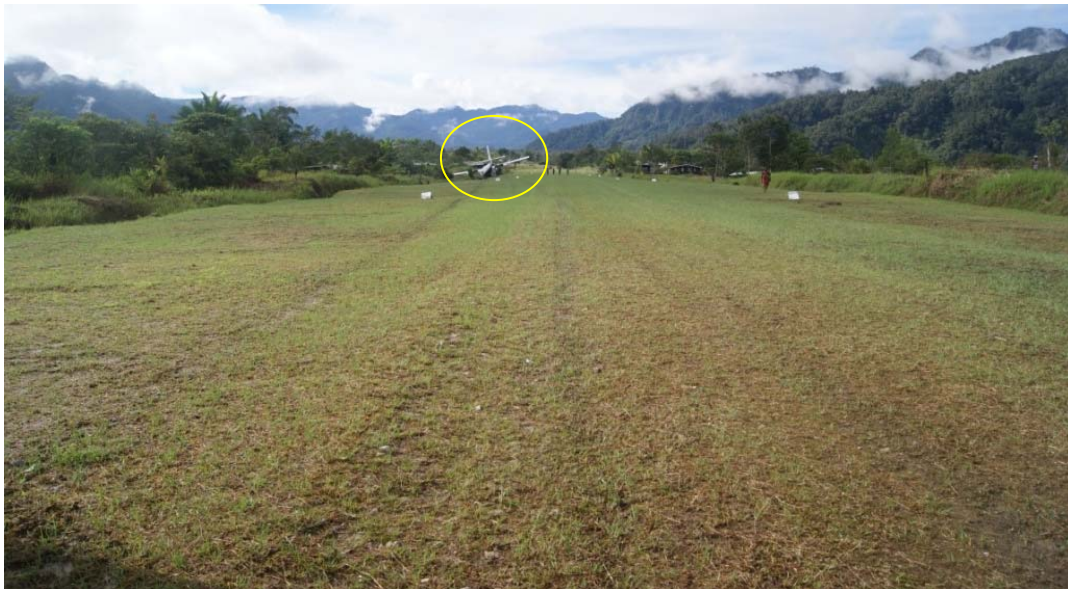
Figure 3. The marks of the landing roll

The marks on the runway found that the aircraft touched down on the centre of the runway. The marks indicated that the aircraft constantly moved to the left as indicated by straight lines and did not align with the runway bearing (see figure 3).

The marks also indicated that the pilot tried to recover the situation by operated the nose wheel steering. The nose wheel deflected to the right, however the aircraft direction maintained toward the final position. The marks showed that the mark of the nose wheel was closer to the right wheel compare to the left on the last part of the aircraft movement. This indicated that the aircraft was faced to the right (skid) while the movement was constant.

The PIC aimed to touch down on the dry gravel surface area on the runway. The marks on the runway found that the aircraft touched down on the centre of the runway, however the marks indicated that the aircraft constantly moved to the left and did not align with the runway bearing (see figure 3). This indicated that the aircraft did not align to the runway bearing since touchdown as result of misalign with the runway on final, as stated by the SIC. This conclusion was supported by CVR transcription.

The marks also indicated that the pilot tried to recover the situation by operated the nose wheel steering. The nose wheel deflected to the right, however the aircraft direction maintained toward the final position. The marks showed that the mark of the nose wheel was closer to the right wheel compare to the left. This indicated that the aircraft moved to the left (constantly) with the aircraft faced to the right. The aircraft was skid.

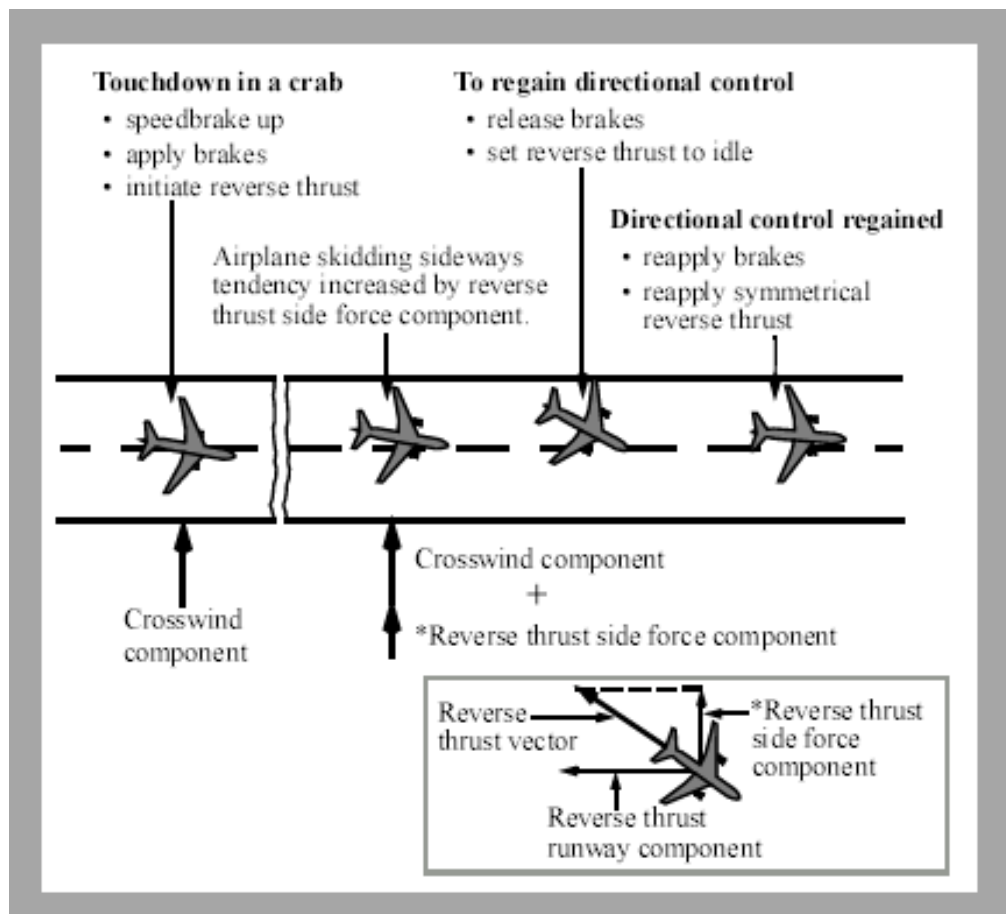
The aircraft experienced skid on the slippery runway. The technique to counter this condition is states as follows:

As the aircraft starts to skid, the reverse thrust side force component adds to the skid inertia and will drift the aircraft to the side of the runway. High braking force reduces the capability of the tires to corner.

Figure 4: Recovery technique for landing on slippery runway

The PIC action to recover the situation by applying thrust reverser, brake and nose wheel steering were differed to the technique and statement in the AOM and worsening the condition.

To correct back to centre line, release the brakes and reduce the reverse thrust. Release the brake increases the tire cornering capability and contributes to maintaining or regaining the directional control. Reducing the reverse thrust will

reduces the reverse side force component. Use rudder pedal and/or differential braking as required to regain the centre line. Avoid over correction not to pass the runway centre line. When the directional control is regained and the aircraft is correcting toward the runway centerline, apply maximum braking and symmetrical reverse thrust to stop the aircraft. This technique will increase the required landing distance.

If the aircraft weathervanes into the wind and drifted away from centre line, recover by cancelling reverse, release brakes, regain and keep centre line with use of rudder, nose wheel and differential reverse as necessary.
