**KOMITE NASIONAL KESELAMATAN TRANSPORTASI
REPUBLIC OF INDONESIA**

Aircraft Serious Incident Investigation Report

PK-AEE; Piper Warrior III

Tunggul Wulung Airport, Cilacap Central Java

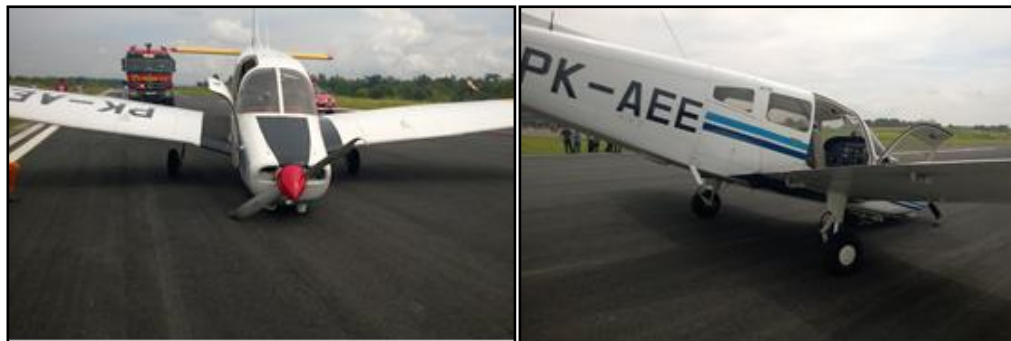
Figure 1: The aircraft condition after the occurrence

According to the pilot report, the aircraft at approach speed of 70 kts when over the threshold, the pilot then leveling the wings and closed the throttle. After the main wheels touched the runway and while the pilot expecting the nose wheel touching the runway, the propeller hit the ground and the nose landing gear collapsed.

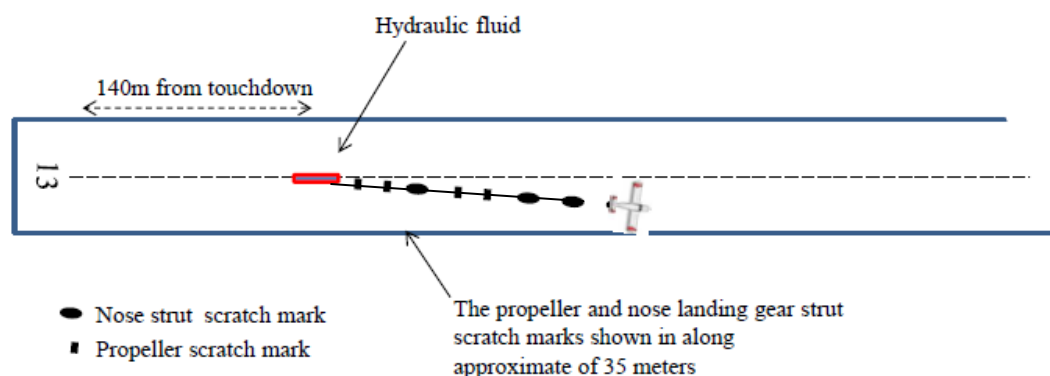
Distance from the main wheel touchdown until the aircraft stop was 181 meters and approximate 35 meters before the aircraft stop there were several marks on the runway and illustrated on the figure below;

Figure 2: Propeller and nose strut scratched and impact illustration

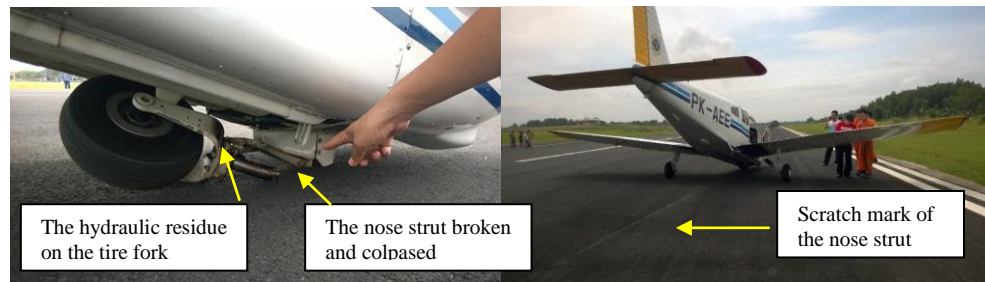
Observation on the runway and aircraft after the occurrence showed that the nose wheel was collapsed backward, propeller blade tips bend, hydraulic residue on both side nose tire fork and also the scratch line of the nose strut on the runway.

Figure 3: The scratch mark and nose strut collapsed

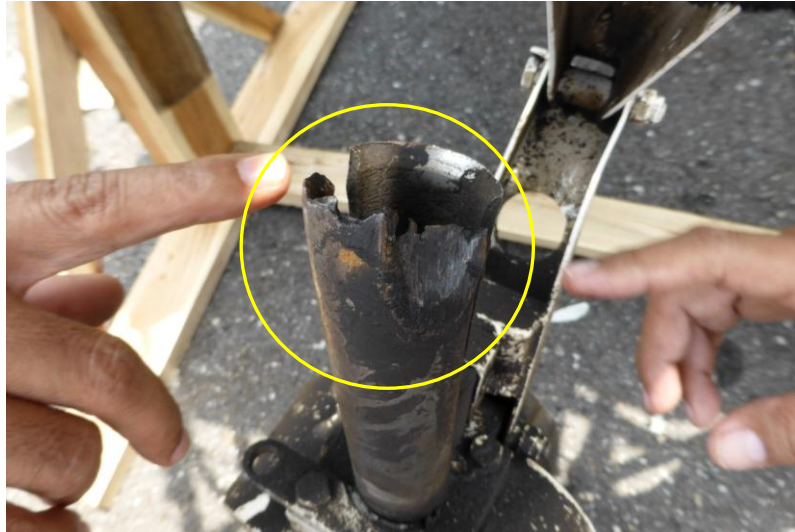
Figure 4: Nose sliding member

1. The failure of the nose landing gear was caused by the fatigue crack.
2. The crack initiation was from the inside and begun from two locations, it indicated on the figure 4 and 5.

3. Such fatigue crack propagated out, it went up and down to approximately 2 cm, and continuing by static failure mode. These indicated by an area which orientated in about 45°, it included in a circular failure.

The examination at metallurgy laboratory concludes that the failure was initiated from a fatigue crack. The fatigue crack initiated from two locations at the inside part and propagated up and down to approximately 2 cm. After the development of the fatigue and continued by static failure mode then the landing gear collapsed. These indicated by an area which orientated in about 45°, it included in a circular failure. Due to such fatigue crack propagated from internal, it could not be detected visually and could be worsen if the area covered by the dirt or oil.

To ensure that all the nose gear sliding member of the similar aircraft to be inspected to ensure that there was no fatigue crack.

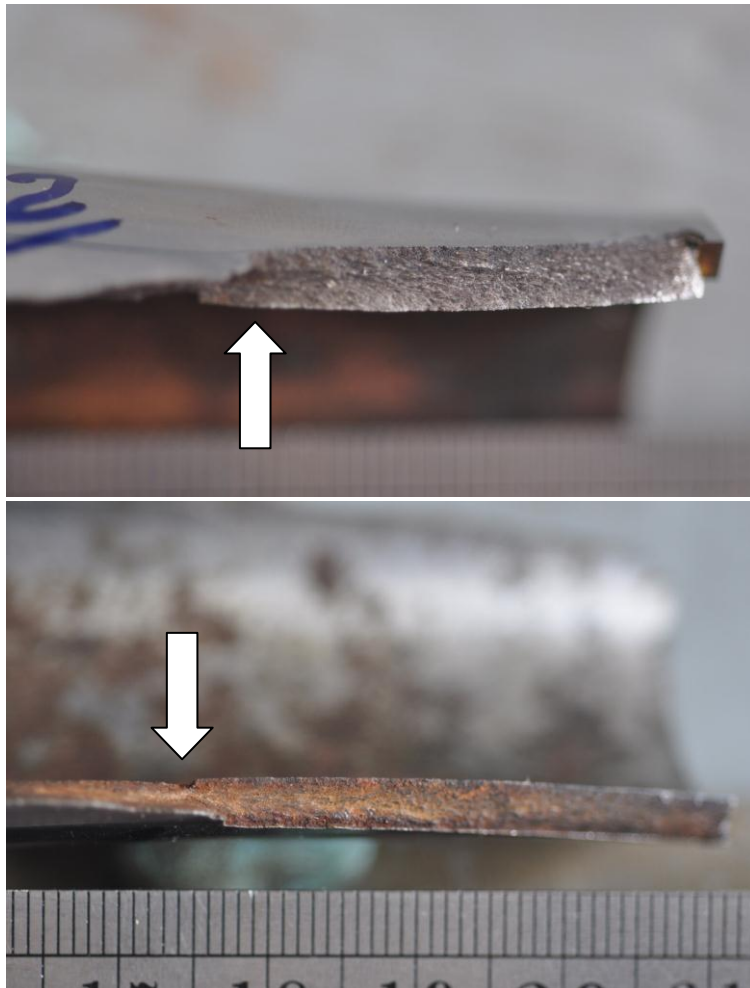
4. Due to such fatigue crack propagated from internal, as such the crack could not be detected visually, it could be worsen if the area covered by the dirt or oil. As a suggestion to identify this particular crack the operator should perform the Eddy Current Technique.

5. This internal fatigue crack initiated from the internal, as such it can be concluded that the cause was not from the operation and maintenance side, and as well as this fatigue crack might be suspected from manufacturing pipe failure. Base on the initial crack location which was likely a point (not a line), so this manufacturing failure will not occur often.

Figure 5: The arrow indicated the location(s) of fatigue crack initiation

Refer to the condition that the aircraft accumulated 305.54 flight hours which relatively new and the initiation of the fatigue crack which was from the inside part of the landing gear. It is most likely that the initial fatigue crack suspected from manufacturing pipe failure. Base on the initial crack location which was like a point (not a line), so this manufacturing failure will rarely occur.

To review the current inspection method to enable detecting specific crack that could not be detected visually.
