FINAL
KNKT.14.12.29.04

Aircraft Accident Investigation Report

**PT. Indonesia Air Asia
Airbus A320-216; PK-AXC
Karimata Strait
Coordinate 3°37'19"S - 109°42'41"E
Republic of Indonesia
28 December 2014**

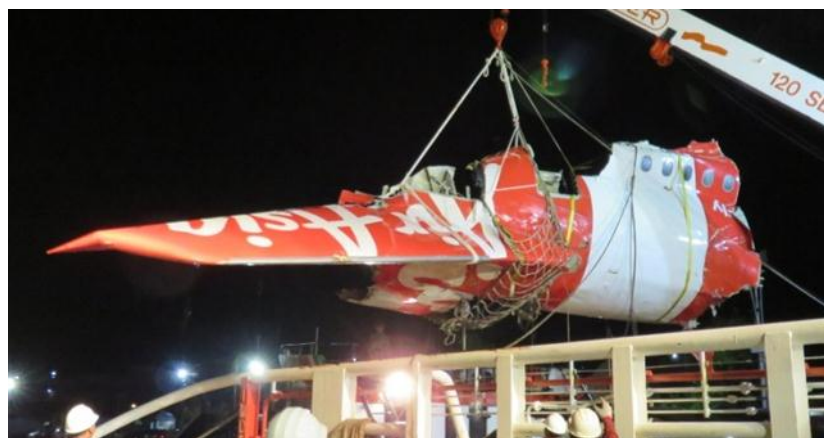
Figure 3: The recovered tail section being transferred to Kumai Harbour

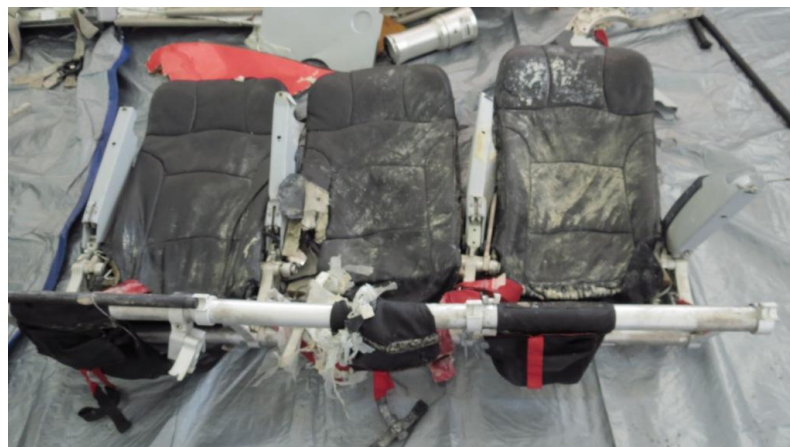
Figure 4: One section of passenger seats

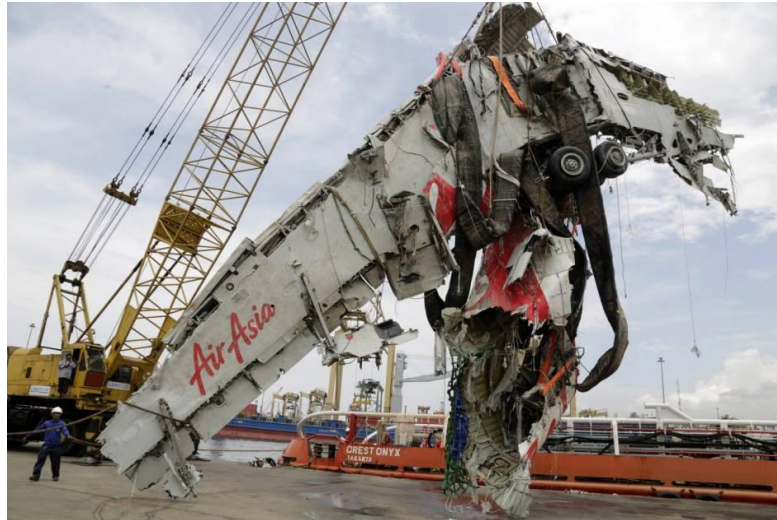
Figure 5: Centre fuselage section including the wings and main landing gears

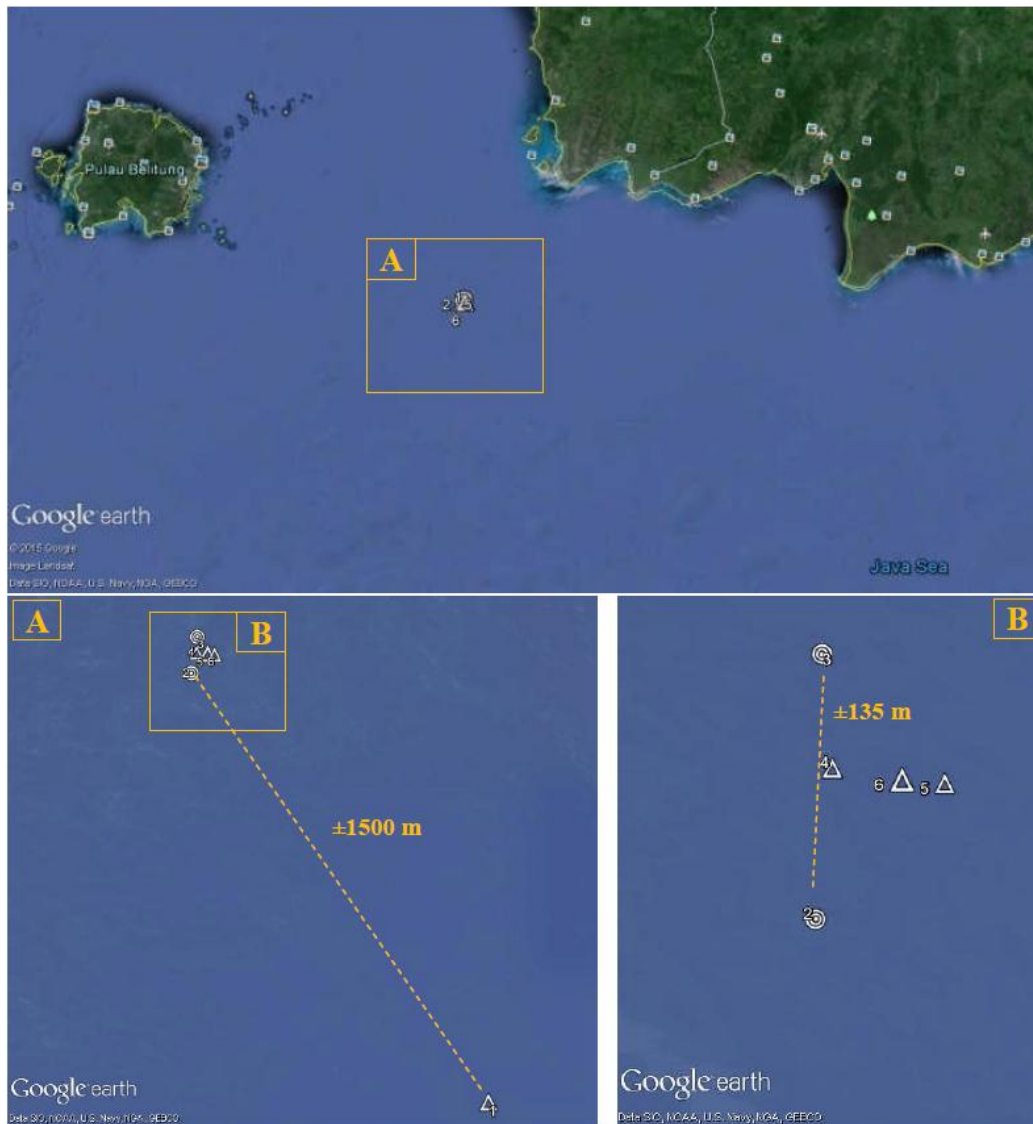
The tail section and fuselage were recovered and transferred to Kumai Harbour at Pangkalan Bun and afterward to Jakarta. The part sections recovered contain of vertical stabilizer and aft section of the fuselage up to section 73. The recorders were detached from its rack.

Figure 30: Wreckage Diagram superimposed on Google Map

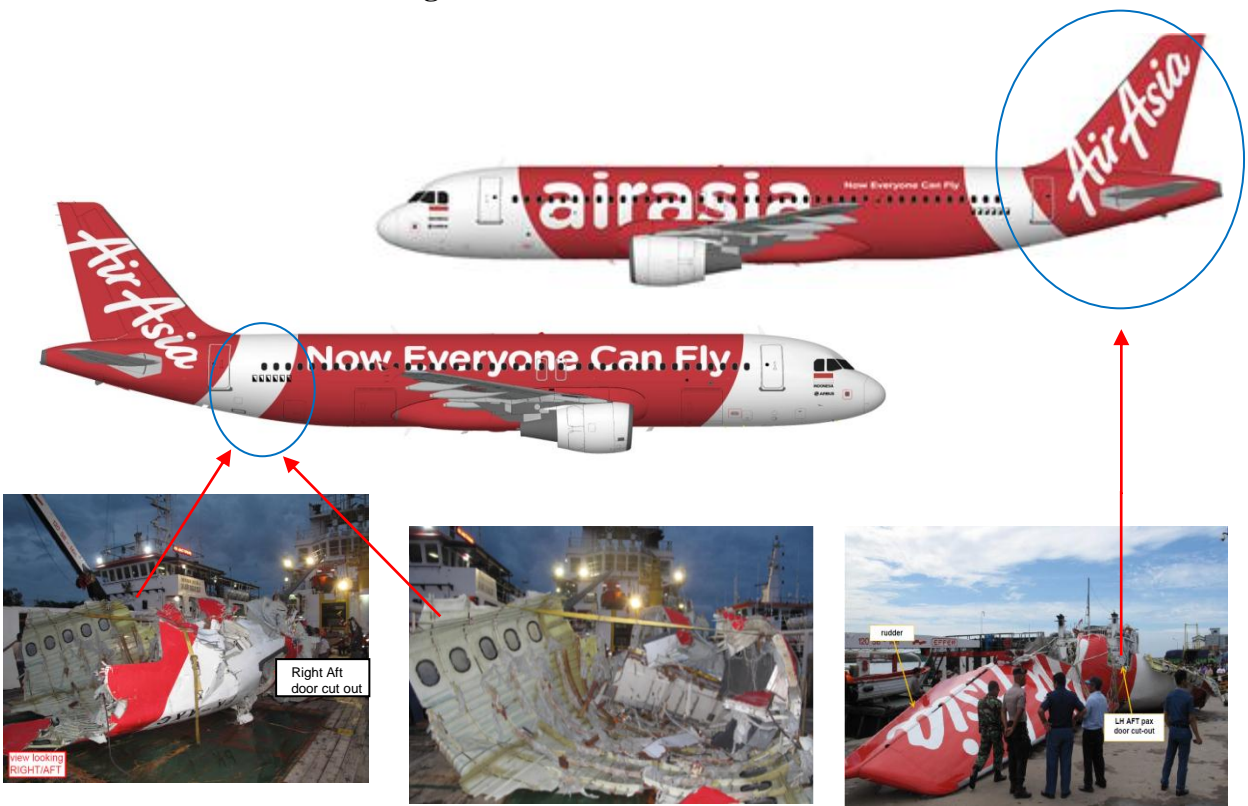
Figure 32: Pictures of identified parts and its original position

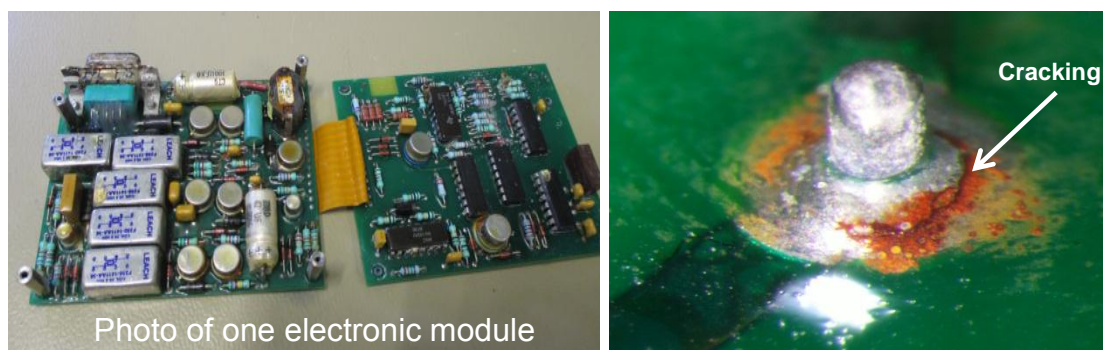
- The cracking of a solder joint of both channel A and B resulted in loss of electrical continuity and led to RTLU failure.
- The existing maintenance data analysis led to unresolved repetitive faults occurring with shorter intervals. The same fault occurred 4 times during the flight.

Figure 35: Electronic Module of RTLUs
