FINAL
KNKT.14.10.24.04

Aircraft Serious Incident Investigation Report

PT. Cardig Air
Boeing 737-300; PK-BBS
Wamena Airport
Republic of Indonesia
24 October 2014

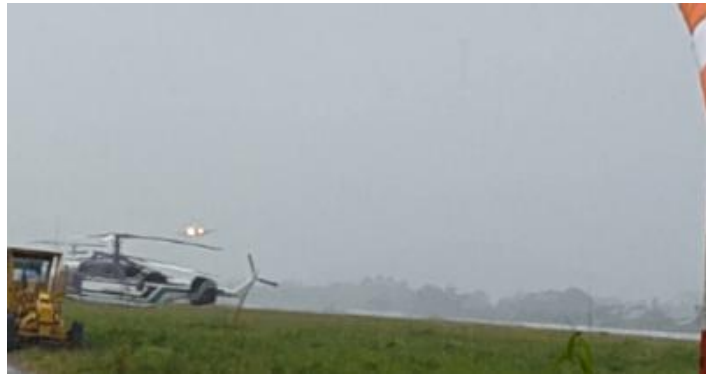
Figure 2: The video footage of the aircraft on short final

The video footage shows that the aircraft roll to the right and headed to the person taking the video.

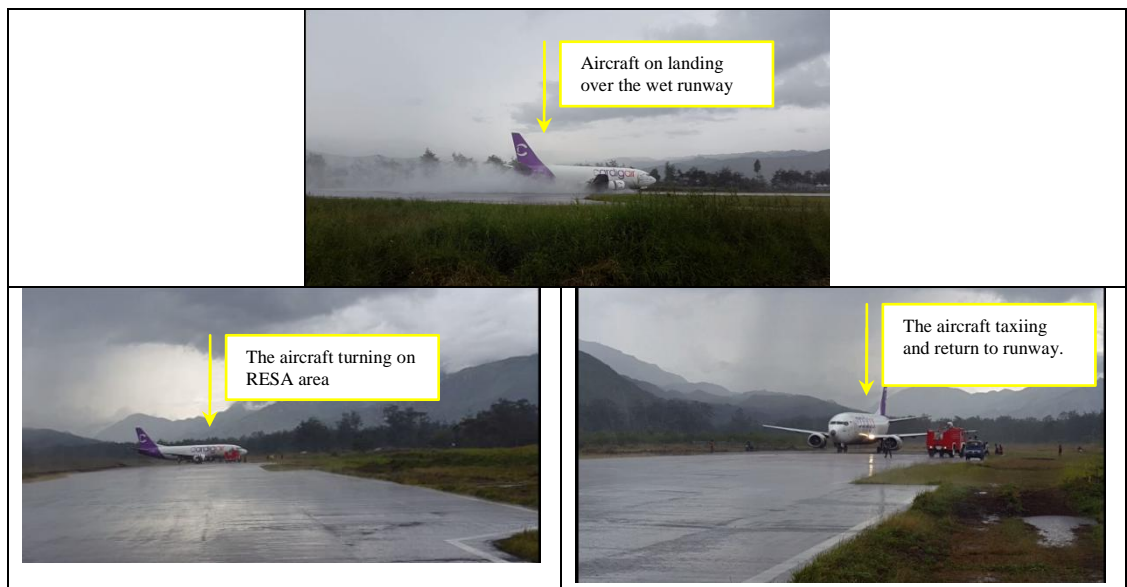
Figure 3: The video footage made by a person on ground Wamena of the accident flight from short final until taxi to runway

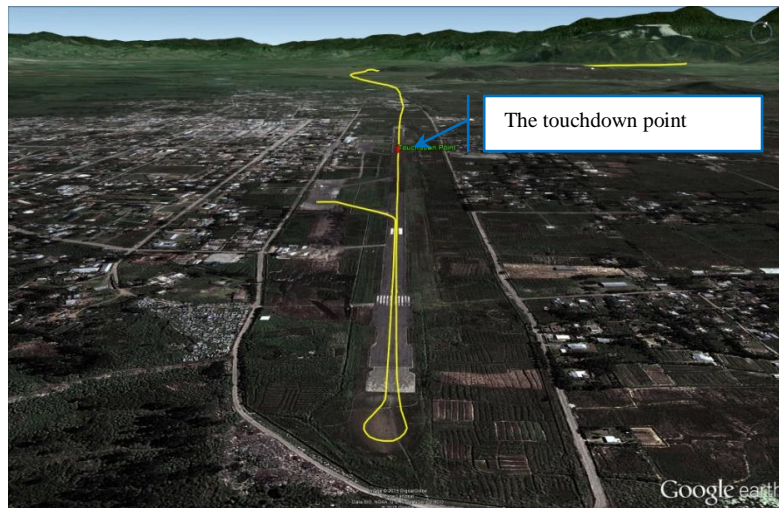
Figure 4: Aircraft trajectory based on FDR data and superimposed to Google earth

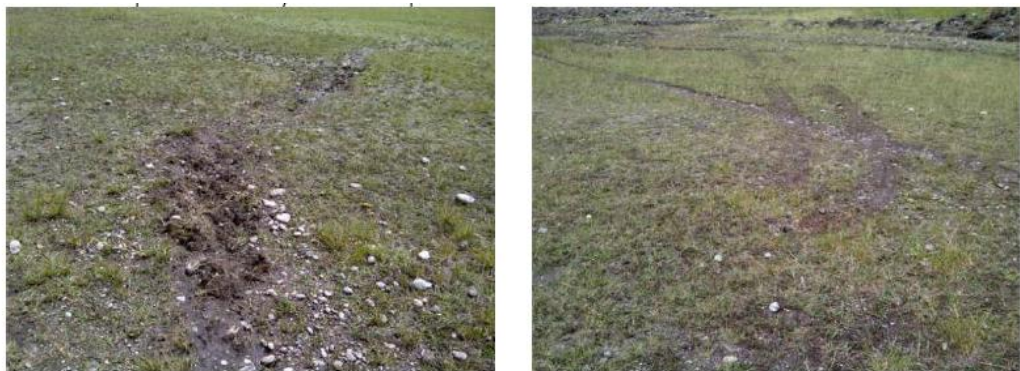
Figure 5: The wheel marks found on RESA surfaces after the occurrence

Observation on some figures shows that the Airport Rescue and Fire Fighting and some airport ground staffs were at the stop-way when the aircraft taxiing. The conditions above indicated that the situation nearby the aircraft was unsafe for the persons as well as for the aircraft operation. The pilot decided to turn 180° and taxied the aircraft to the apron.

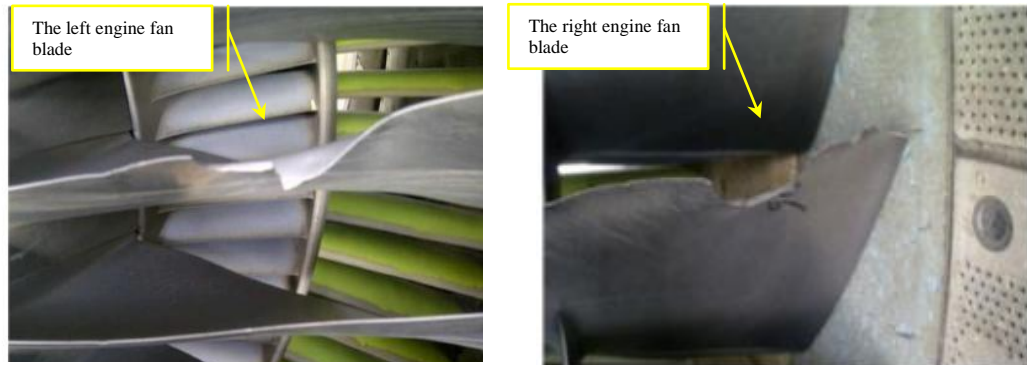
After the aircraft parked on the apron, the aircraft inspections found that number 3 and 4 tires spotted, fan blades of both engines and the left side of aircraft horizontal stabilizer damaged.

Figure 6: The damage of left & right engine fan blades

The post occurrence inspections found that both engines fan blades and the left side of aircraft horizontal stabilizer damaged which was most probably due to the FOD of excavated surface sucked by the engines when the aircraft was taxiing to the apron.

13. Post flight inspection found main wheel tire number 2 melting/burst, number 3 and 4 were spotted and damage on engines fan blades and left horizontal stabilizer which most likely from the foreign object damage (FOD) of excavated surface sucked by the engines when the aircraft was taxiing.

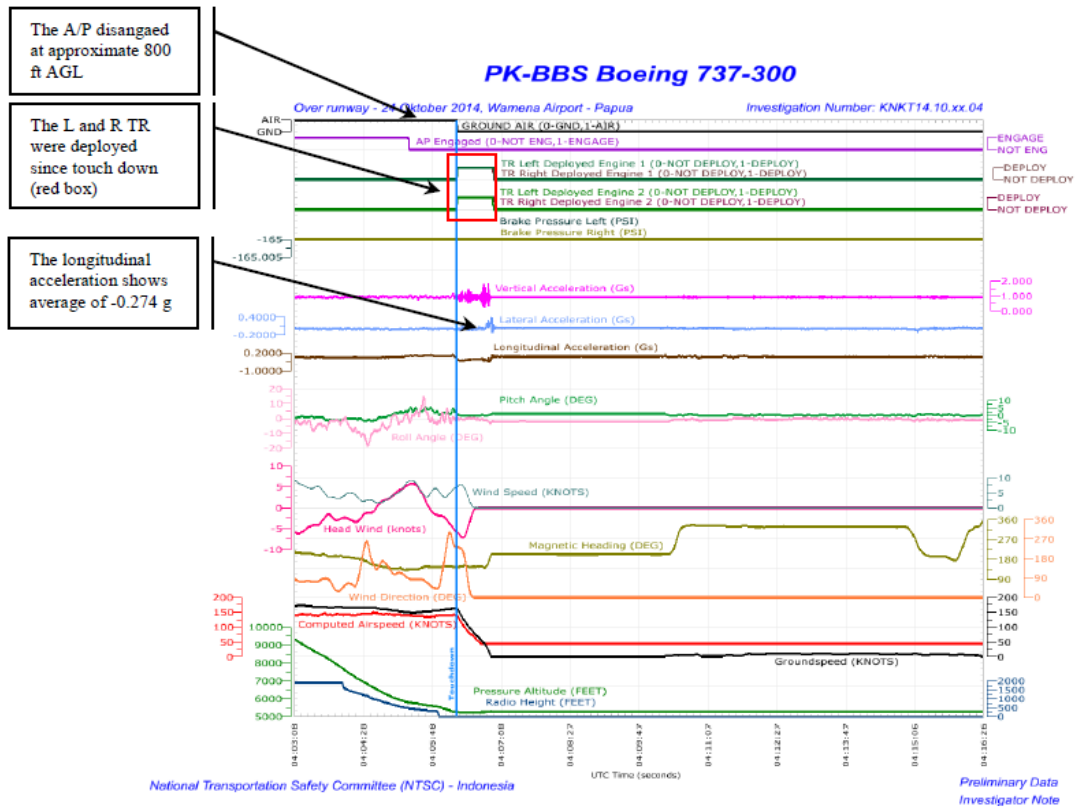
Figure 7: FDR graph of relevant information from 800 feet AGL

At about 700 ft aircraft was at normal speed & configuration

The aircraft rolled 11° left then 14° right

At approximate 550 ft the aircraft speed down to below min speed

The wind direction changed from north easterly to short westerly, wing calm

Aircraft touched down at Vref + 4 kts and the reversers deployed and brakes activated along the runway.

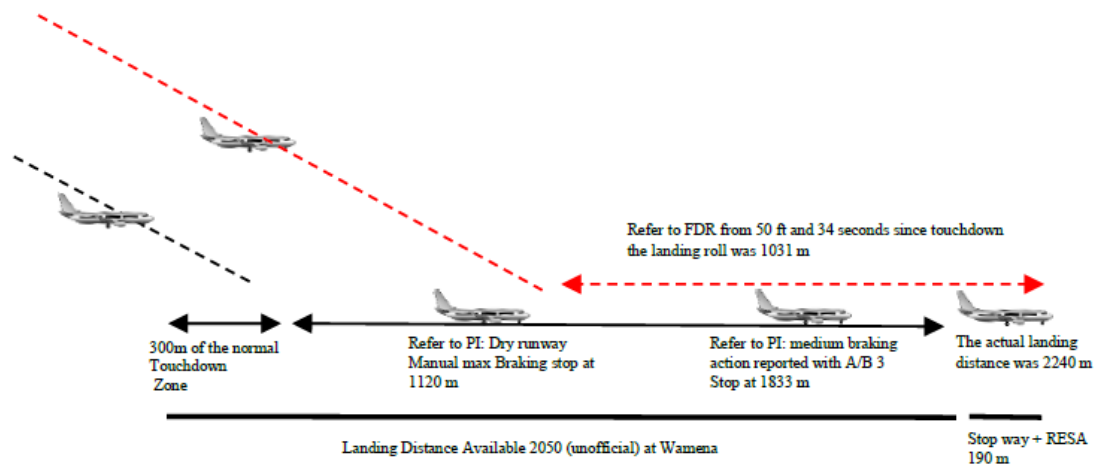
Illustration of the landing distance refers from FDR and Boeing manual on chapter Performance In Flight shows as follow:

- The right line is illustration of the flight path and the landing distance based on the calculation of FDR data.
- The black line is the illustration of the flight path based on the calculation from Boeing manual, chapter Performance In Flight with the landing weight of 51,144 kg for dry and medium braking action.

According to the calculation the particular condition (configuration flap 40, assumed the braking action was medium, auto brake 3 and normal approach profile), the aircraft would be able to stop at 1833 meter from the touchdown point or within the
