FINAL
KNKT.14.01.02.04

KOMITE NASIONAL KESELAMATAN TRANSPORTASI

Runway Incursion Investigation Report

**PT. Sriwijaya Air
Boeing 737-300; PK-CKL
Juanda International Airport Surabaya
Republic of Indonesia
27 January 2014**

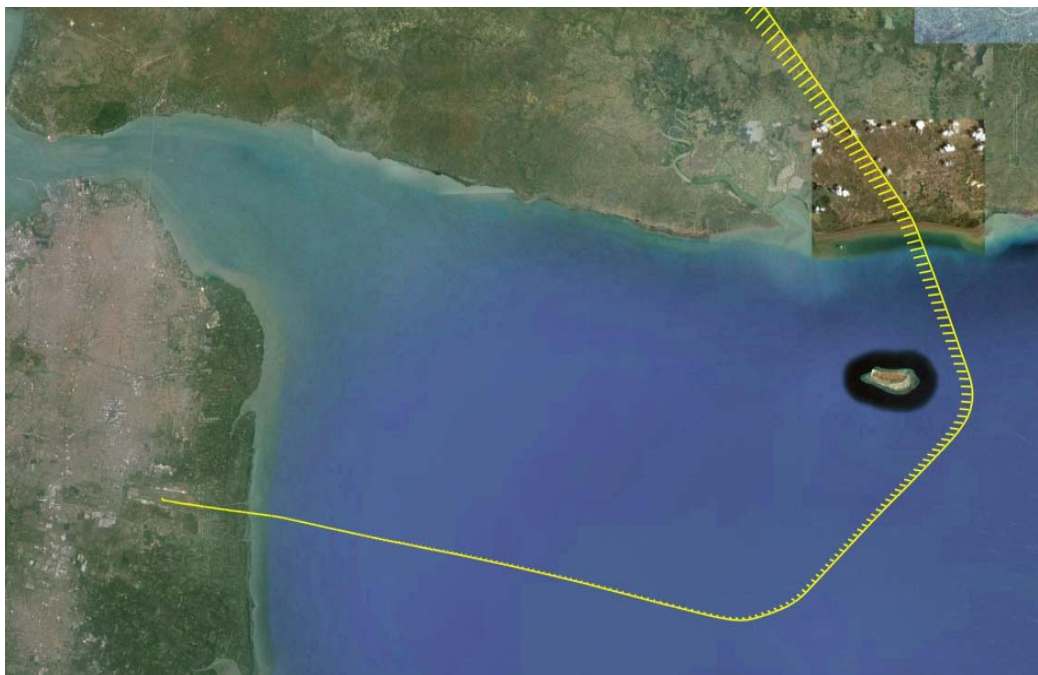
Figure 1: The flight track as recorded on the FDR data and superimposed to Google Earth

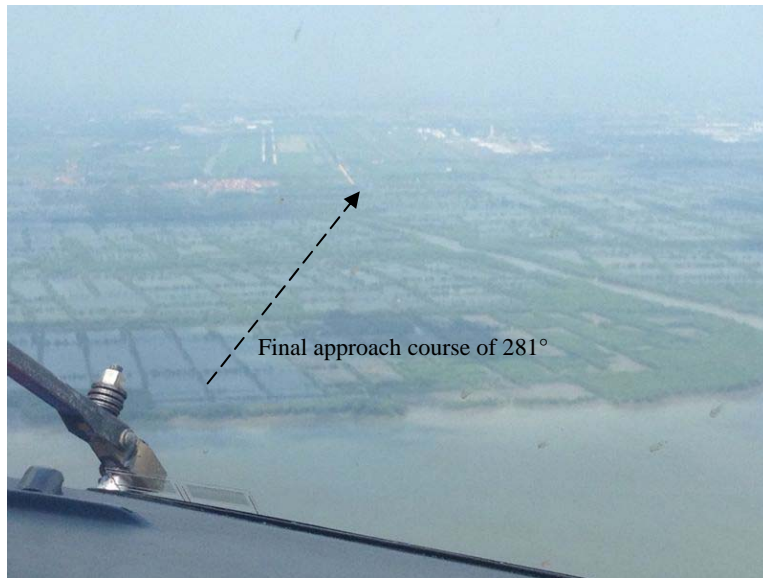
The figure below was taken from 500 feet by a B 737 pilot while performing VOR/DME approach runway 28 Juanda Airport, two days after the serious incident.

At the time of taking this picture, the visibility reported was greater than at the time of the serious incident and the picture showed that the SP2 taxi way was darkest and shiniest in surrounding area than the active runway 28.

Figure 4: The picture from approximate 500 feet of final approach course VOR/DME runway 28

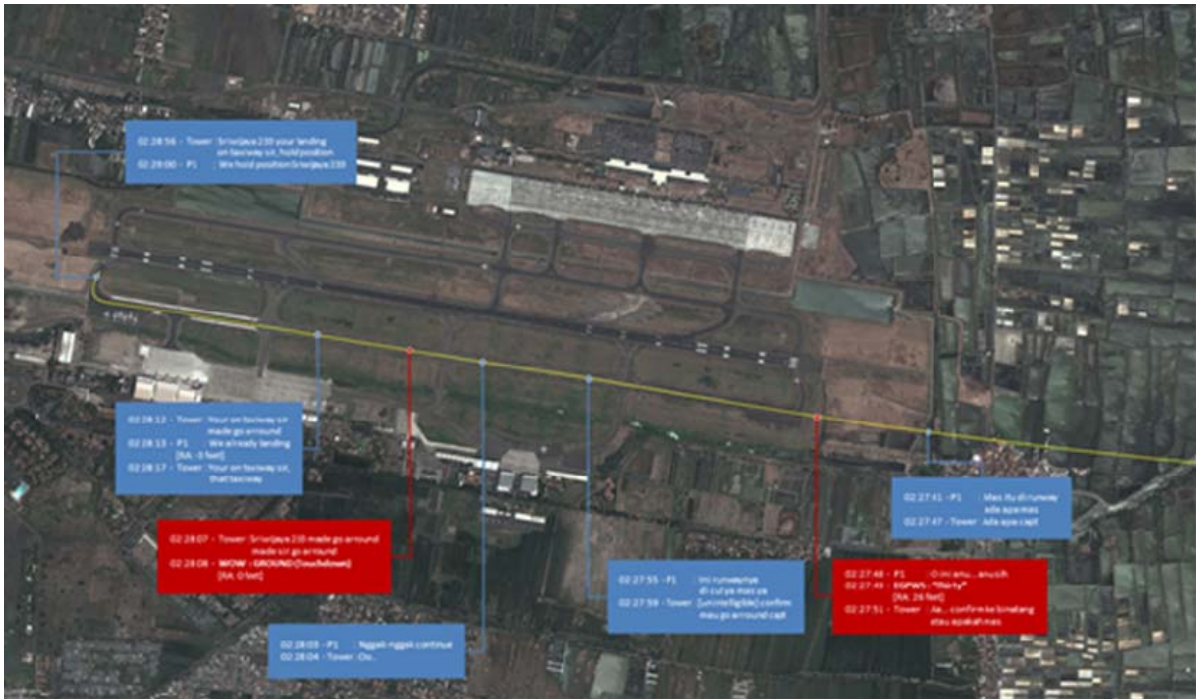
Figure 5: The aircraft flight and on SP2 taxiway trajectory revealed from the FDR plotted to Google earth

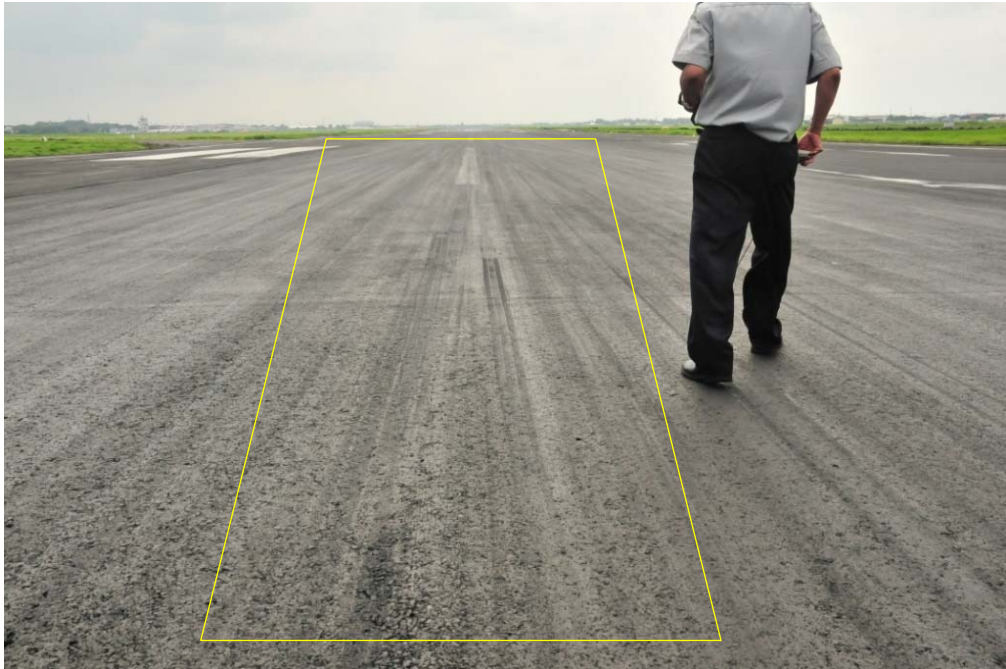
The observation on the runway 28 found that the centreline markings were covered by rubber deposit and not clearly visible.

Figure 7: The centre line marking on the runway 28 covered by rubber (yellow box)

18. Observation on the runway, found that the runway centrelines marks were blurred by rubber deposit.
19. The SMS organization of the ATS and Airport Services provider were not in accordance to CASR SMS subpart 7.

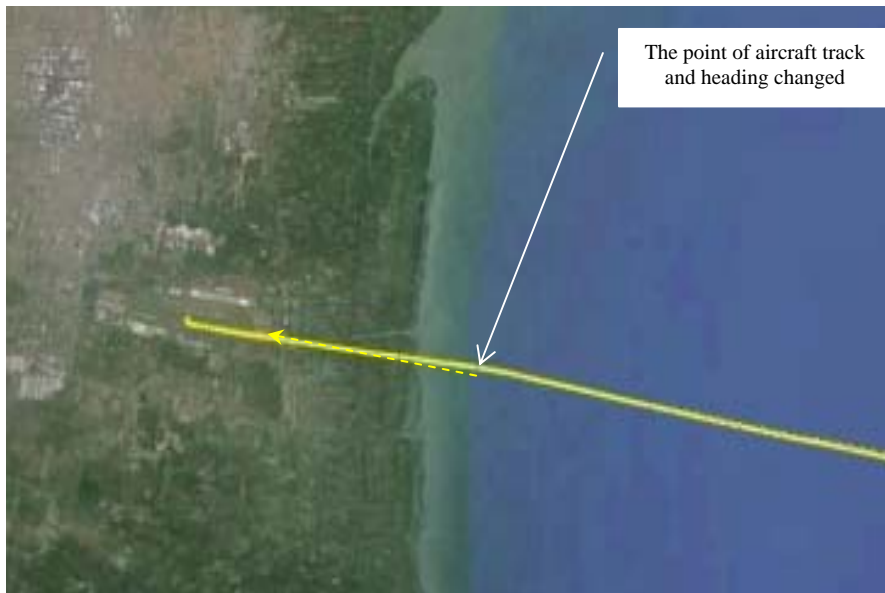
Figure 10: Shows the aircraft heading changed from 283° to 277° at approximate 500 feet

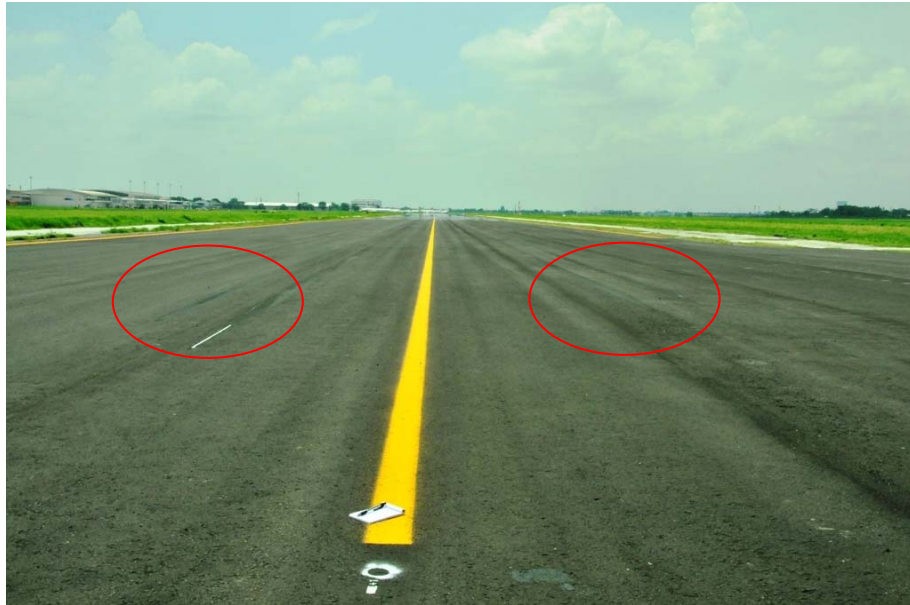
Figure 11: Touchdown marks on taxiway SP2

16. At 0228 UTC the aircraft touched down on the taxiway SP2 at about the intersections of taxiway S3.
17. The investigation could not found the operator's manuals which described that if
