FINAL
KNKT.14.11.27.04

Aircraft Accident Investigation Report

**PT.Elang Nusantara Air (ENA)
S2R-T34 Thrush; PK- ELR
Near Manado;
North Sulawesi
Republic of Indonesia
30 November 2014**

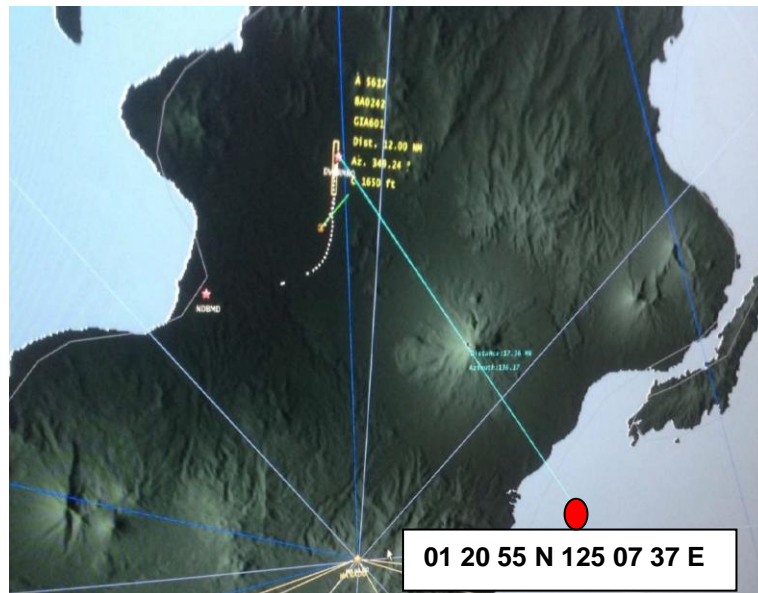
Figure 3: The estimated last point recorded on radar screen

At 0205 UTC (1005 LT), the Manado Approach controller called the pilot but there was no reply. The last position of the aircraft displayed on the Manado Approach controlled radar screen was at coordinate 01 20 55 N 125 07 37 E at approximately 2 miles from the nearest coast line.

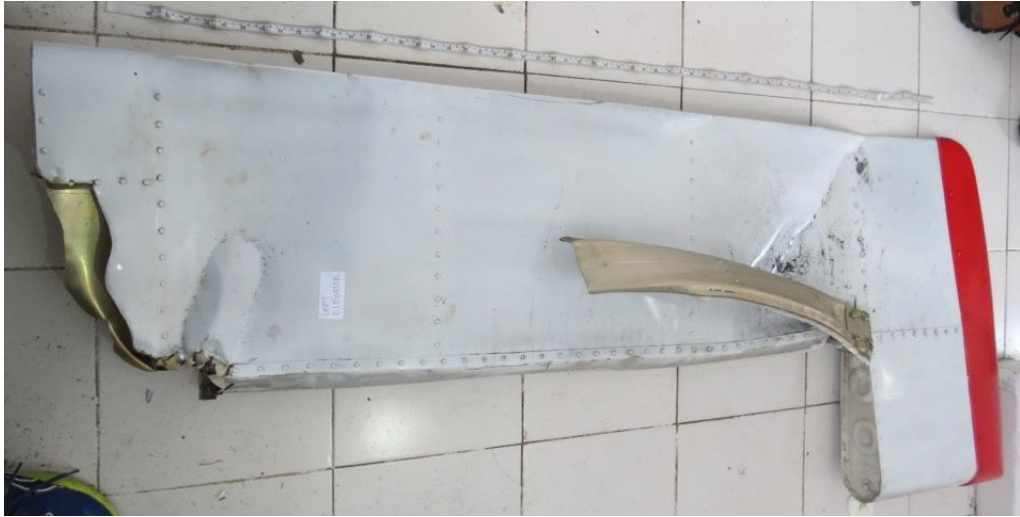
Figure 4: Outboard part of elevator

The occupants and the main aircraft wreckage were not recovered. Parts recovered were left main landing gear, nose and right main wheel tires, outboard part of left elevator and two bags.

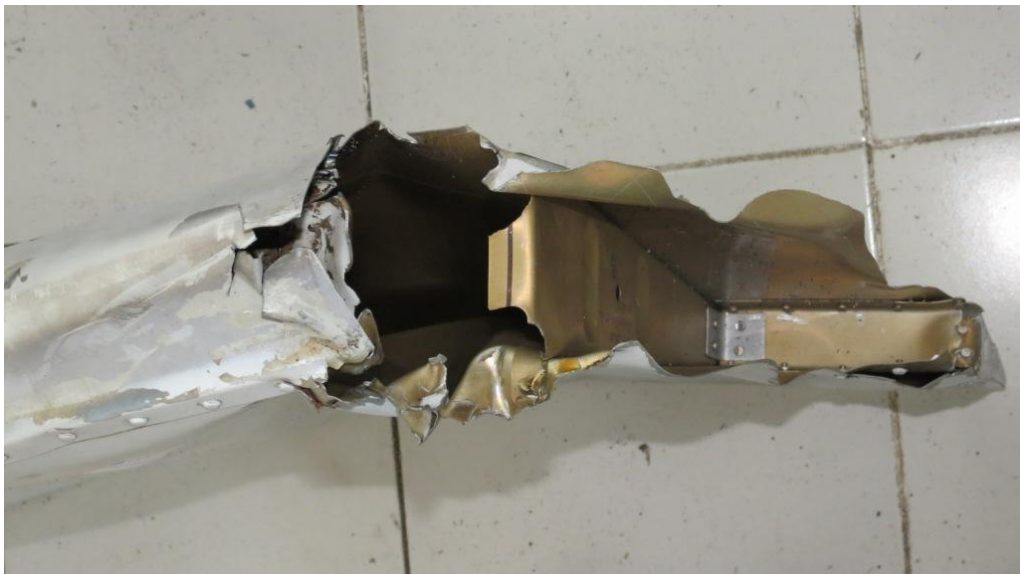
Figure 5: Random damage on the inboard hinge of the elevator

This calculation did not count the factor of engine power. The calculation of speed found that the aircraft speed was higher than the never exceed speed (VNE) of 159 MPH and the speed found vibration speed of 204 Knots.

This calculation was supported by the evidence of the random damage on the left elevator hinge that indication of vibration.

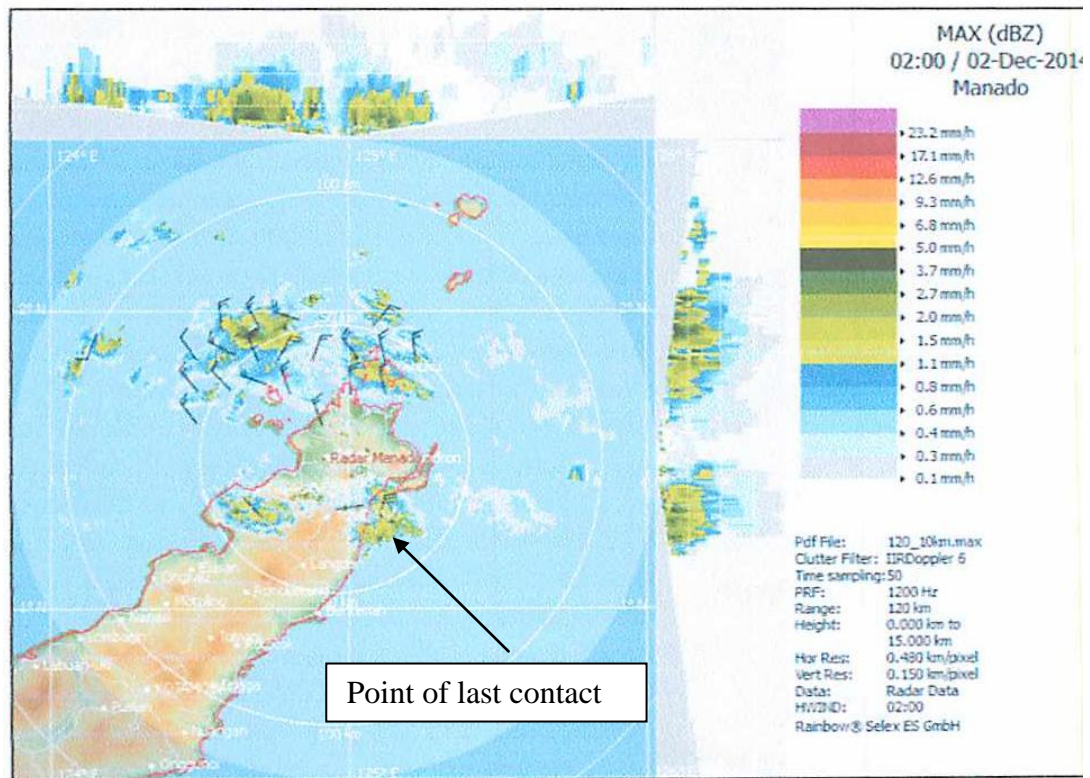
Figure 9 : Satellite weather image on Manado area at the time of occurrence

The satellite weather image on Manado area, weather analysis of BMKG and witness statement indicated that the area was raining with intensity of moderate to heavy with cumulonimbus cloud during the occurrence. The witness also stated that he saw the aircraft descend out of cloud.

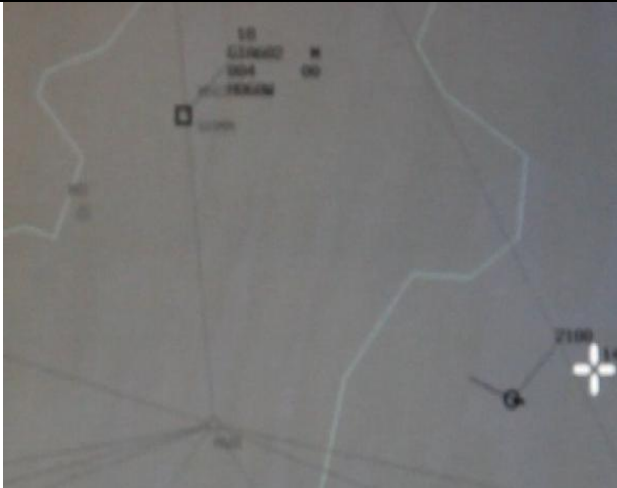
<p>The radar display indicated the aircraft flew toward MD NDB.</p>

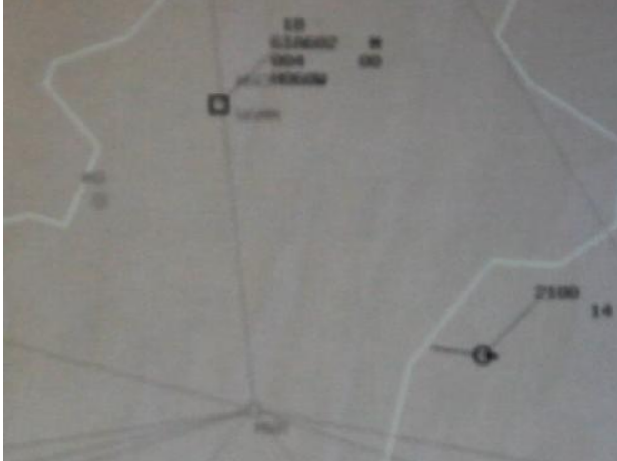
<p>The aircraft turned further to the left.</p>

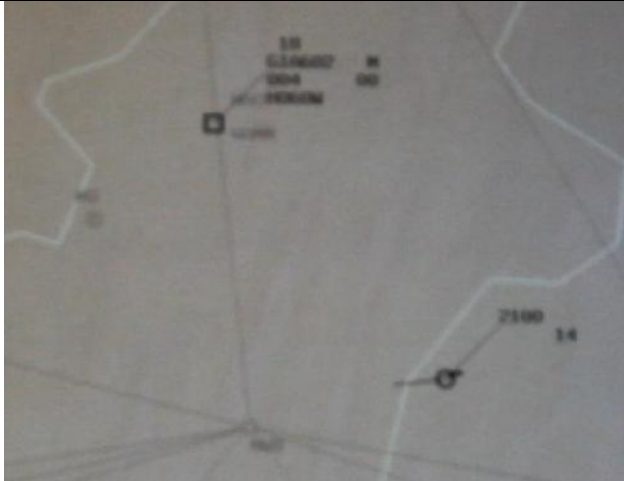
<p>The aircraft flew further to the left to MWB VOR.</p>

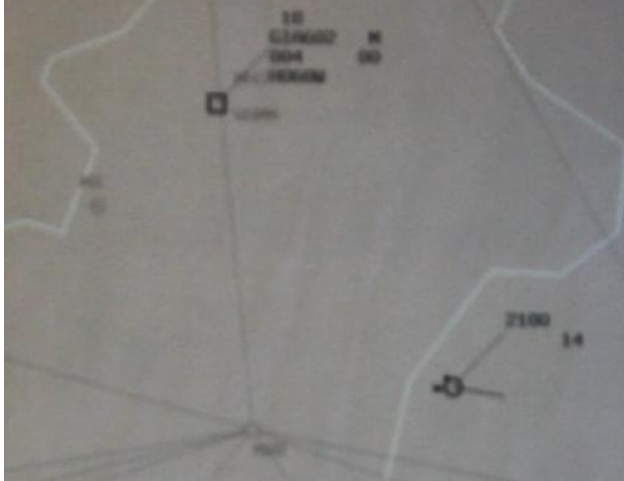
<p>8 seconds later, the aircraft flew eastward.</p>

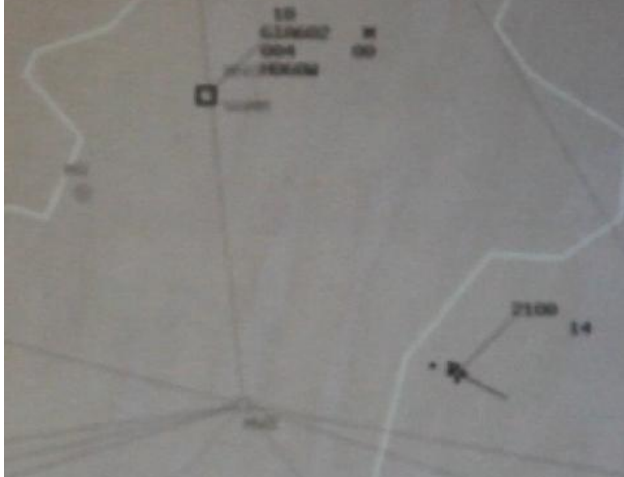
<p>The aircraft data started to disappear from the radar screen</p>
