**KOMITE NASIONAL KESELAMATAN TRANSPORTASI
REPUBLIC OF INDONESIA**

Aircraft Accident Investigation Report

PT. Intan Angkasa Air Service

Piper Chieftain PA 31-350, PK-IWT

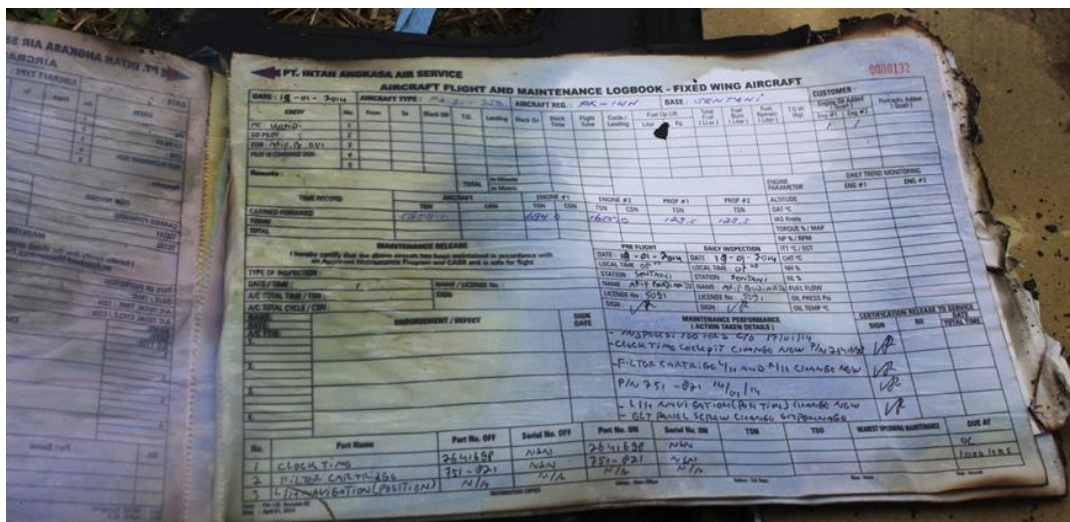
The operator informed that after the last major inspection on 12 April 2013, the aircraft served in Papua which was outside of the operation base. The maintenance record in the head office may not be updated.

Figure 1: The recovered page of the Aircraft Flight and Maintenance Logbook

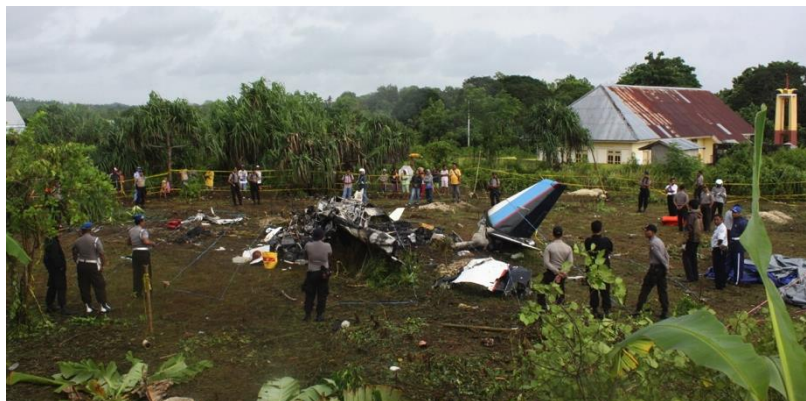
The aircraft heading was approximately 300° , the wreckage distributed on an area with radius of approximately 50 meters and the fuselage destroyed by the post-impact fire from the cockpit to the empennage.

Figure 6: The general view of wreckage distribution

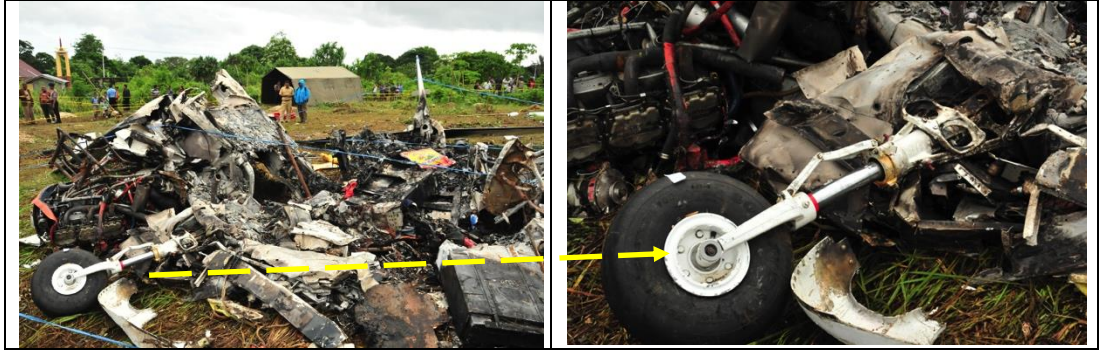
The nose landing gear tire was still pressurized, and the gear was appeared to be extended and locked which subsequently collapsed forward most likely at impact. There was no sign of abnormality to the nose landing gear and tire.

Figure 7: Nose landing gear and nose wheel tire

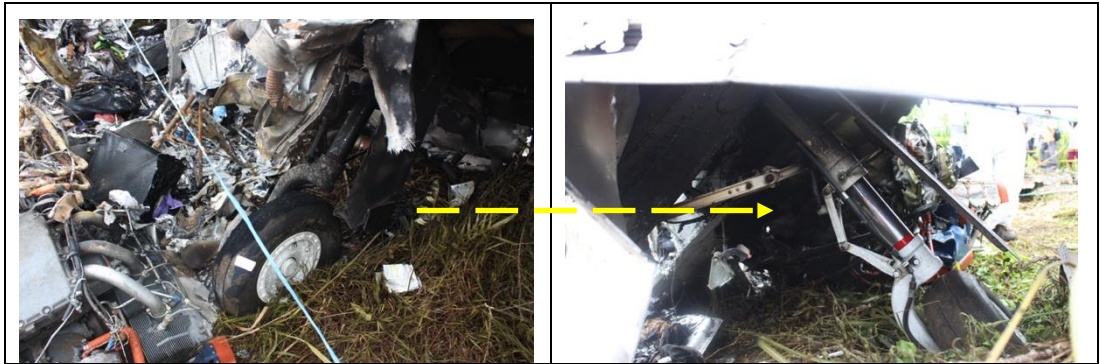
Both main landing gears were still intact at the wing structure and appeared to be extended and locked. There was no indication of abnormality and it was appeared that landing gear had been extended.

Figure 8: Left landing gear and left wheel tire

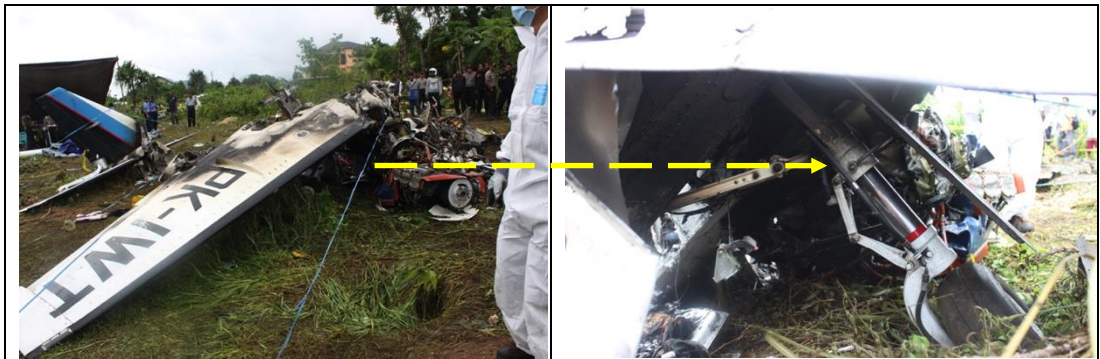
Figure 9: Right landing gear and right wheel tire

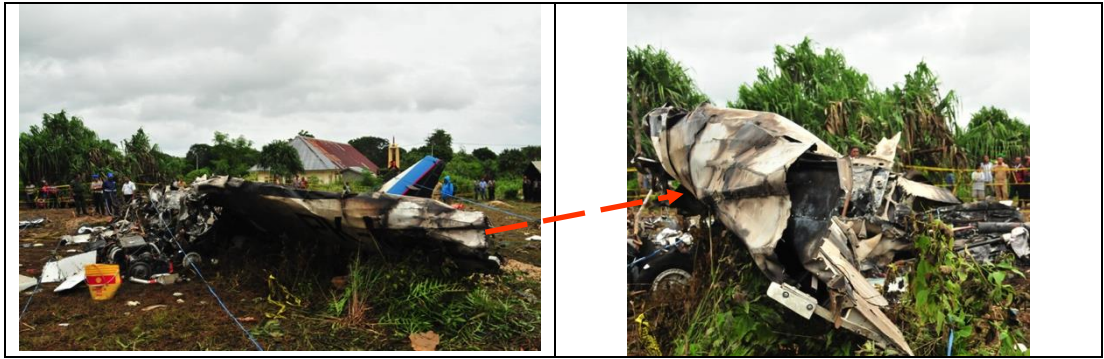
The leading edge of the left wing bent upward at approximately 3 – 4 meters from the wing tip which was a sign of impact force at the left wing. The left wing root was destroyed by post-impact fire. The witnesses reported that the right wing was found at an angle of approximately 45° with the wing tip at the top, prior to collapse due to post impact fire.

Figure 10: The deformation of the left wing leading edge

The left wing leading edge was found bending upward up to 4 meters, indicated that the left wing was the first part impacted to the ground. This indicated that the aircraft rolled to the left during impact. This supported by the evidence of the aircraft was tilted to the left prior to rest on the final position after the fire extinguished. The impact to the ground with position rolled to the left most likely resulted to the left propeller impacted to the ground prior to detach from the engine.

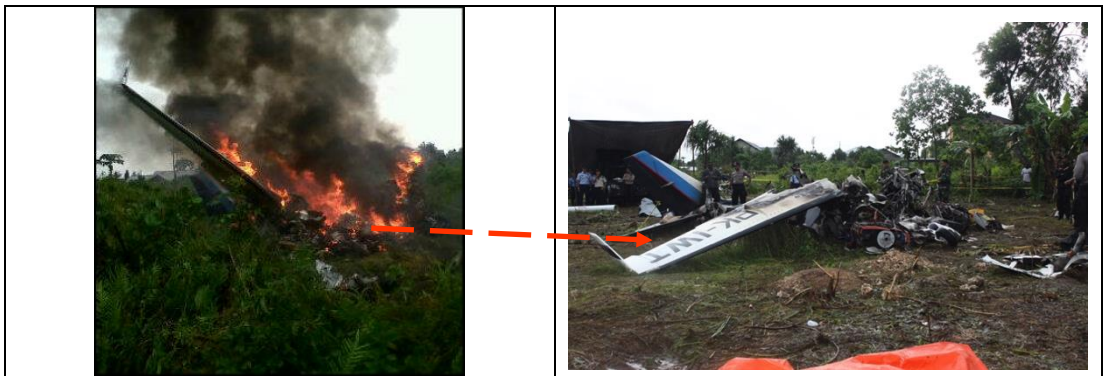
Figure 11: Right view after crashed and after the fire was extinguished

There was no sign of fuel spill on the ground or remaining in the left wing tank most likely the fuel tank was broken after impact, the fuel leaked and burnt.

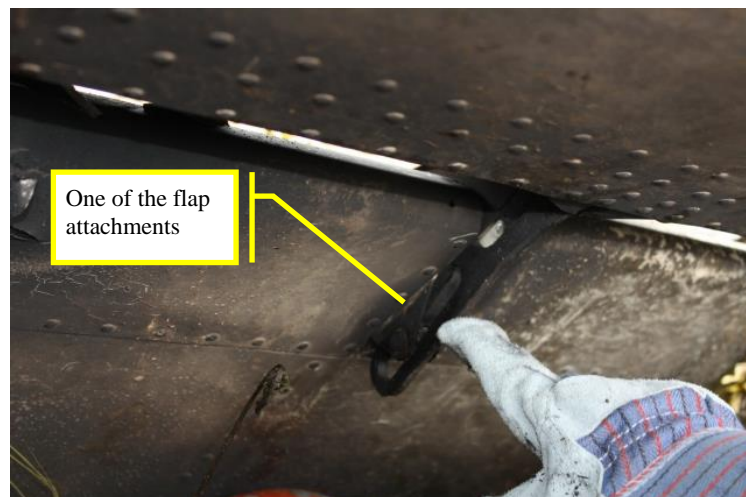
All the wing flaps were not in the fully retracted position however, the angle of the flap extension could not be determined.

Figure 12: Wing flap found not on up position

The wreckage provided evidence that all the landing gears appeared down and locked, the wing flaps were not in the fully retracted position however, the angle of the flap extension could not be determined. Referred to the Piper Navajo Information Manual, the normal procedure checklist stated the landing gear down selected after the flap selection to 15°. Assumed that the procedure was performed and information of the wreckage that the landing gear had been extended, it can be concluded that the flap was minimum at 15° positions. This condition indicated that the aircraft was in preparation for landing.

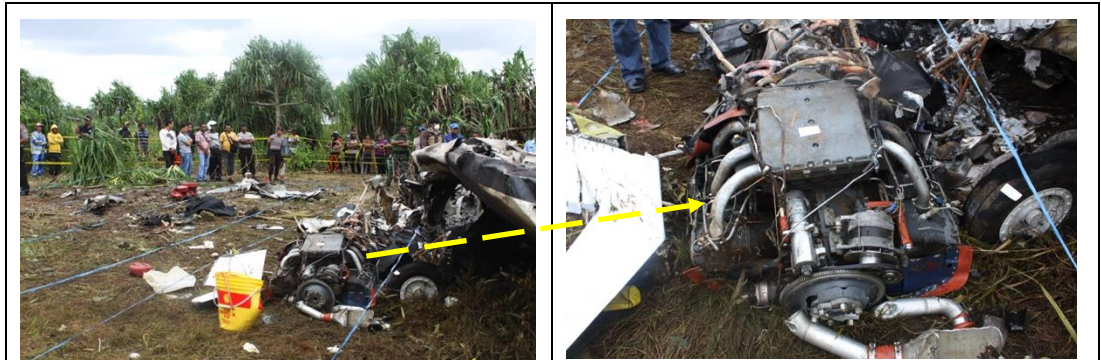
The left and right engines detached from its mountings and the propeller assemblies detached from its engines. The left engine was found in upside down position and faced about 60° to the left from its original position, compared to the position of the left wing. There was no sign of fire on the left engine.

Figure 13: Left engine condition

The evidence of the left engine found facing to the left relative to the wing position, indicated the dominant impact forces were downward and to the left. This situation was consistent with the possibility of wind-milling condition on the left engine while the propeller was not set to feather subsequently created drag followed by yaw and roll tendency to the left.

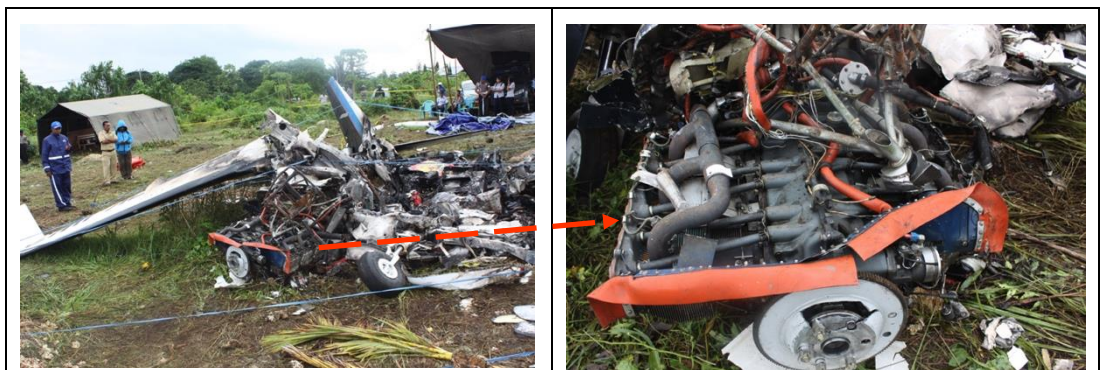
Figure 14: Right engine condition

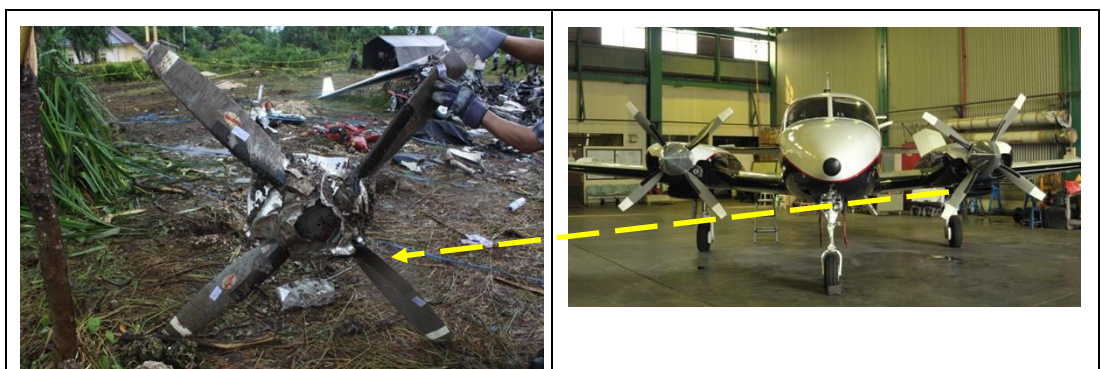
The left engine propeller detached and found at approximately 8 meters in front of the left engine. The spinner submerged in the mud and damage. The propeller blades were in the low pitch angle and several scratch marks on the propeller leading edges and the blades. The propeller blades were not bent in any position.

Figure 15: Left propeller

In contrary with the right propeller, the evidence of left propeller showed less damage without any bending blade. The left propeller most probably was also rotating at impact indicated by the several scratch marks at the blade leading edges and the blades, the unbending propeller indicated less rotational energy compared to the right propeller.

The investigation concluded that the left engine failed during approach. The propeller did not set to feather resulted in significant asymmetric forces on the left and right side of the aircraft. KNKT recommend to review pilot training in handling engine failure including during critical phase.

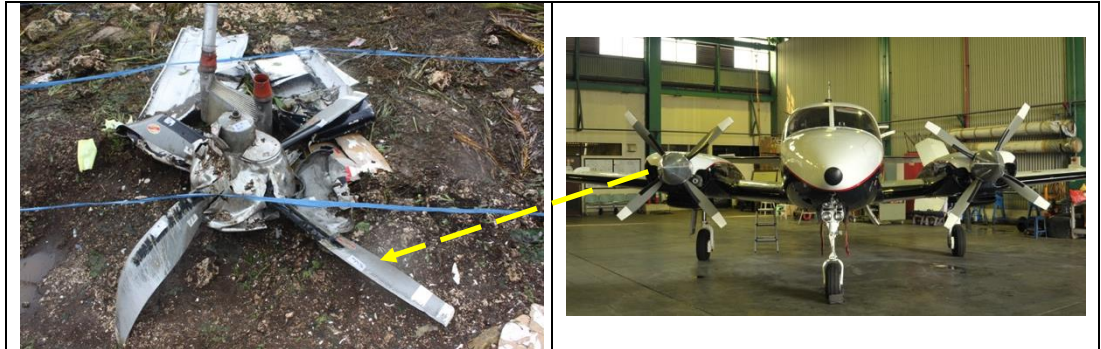
The right engine propeller assembly detached from the engine and separated at approximately 4 meters in front of the engine. Two blades were found bent backward with scratch marks and two blades were relatively less damage. The propellers were at low pitch angle. The spinner detached from the propeller unit.

Figure 16: Right propeller

Examination of the right propeller found that two blades bent backward and spinner damage, these evidences showed that the engine completed about a half revolution when contacted with the ground before propeller detached. The damage on the right engine showed high rotational energy at impact. It was likely that the engine may have been operating prior to impact.

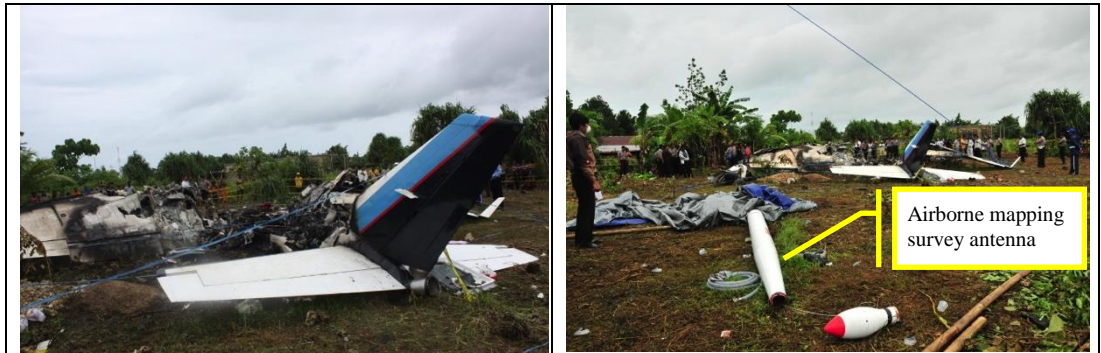
The tail section was found not significantly damaged. The aircraft was equipped with airborne magnetic mapping survey and the antenna boom was installed on the tail section. The antenna of airborne magnetic mapping survey was detached and separated approximately 6 meters behind the tail section.

Figure 17: Tail section and the antenna of airborne mapping survey

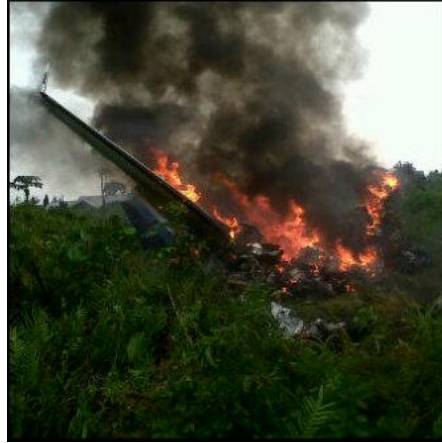
The witnesses state that the fire started after the impact. The cockpit through the empennage was destroyed due to post-impact fire. The source of the fire was unable to be determined.

Figure 18: The exposure of fire after crash. The photo was taken by local witness
