**KOMITE NASIONAL KESELAMATAN TRANSPORTASI
REPUBLIC OF INDONESIA**

Aircraft Accident Investigation Report

Cessna 172; PK-MSN

19 September 2014

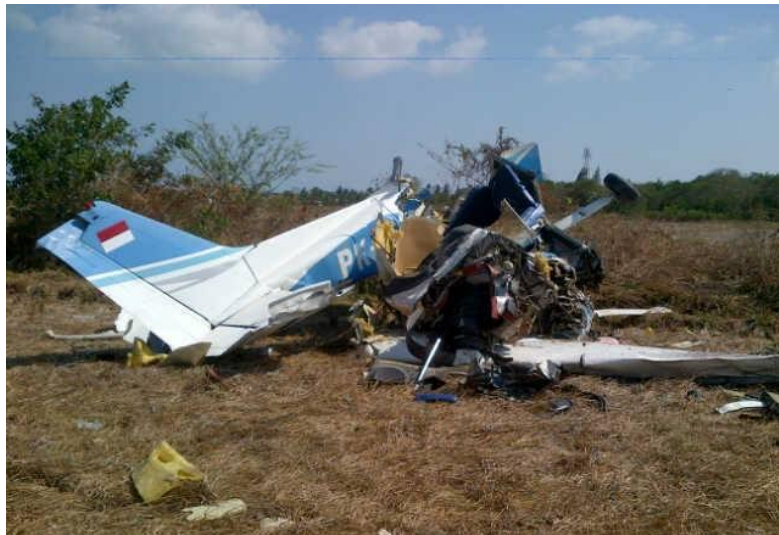
Figure 3: The accident aircraft

The aircraft was substantially damaged.

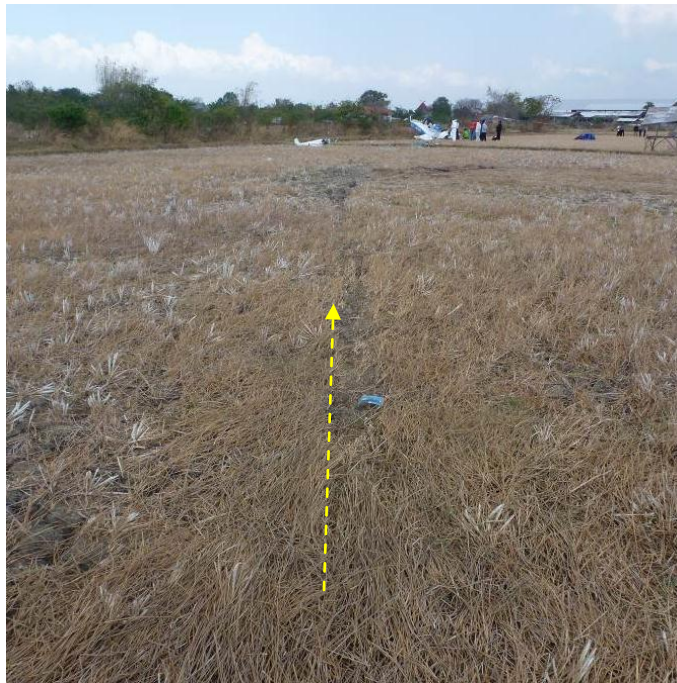
Figure 4: The ground mark towards main wreckage

Based on the observation, the right wing tip hit the ground first and followed by the nose and fuselage, and there was a ground mark towards the main wreckage (figure 4).

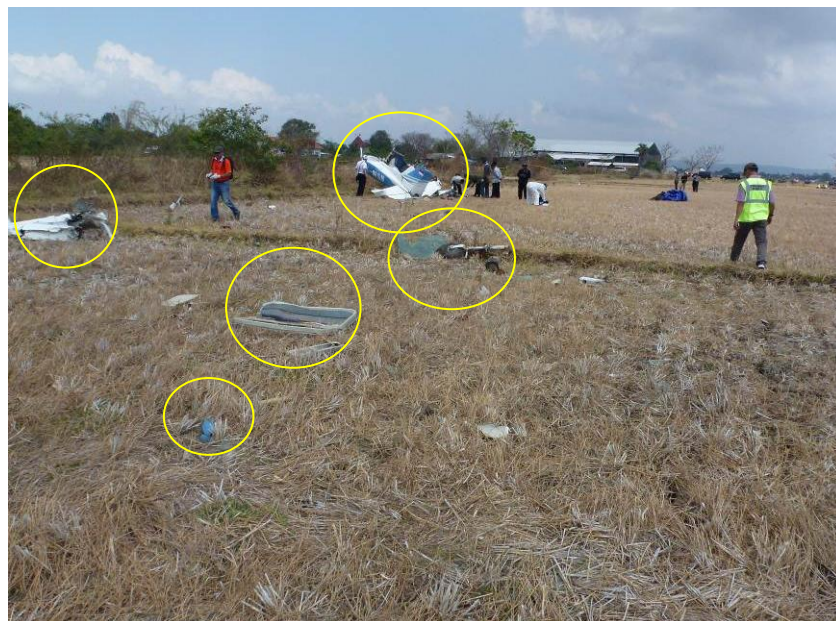
Figure 5: The wreckage distribution

The right wing, right main wheel and nose wheel detached and found in different location with the main wreckage. The debris spread along 60 meters on approximate direction of 170°. One of the propeller blades bent backward. The detail of the wreckage distribution can be seen on figure 8.

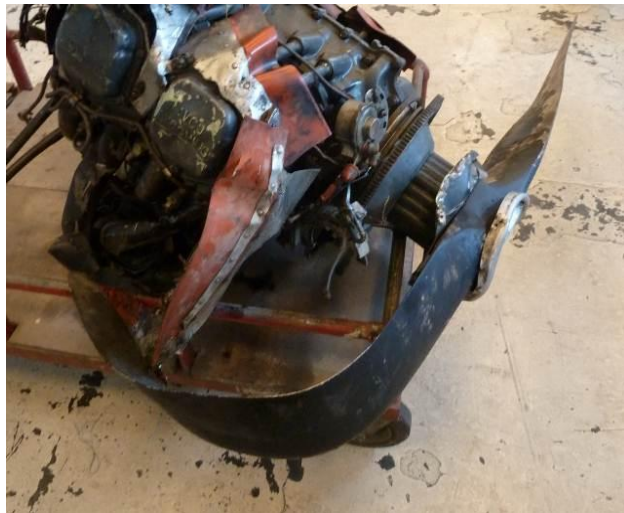
Figure 7: The propeller blade bent backward

At the crash site found that one of the propeller blades was bend half side backward. This indicated that the propeller was on slow rotation or stop when impacted to the ground.

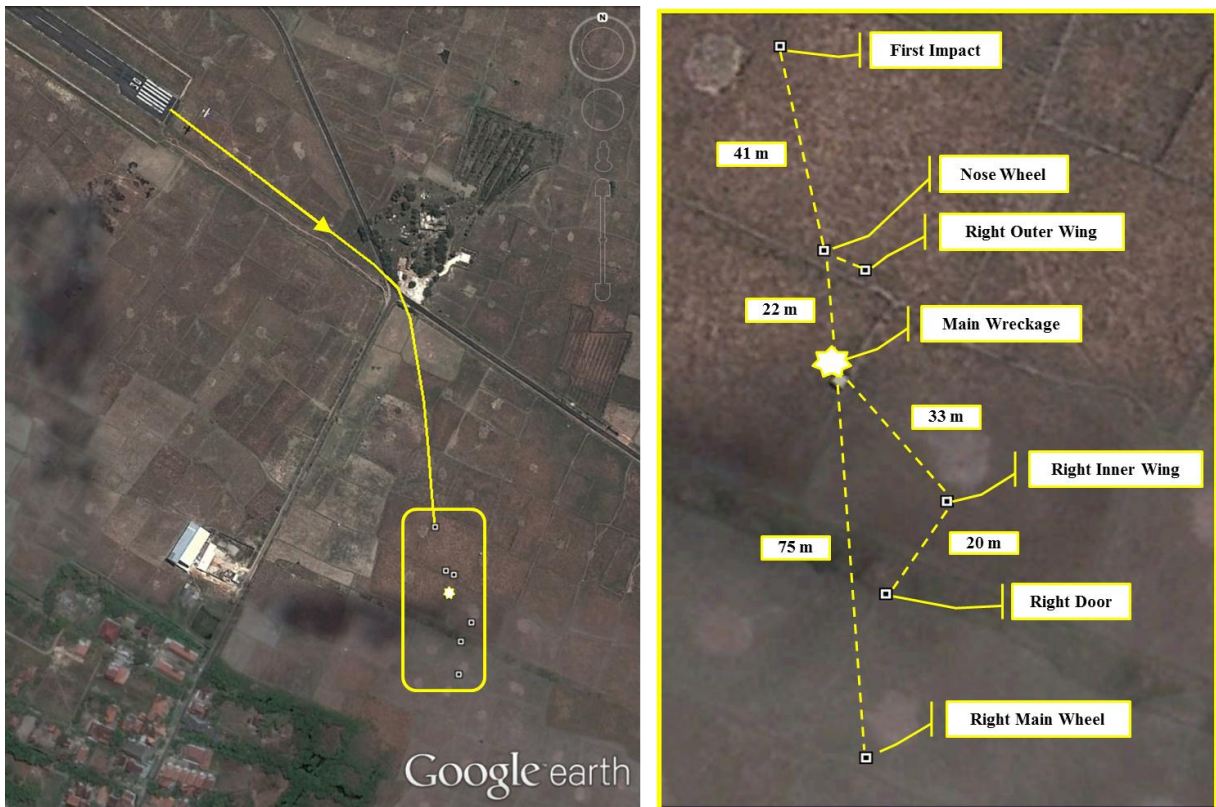
Figure 8: The predicted flight path and aerial view of wreckage distribution

Examination to the spread out debris along 60 meters from the first impact mark at approximate direction of 170° and this trajectory was align with white surface land along the takeoff path (ref to the Google earth). Observation found that the part of right wing tip hit the ground first then followed by the nose wheel and the fuselage.

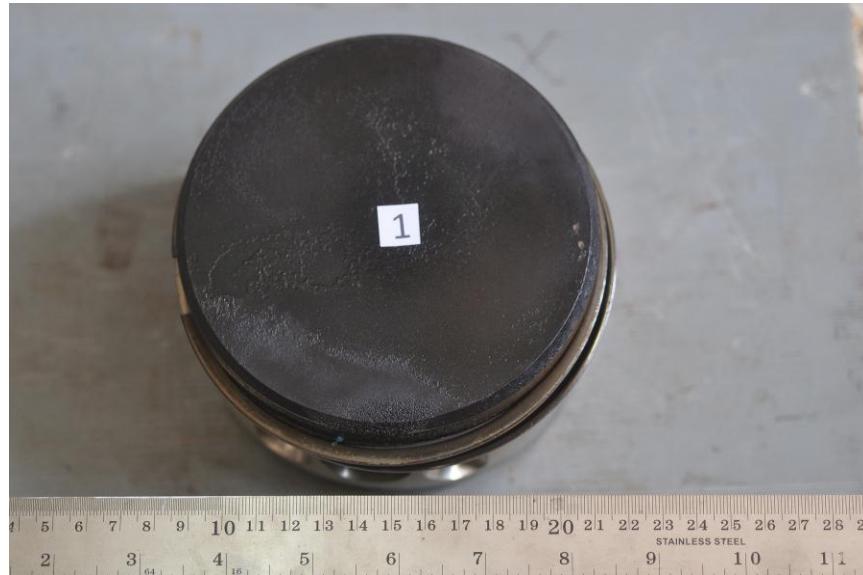
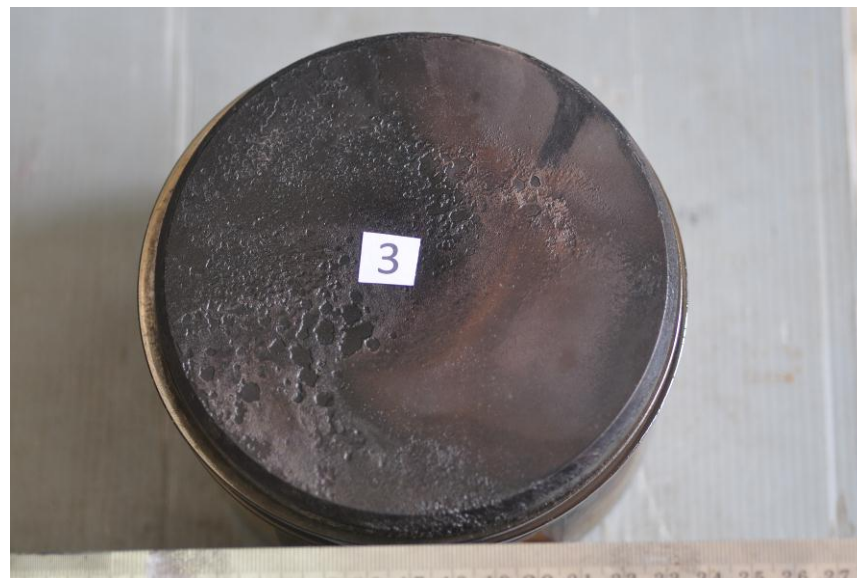
The further inspection was conducted at the Laboratory of Metallurgy, Institute of Technology Bandung. The inspection revealed that the pistons of number 1 and 3 cylinders were found locally melted at its cylinder head (figure 9 and 10).

Figure 9: Piston number 1

Figure 10: Piston number 3

The piston showed a significant carbon deposit and scrubbing action. Theoretically referred to FAA Powerplant handbook volume 1, carbon deposit can build up on the cylinder due to the incomplete combustion within the engine cylinder. The carbon deposit may lead to misfiring. This condition similar to early timing of spark plug or pre-ignition where the charge in the cylinder is ignite before required time for normal engine firing. This combination of pre-ignition with the incorrect fuel mixture and/or fuel octane quality will ignite spontaneously and burn with explosive violence that leads to detonation.

The detail observation of the engine in the workshop and laboratory examination showed there were carbon deposits, scrubbed and melted locally on the pistons surface. The condition piston surface most likely was a result of the detonation.

1. Performed one time inspection refers to task card of 200 hours Approve Aircraft Inspection Program (AAIP) for all aircraft.
2. Performed visual inspection on the cylinder kit (cylinder bore, piston ring, and piston head) to detect any possibilities of inappropriate function.
3. Documented the result of all inspection as the evidence.
4. Fueling all aircraft using avgas until the KNKT recommendation has been issued.

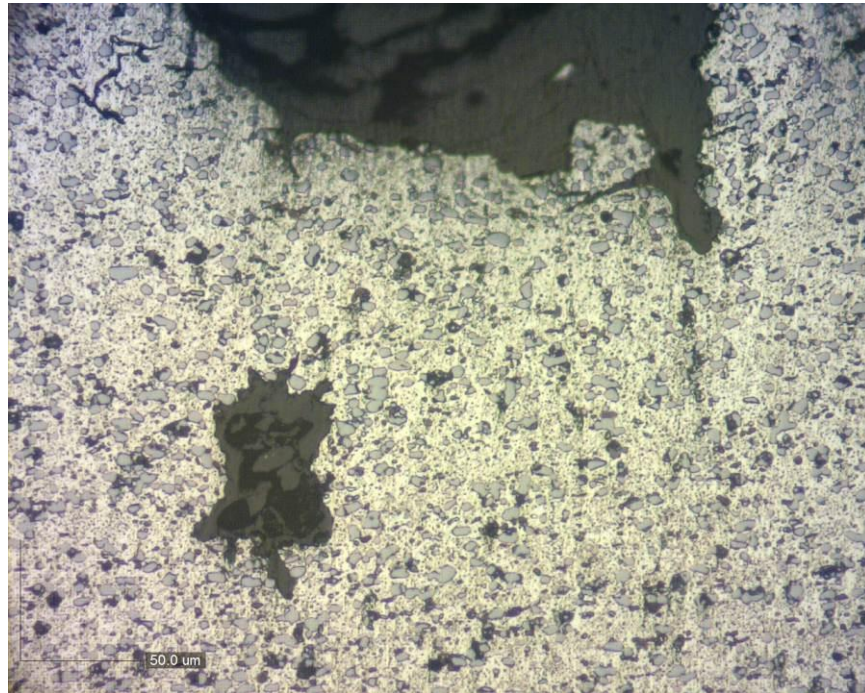
Figure 11: Microstructure nears the melted zone; the depth of structure change is approximately 50 μm

The microstructure change is 50 μm from the melted zone. It indicates that the process of overheating was in a relatively short time, probably in the order of minutes.

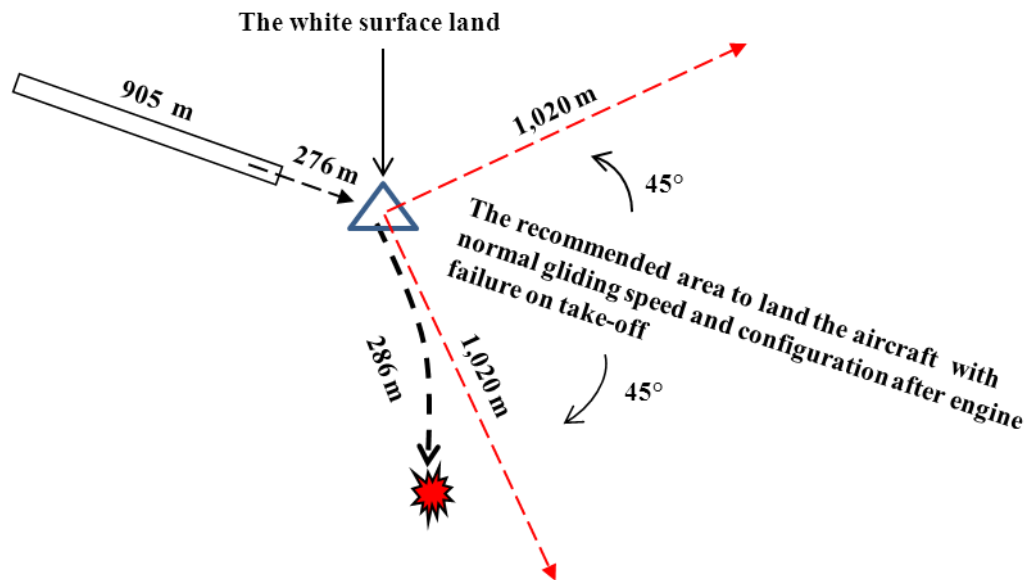
Figure 14: The expected trajectory and crash site

The investigation could not determine the actual altitude and position when the engine failed. However, based on the assumption of the normal takeoff distance and comparing with the eyewitness, the engine fail occurred between 245 feet to 400 feet.

The aircraft impact point was at 286 meters from the aircraft started to turn (white surface land) and out of the recommended area for emergency landing after takeoff. The aircraft initial impact point and the trajectory indicated that the aircraft rolled to the right and dive.

The impact point and trajectory indicated that the aircraft was uncontrolled that might be caused of the lack of flying skill and judgment when facing a critical situation.
