FINAL
KNKT.14.09.19.04

Aircraft Serious Incident Investigation Report

**PT. Enggang Air Service
Grand Caravan C-208B; PK-RSC
Mulia Airport, Papua
Republic of Indonesia
09 September 2014**

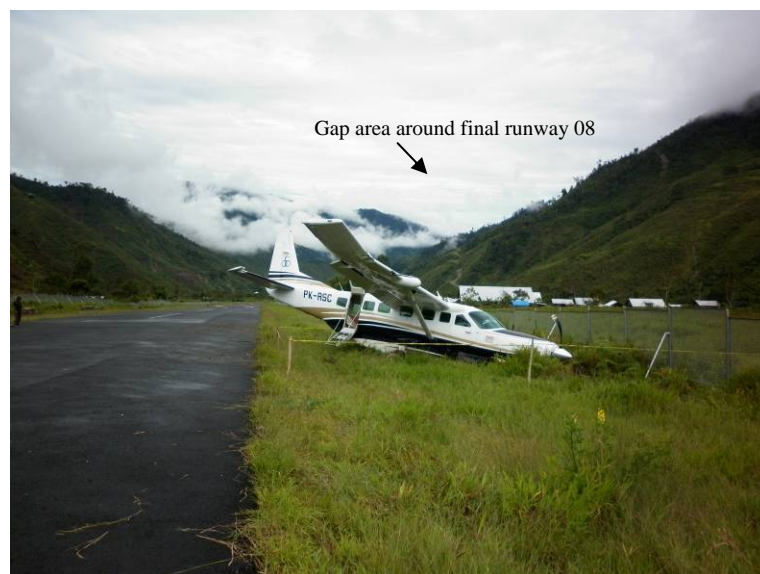
Figure 2: The aircraft at the occurrence site

The aircraft stopped on the left side of the runway with left main and nose landing gear damaged and sunken into soft soil.

The aircraft touched down within the touchdown point of runway 08, bounced then floated and started swing to the left. At the second touched the PF pushed the control column and applied full right rudder following by the application of reverse thrust and brake. The aircraft continued veered to the left. The aircraft stopped on the left side of the runway with left main and nose landing gear damaged and sunken into soft soil.

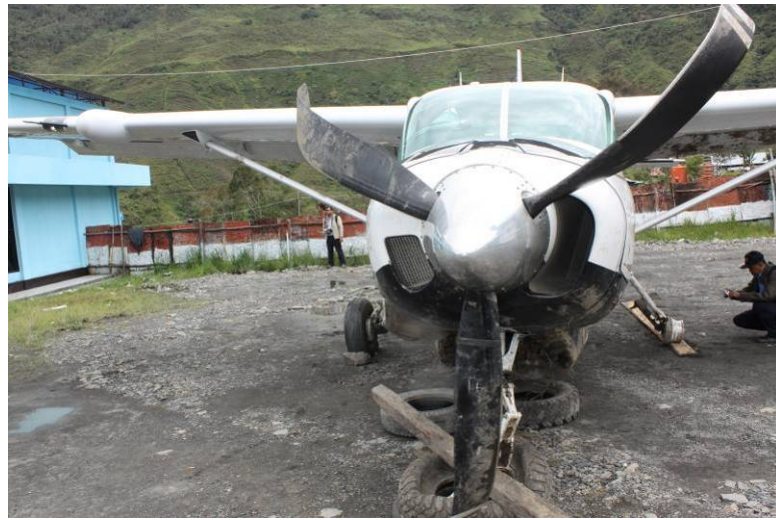
Figure 3 : Damage to the aircraft

An observation showed that all propeller blades twisted, left main landing gear damaged. Part of the aircraft belly scratched and dent.

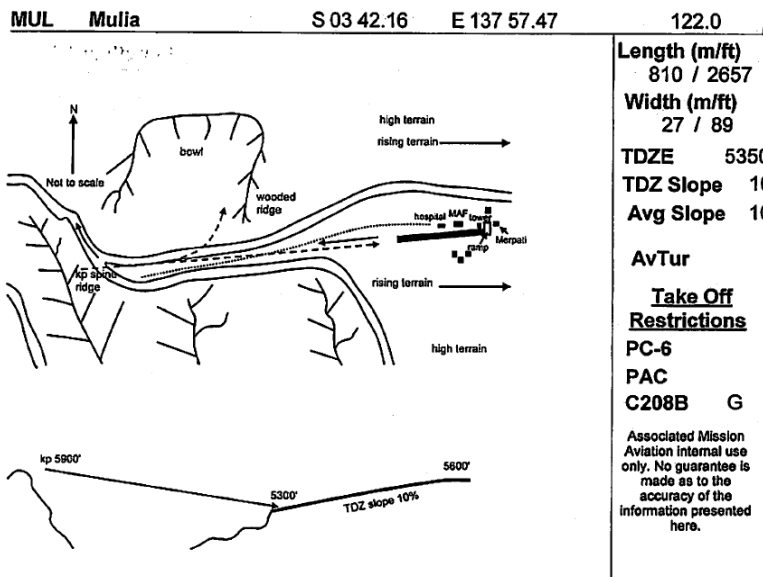
Figure 4: Aerodrome chart issued by Associated Mission Aviation (AMA)

The runway slope is 10%

Surface
 Asphalt; hard and rough; side slope from the bottom to middle.

Obstacles
 Dangerous lip between overrun and approach end of runway.

Hazards
 Possible sun/shadow problems 06:15 - 07:00. When clouds and sun on approach make sure runway is in sight before committed to land. Lip where asphalt begins at TDZ.

- The runway slope was 10° up from runway 08.
- Weather phenomenon
- Aborted landing procedure.

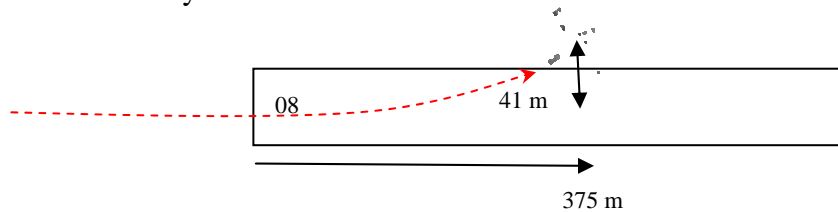
Figure 5: Sketch of the occurrence

The illustration of the impact information based on the marks signed on the surface of the runway.

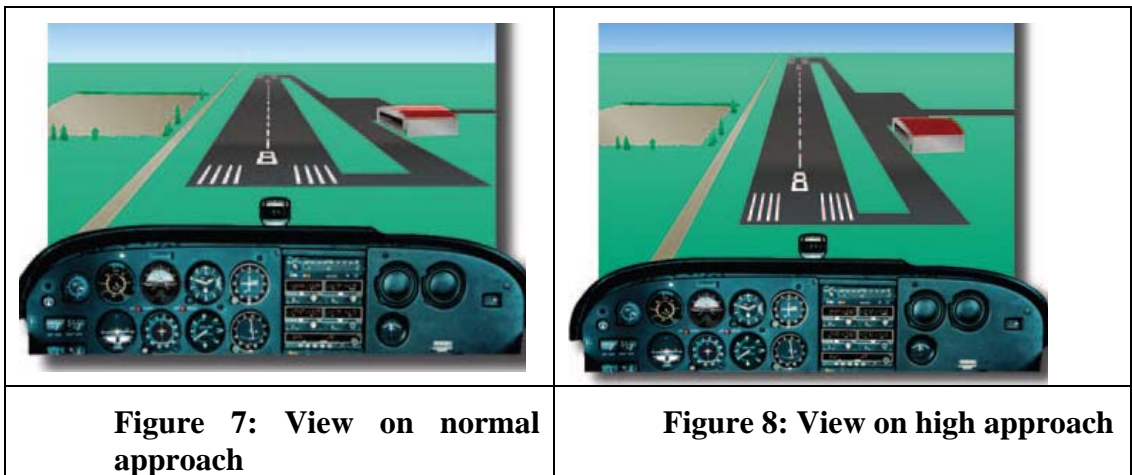
The bounced was possibly due to the runway illusion to the pilot as the runway slope was 10%. The illusion was the aircraft felt like higher approach angle than normal approach. This may result to late flare out for touchdown.

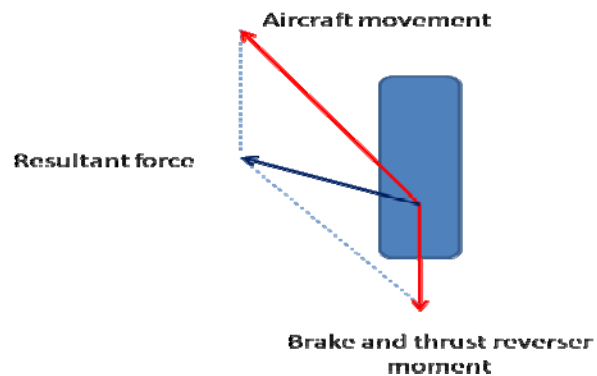
Examinations of the side force energy and several sequences of events prior to the aircraft stop it found that, after touched down the aircraft veered to the left and the pilot applied brake and reverse thrust. These two actions resulted backward moment (force) while the aircraft moved to the left. The resultant of the backward moment and side movement resulted to the force further to the left.

Illustration of the forces applied to the aircraft.

All the forces applied to the aircraft have made the aircraft moved further to the left and difficult to recover back to the runway centerline. This situation would be worst on slippery runway.

- a. The missed of the standard call out as required by the COM might cause less of effectiveness of the goals of such statement on COM as well as cause the pilot kept to land un align aircraft with the runway, as such the KNKT recommends that the operator should ensure that pilots performs correctly the standard call out and the implementation of COM Chapter 6 page 6-48.
- b. Examinations of the side force energy and several sequences of events prior to the aircraft stop found that, when reverse being applied the aircraft start veer off to the left. The pilot reaction to these moments was applying the reverse thrust and breaks intermittently but the aircraft kept move to the left. As such the KNKT recommends that the operator has to review the cornering landing technique and ensure that the pilots had well understand and sufficient skilled to this particular cornering technique.
