**KOMITE NASIONAL KESELAMATAN TRANSPORTASI
REPUBLIC OF INDONESIA**

Aircraft Serious Incident Investigation Report

ATR 72-212A; PK-WFR

Sultan Hasanuddin Airport, Makassar

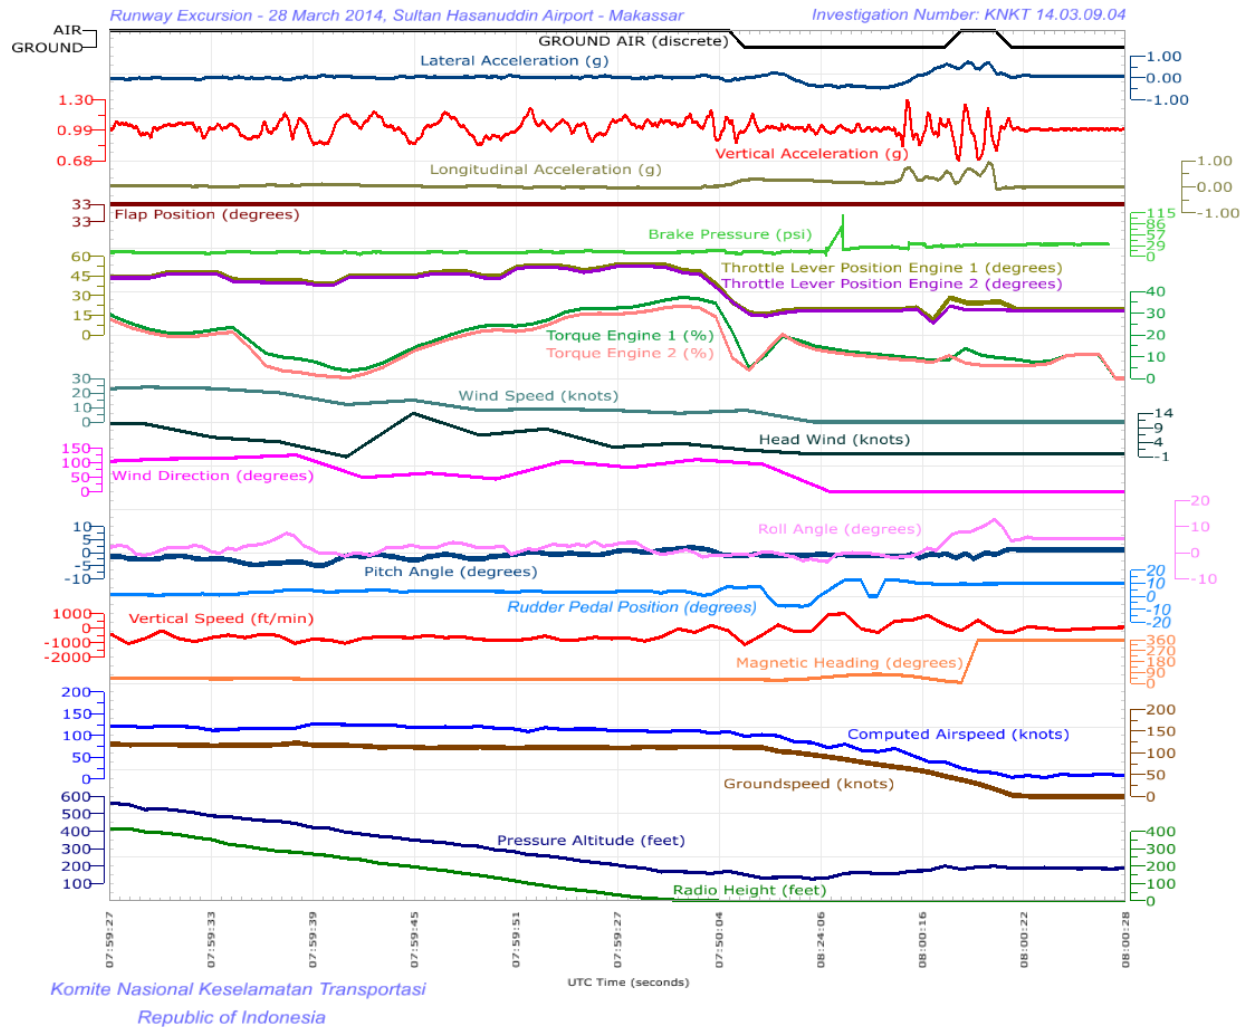
Figure 2: Graph of the FDR data started from prior to touch down
