INTERIM REPORT

Aircraft Accident Investigation Report

British Aerospace BAe ATP; PK-DGB

Wamena Airport, Papua

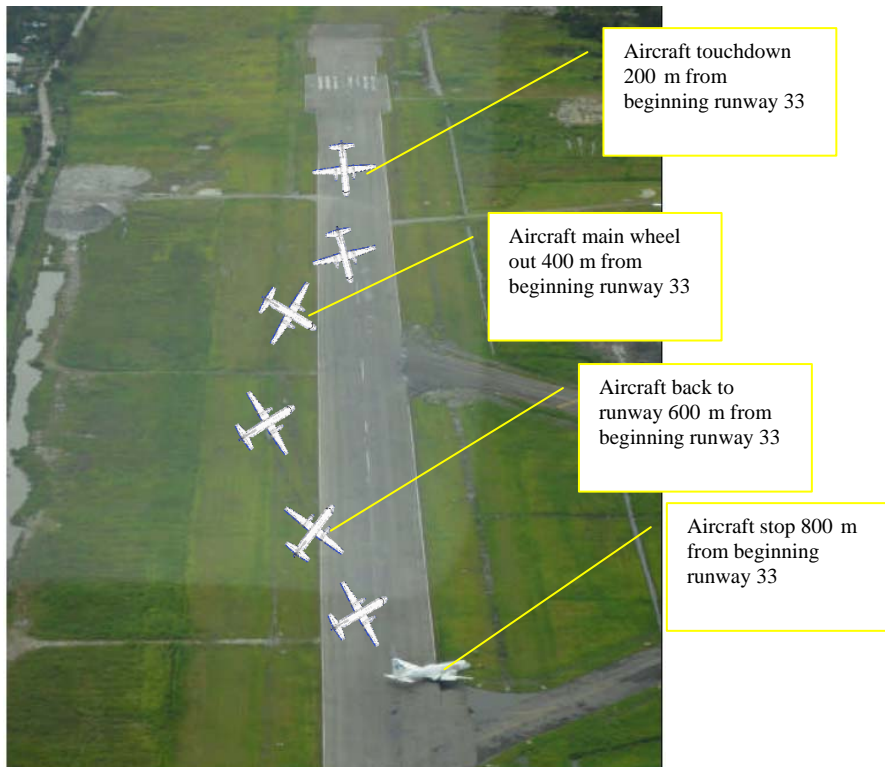
At 0620 UTC, the aircraft touched down, thereafter veered off to the right of the runway and skid. The aircraft re-entered the runway at approximately 400 meters from beginning runway 33 and stopped near taxiway Delta at approximately 800 meters from beginning runway 33.

Figure 1: The illustration of aircraft movement

The aircraft touch down mark found at approximately 200 meters from beginning runway 33. The initial main wheel mark out of the runway was found at approximately 400 meters from the beginning of the runway, the main wheel mark re-enter the runway surface at approximately 600 meters from the beginning runway 33 and the aircraft stopped at approximately 800 meters from the beginning of the runway.

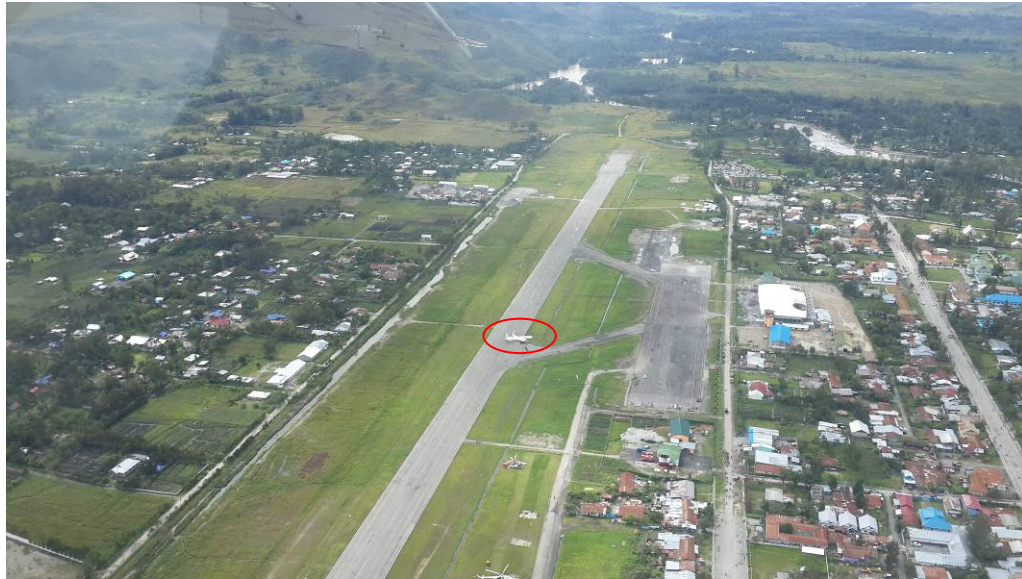
Figure 2: The aircraft final position, taken from aircraft holding over Wamena airport at 500 feet AGL

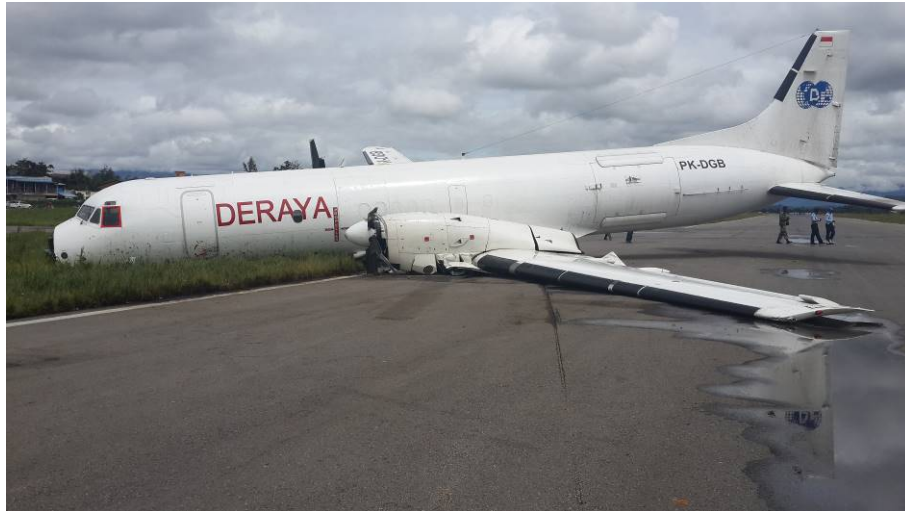
The aircraft substantially damaged, the detail damaged were as follows:

- The nose landing gear and left main landing gear were detached.
- The propeller blades of the left engine and radom were broken.
- The left engine dislocation from the main body.

Figure 3: The damage of the aircraft

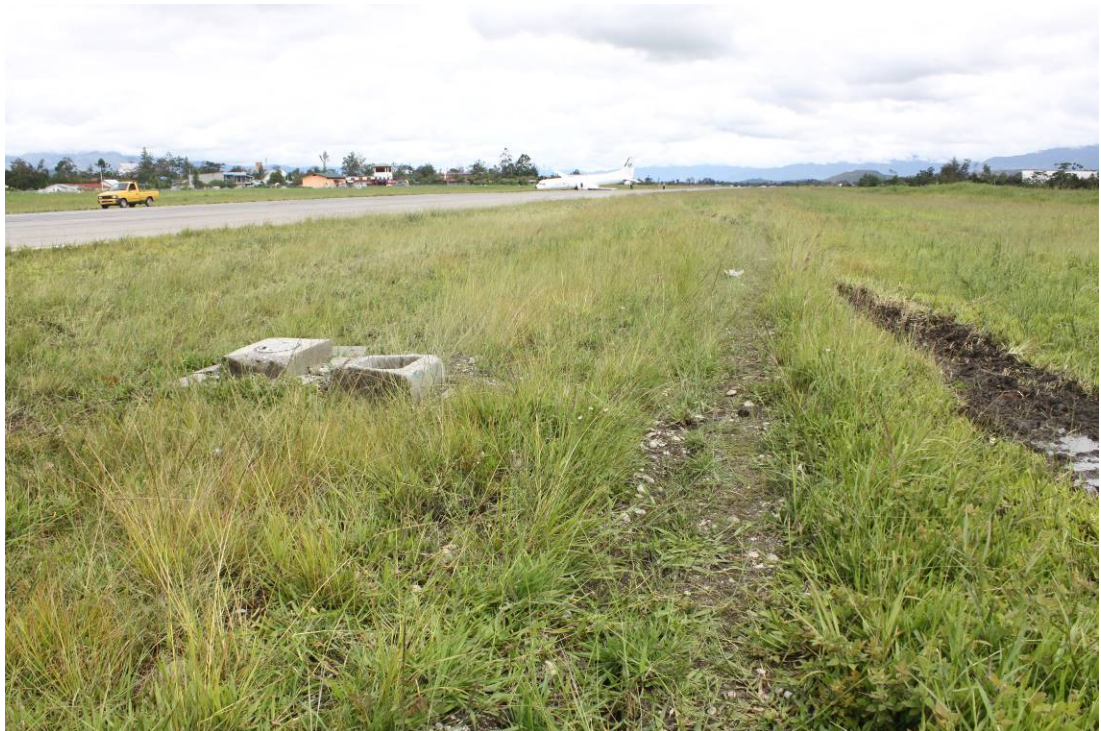
A runway light was damage after hit by the aircraft.

Figure 4: Damage on the runway light hit by the aircraft
