**Aircraft Accident Investigation Report**

**PT. Cardig - Air**

**Boeing 737-300 F; Reg. PK-BBY**

**28 August 2015**

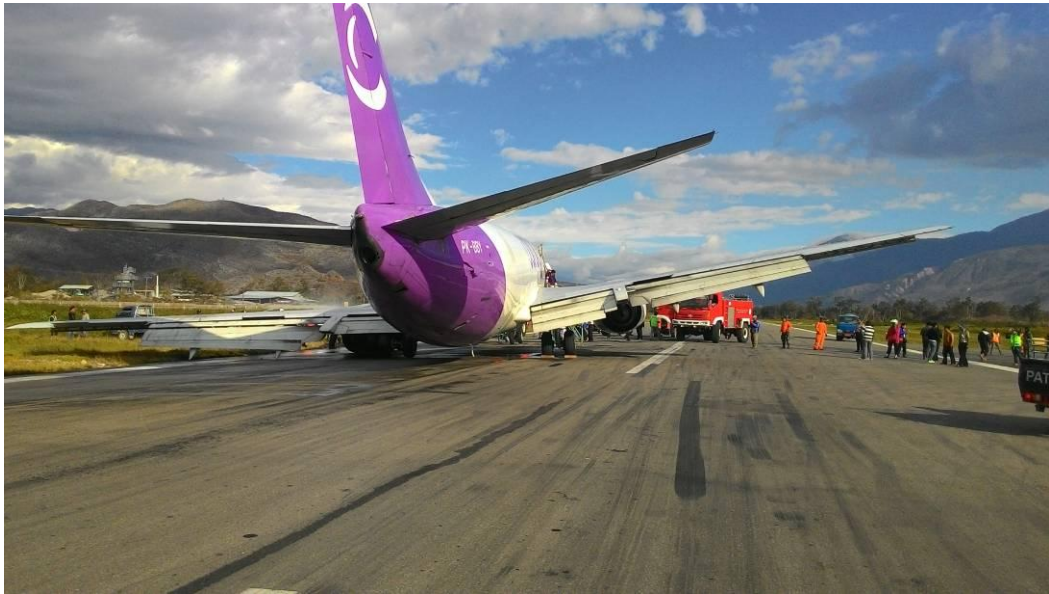
**Figure 1: The aircraft last position**

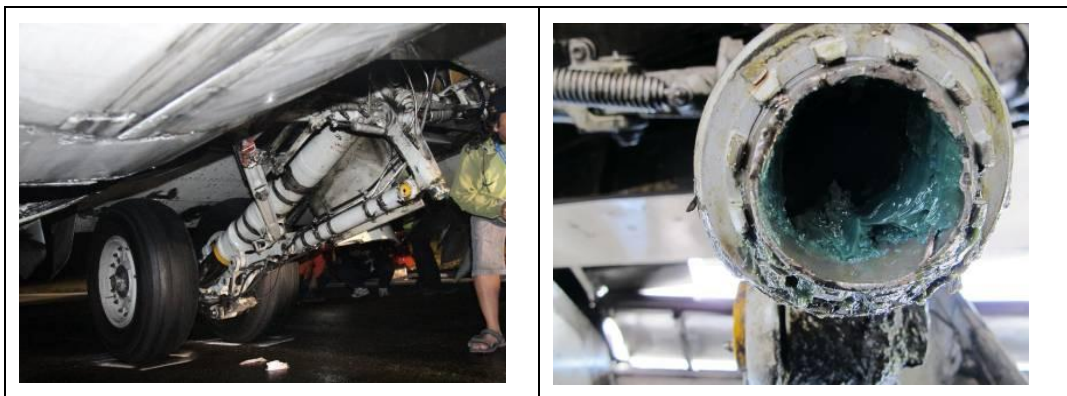
The trunnion link of the left Main Landing Gear (MLG) assembly broken with the detail:

- the left MLG collapsed;
- the left landing gear access panel lower fairing damaged;
- the shock strut of the right MLG leaked and deflated.

**Figure 2: The collapse left MLG and broken trunnion link**

The CASR part 25.561 (b) required the design of landing gear capable to support downward force minimum of 6 G. The downward force recorded in the FDR as vertical acceleration. The FDR recorded the vertical acceleration during touchdown was 3.683 G. This impact caused the left main landing gear collapsed.

The accident flight collapsed the landing gear, the FDR recorded the vertical acceleration was 3.683 G which was within the landing gear design limit. This indicated the degradation of landing gear strength.

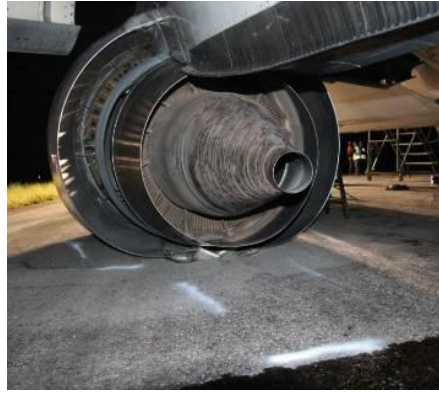
**Figure 3: The left engine condition**

The detail damages on the left Engine are as follow:

- Lower Fan cowling inner and outer damage;
- Lower Gearbox Casing scratch;
- Lower C-Duck thrust reverser inner damage;
- Lower C-Duct thrust reverser outer damage.

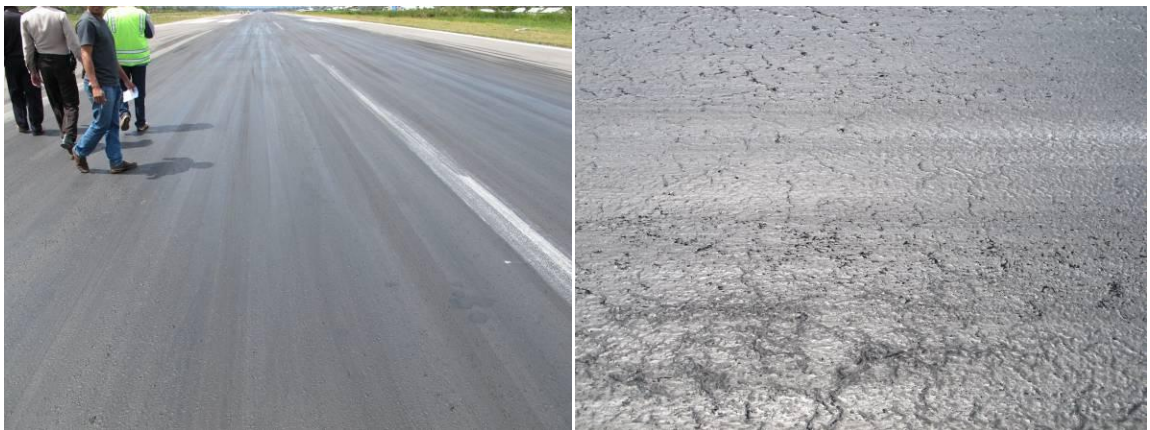
The surface of runway 15 found excessive rubber deposit at about 600 meters started from the runway threshold. The investigation did not found specific aerodrome maintenance program and the inspection system applicable to the runway and other facilities of Wamena airport.

**Figure 4: Rubber deposit on runway 15**

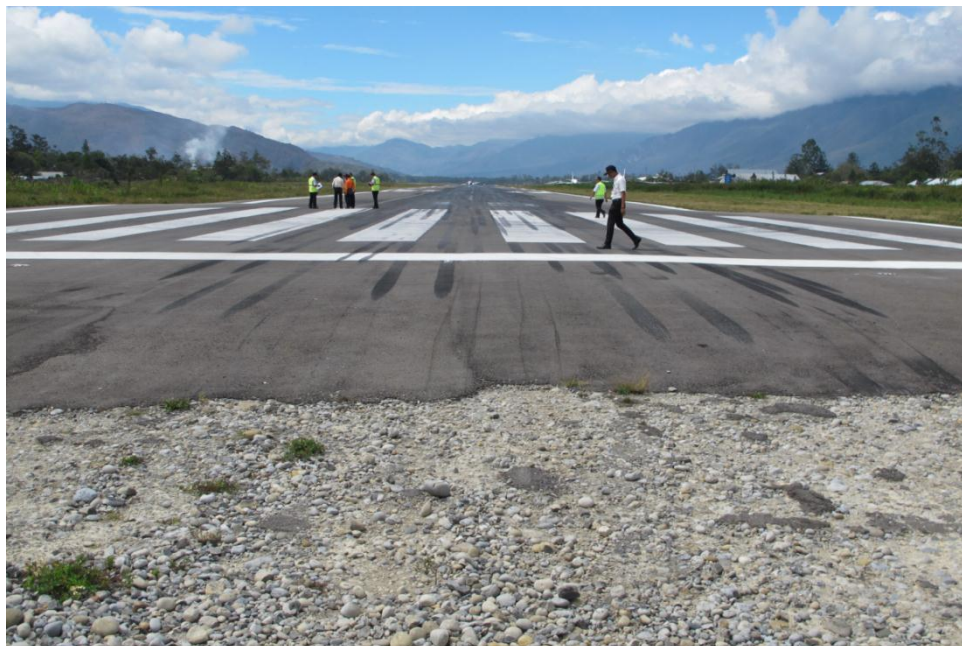
The investigation found several touchdown marks on the pavement before the runway 15.

**Figure 5: Touchdown marks found on the pavement before the runway 15**

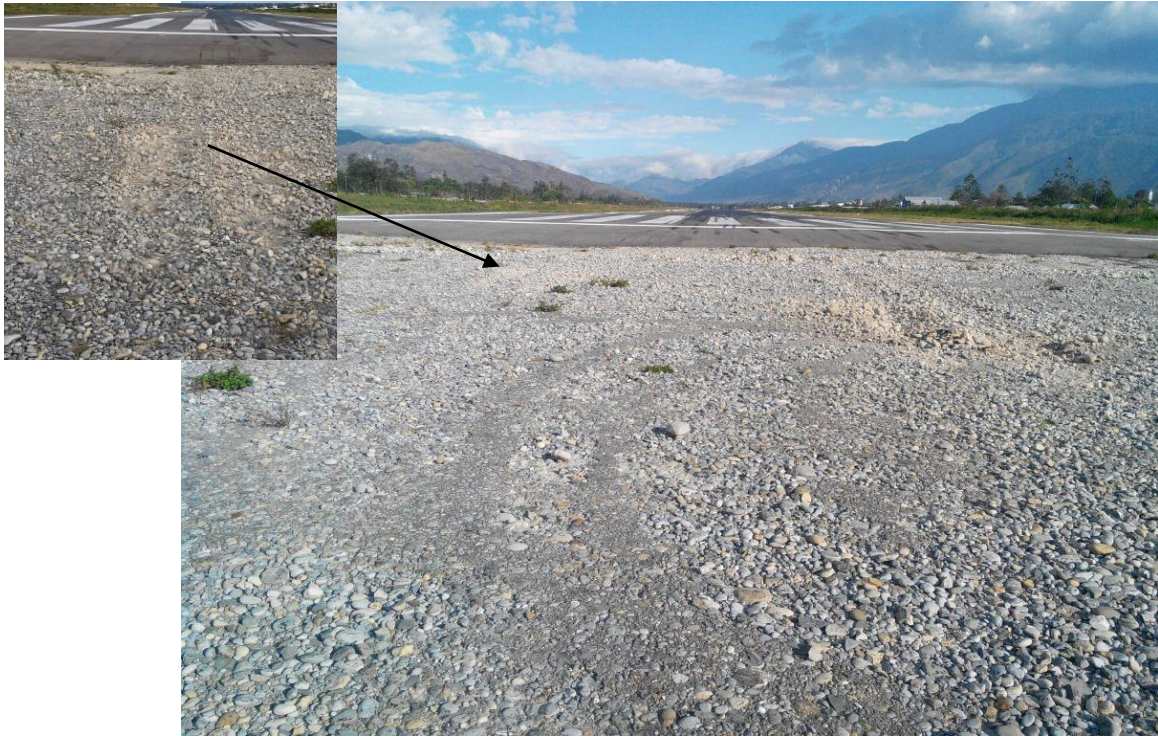
The investigation found touchdown mark before the beginning of the pavement at about 35 meter from threshold runway 15.

**Figure 8: Touchdown mark on the surface before the runway pavement**

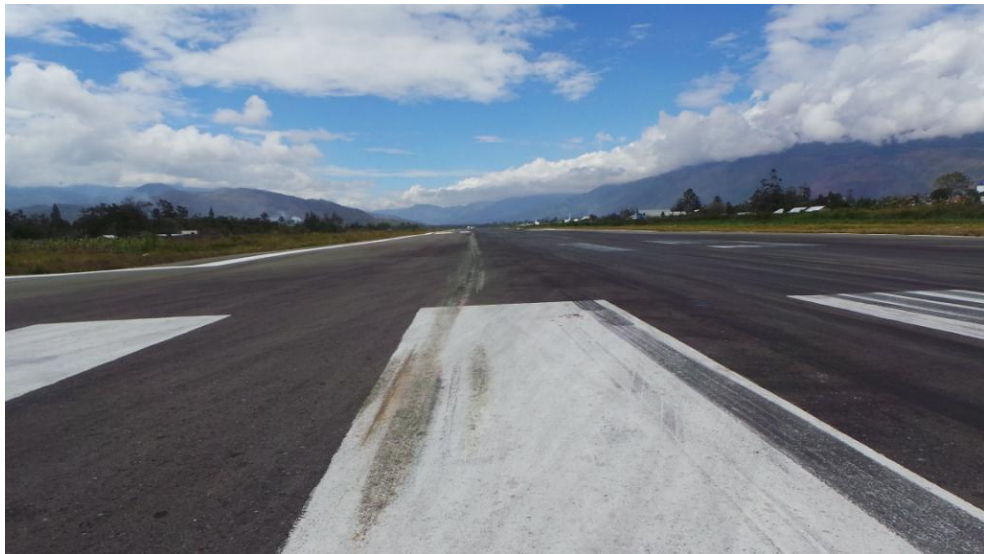
There was a combination of metal and rubber scratch mark started from the threshold until position of aircraft stopped at approximately 1,500 meters from beginning runway 15.

**Figure 9: Metal scratch mark started from the runway threshold until aircraft final position**
