Aircraft Accident Investigation Report

Eurocopter EC130 B4; PK-BKA

Toba Lake, North Sumatera

11 October 2015

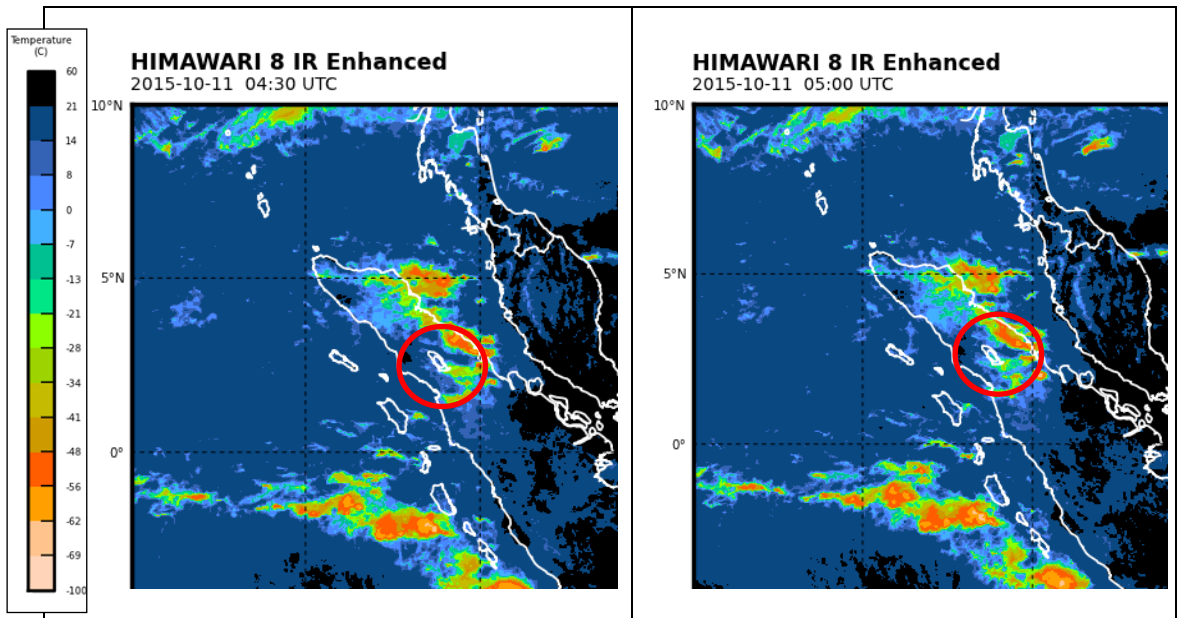
Figure 4: The satellite weather image provided by BMKG

The satellite image issued on 11 October 2015, at 0430 UTC and 0500 UTC by BMKG Kualanamu Meteorological Office showed that there were some cloud formations in the area (figure 4).

The BMKG satellite image shown that at 0500 UTC, the cloud formations moved northerly.

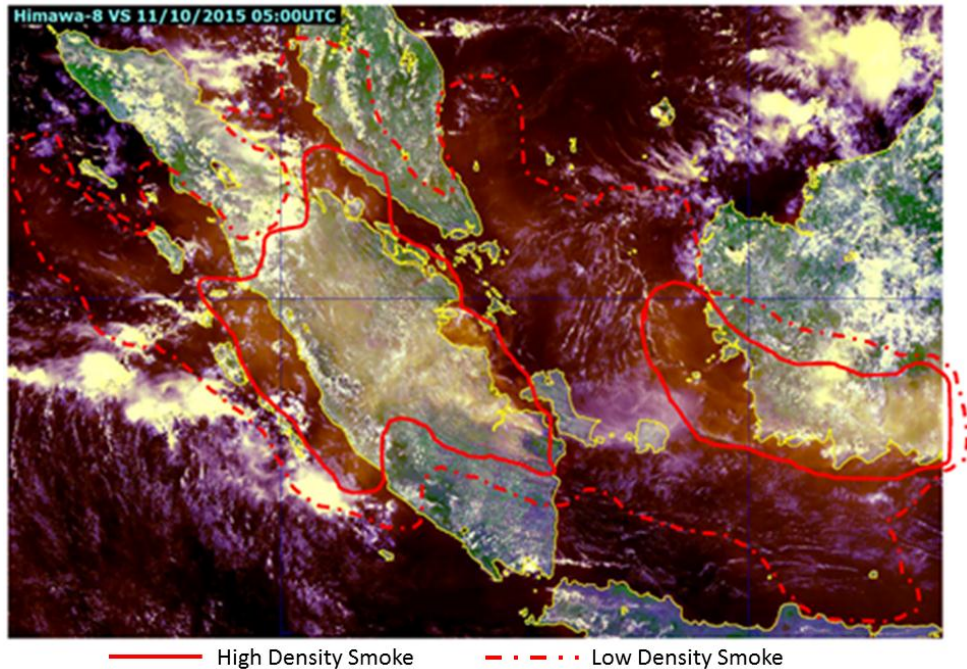
Figure 5: The smoke condition at 0500 UTC on the area provided by BMKG

At the time of the accident, most of Sumatera area, including the route from Siparmahan to Kualanamu was covered by smoke (haze) from the forest fire. The smoke from the forest fire covered almost all area of Sumatera and Kalimantan, the smoke also spread out to Singapore and Malaysia. In some area such as Pekanbaru, Jambi and any other places in Sumatera, the smoke was very dense and the visibility might decrease to 50 meters. The BMKG reported that the smoke over the area was classified as thin smoke.

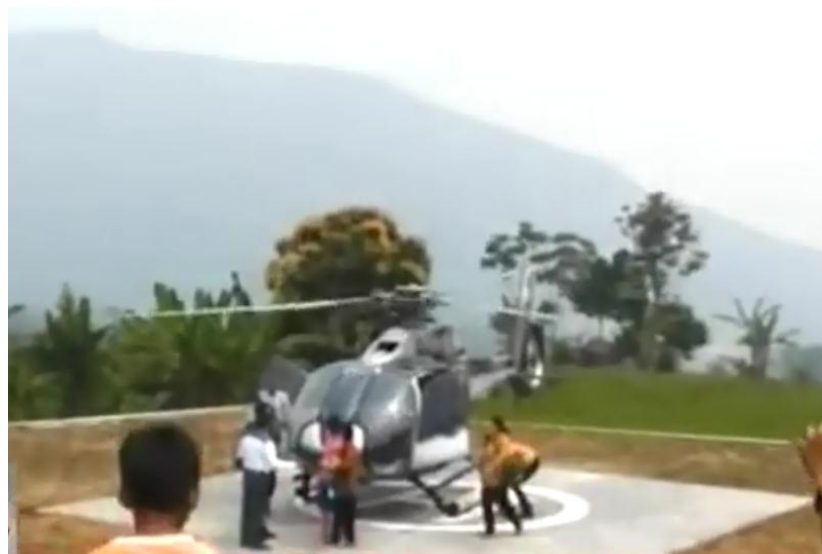
Figure 6: The visibility observed based on the local media video footage at about 30 minutes before take off

According to video footage taken by local media showed that the visibility on the area 30 minutes before take-off was considered clear.

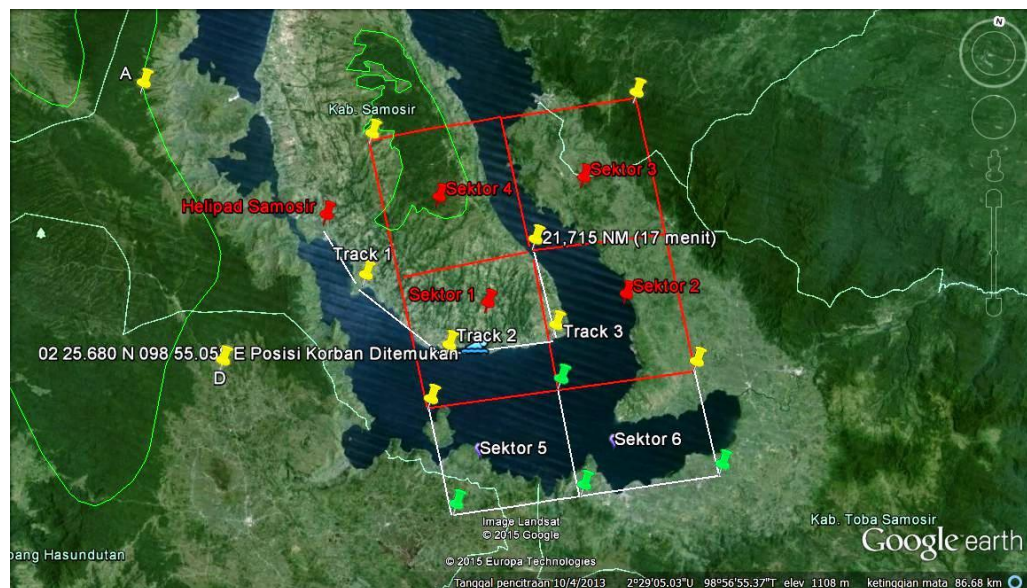
Figure 7: The search area

The KNKT, in cooperation with the Indonesia Navy, conducted a search operation to find the helicopter wreckage using multi beam echo-sounder, sonar detector and submarine profiler. However, the wreckage was not found.
