**KOMITE NASIONAL KESELAMATAN TRANSPORTASI  
REPUBLIC OF INDONESIA**

**Aircraft Accident Investigation Report**

**DHC-6 Twin Otter; PK-BRM**

**2 October 2015**

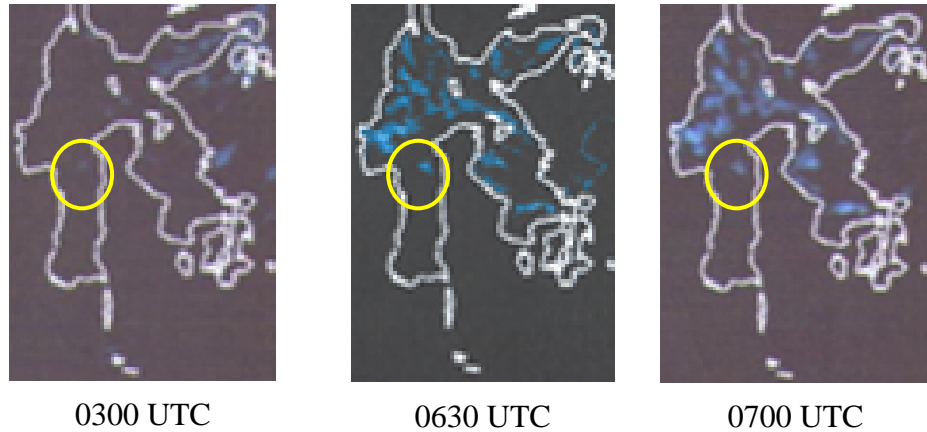
The satellite weather image over the centre of Sulawesi which was provided by BMKG on the day of the accident at 0300 UTC, 0630 UTC and 0700 UTC, and the circles showed the clouds formation at around the crash site (Figure 2).

**Figure 2: Satellite weather images at the accident site (yellow circle)**

The satellite image published by *Badan Meteorology, Klimatology dan Geofisika* (BMKG – Meteorology, Climatology and Geophysics Agency) at 0630 UTC and 0700 UTC, showed partial cloud formation at about 60 Nm from Masamba on the direct track to Makassar around Mount Bajaja and Mount Latimojong.

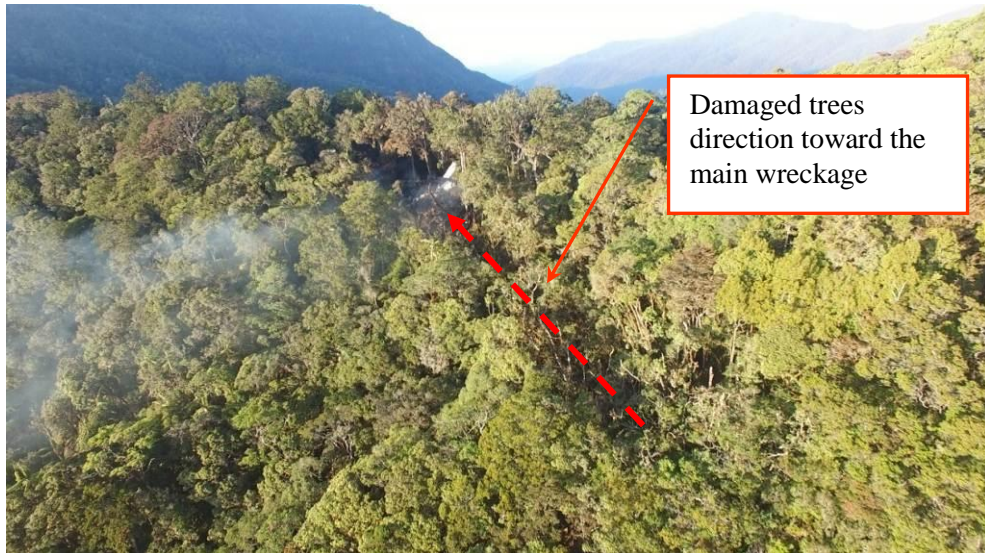
Based on the observation of the accident site area, there were signs of impact marks on several trees starting from about 100 meters from the main wreckage on approximate direction of 200° toward the impact point (Figure 4).

**Figure 4: The collapsed trees shown the aircraft direction**

Prior to the final impact, the aircraft hit several tree tops and resulted in a clean cut on the trees along the flight direction for approximately 100 meters on a heading of approximately 200°. These typical of clean cut were caused by a high speed impact. The cuts on the trees were level indicating that the aircraft was in straight and level flight.

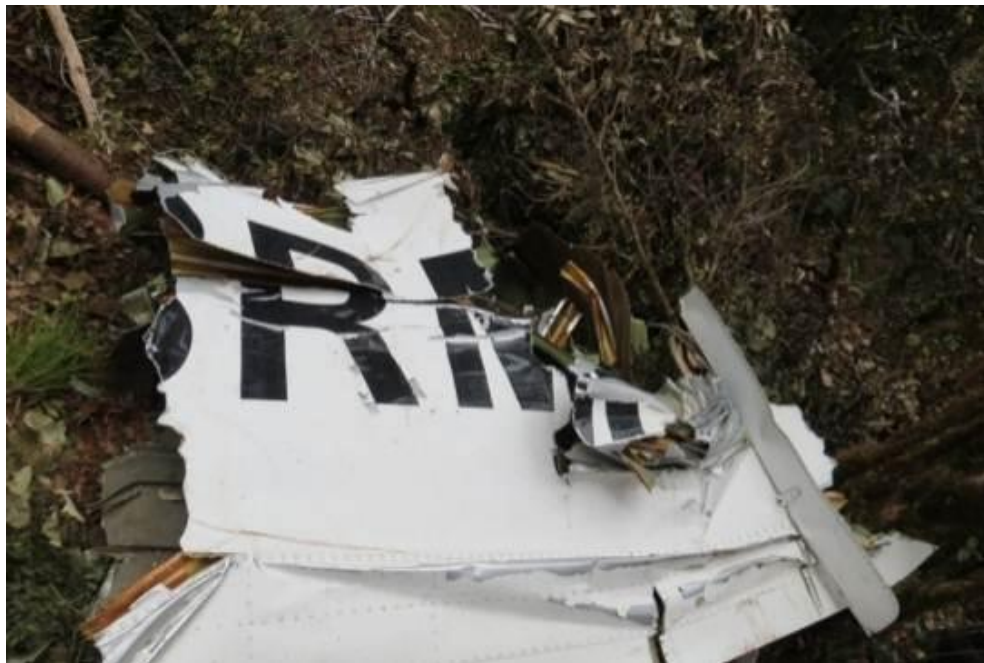
**Figure 5: Part of the right wing found approximately 100 meters from the main wreckage**

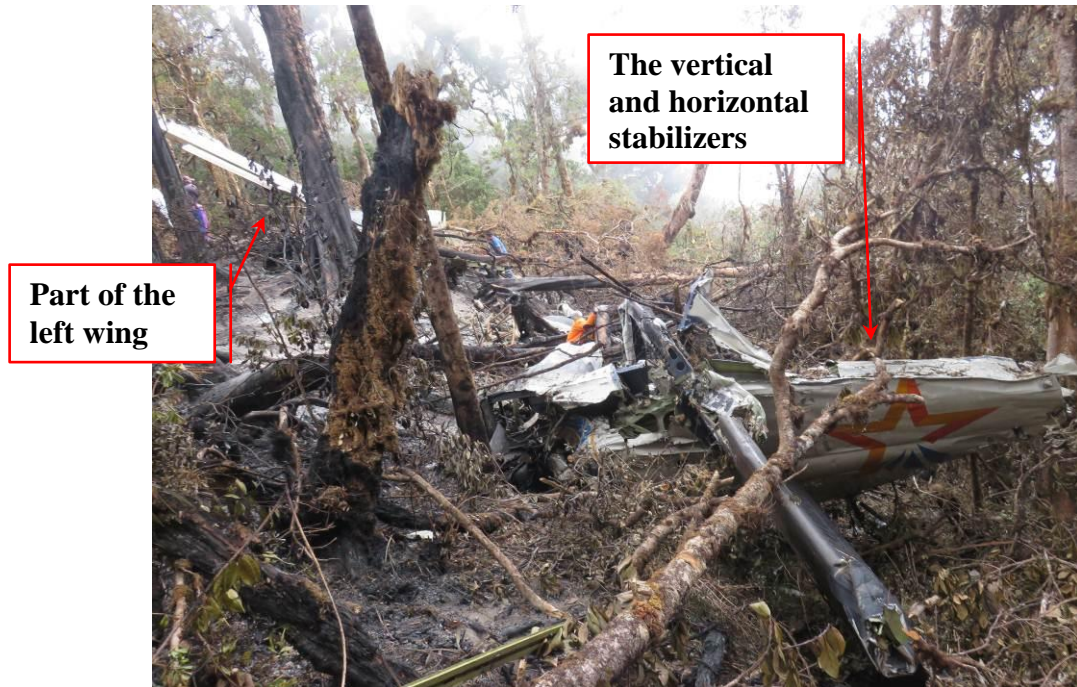
The aircraft wreckage was found on top of Bajaja Mount, Dusun Gamaru, Desa Ulusalu, Kabupaten Luwu, South Sulawesi on the coordinate of 3° 25' 52.80" S, 120° 4' 12.10" E at elevation of approximately 7,734 feet Above Mean Sea Level (AMSL).

**Figure 6: Main wreckage and the distribution of aircraft part**

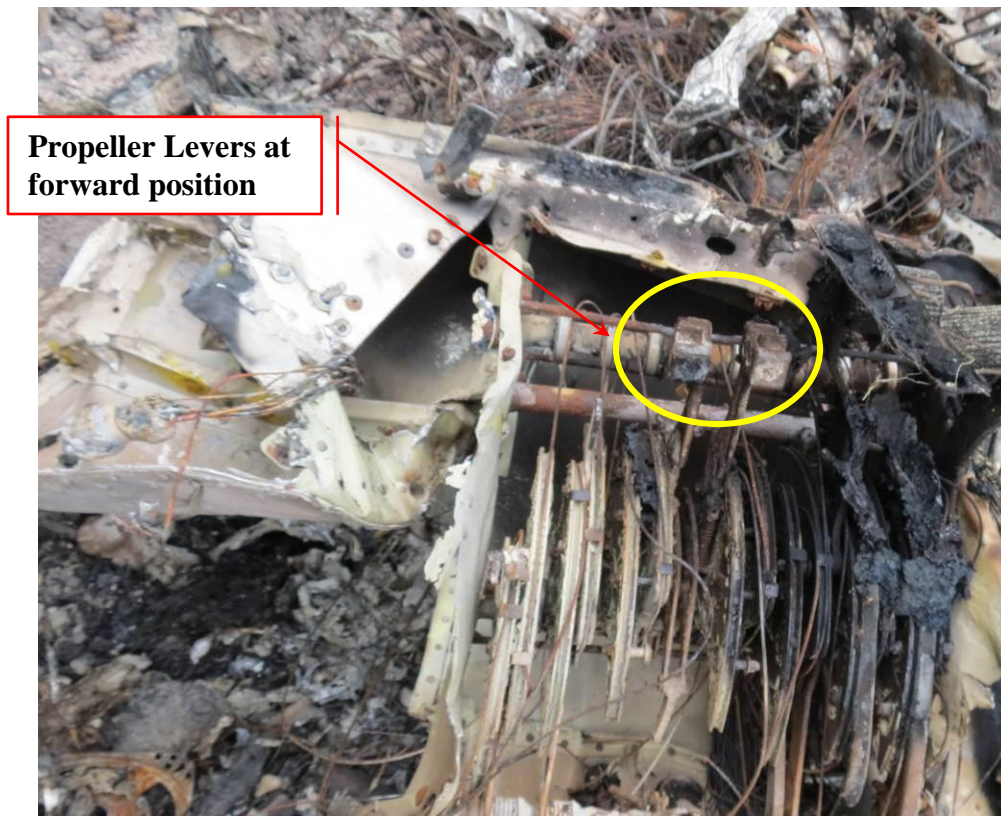
**Figure 7: The power console (upside down) showed propeller lever position and the throttle levers were missing**

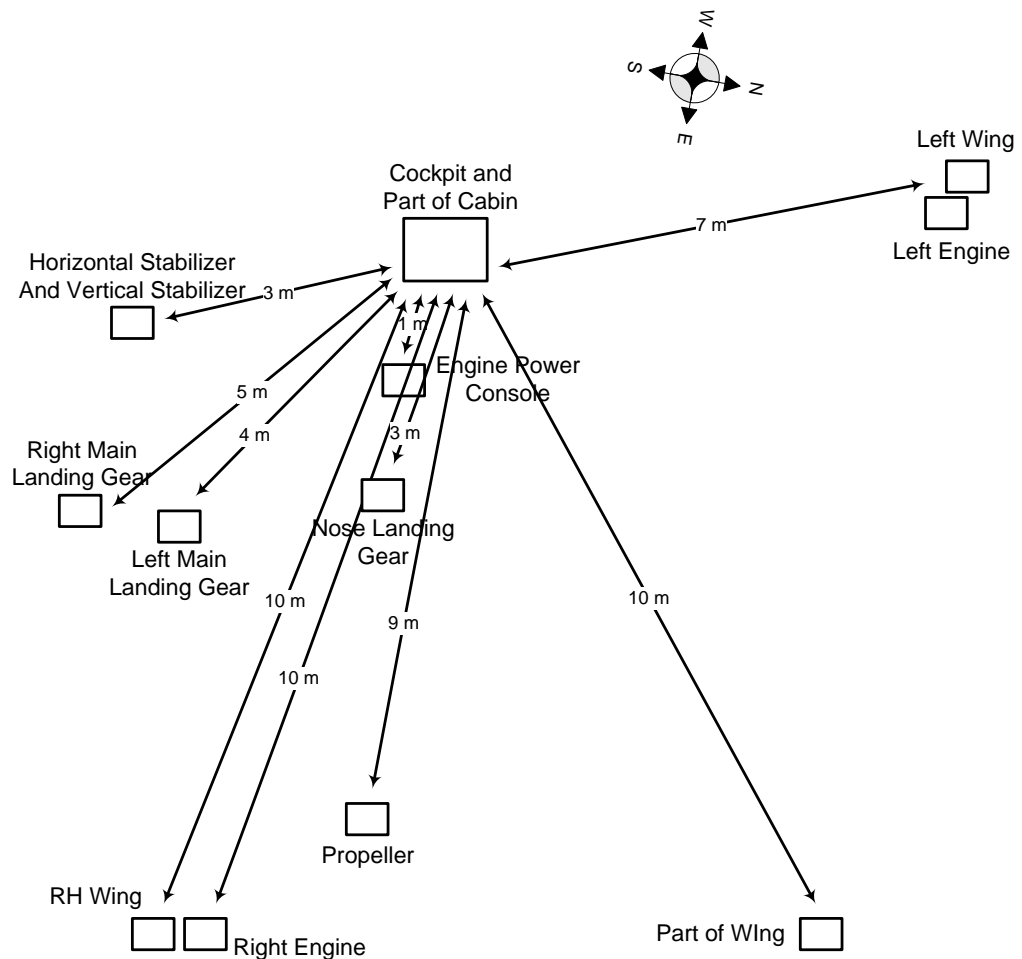
**Figure 8: The illustration of the wreckage distribution diagram**

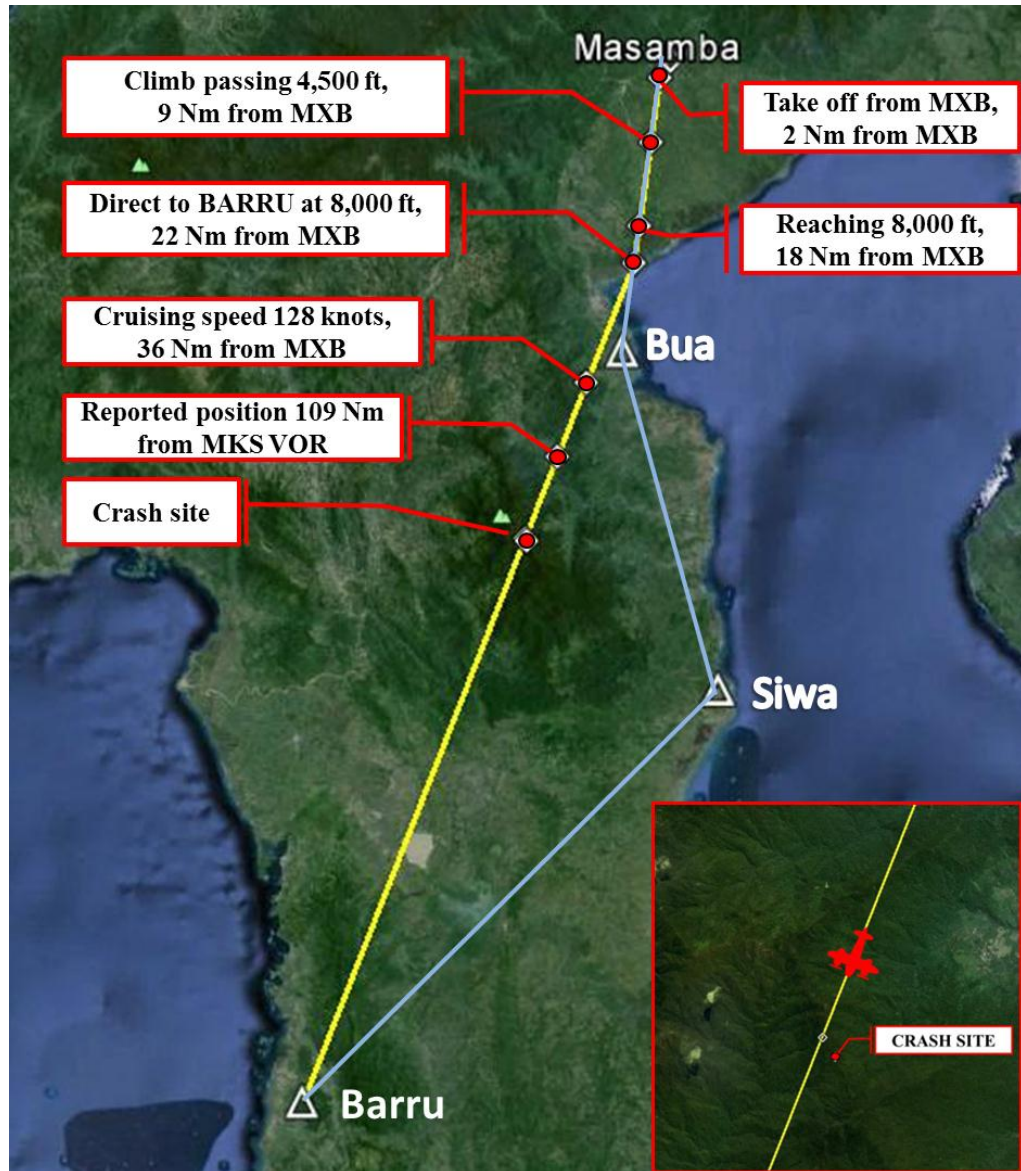
**Figure 13: Predicted flight track superimposed to Google Earth**

The predicted flight route profile shown that the aircraft flew on heading 200° toward the area with high terrain and cloud formation based on the BMKG satellite image.
