**KOMITE NASIONAL KESELAMATAN TRANSPORTASI
REPUBLIC OF INDONESIA**

Aircraft Accident Investigation Report

PT. Hevilift Aviation Indonesia

Sikorsky S-76C+; PK-FUP

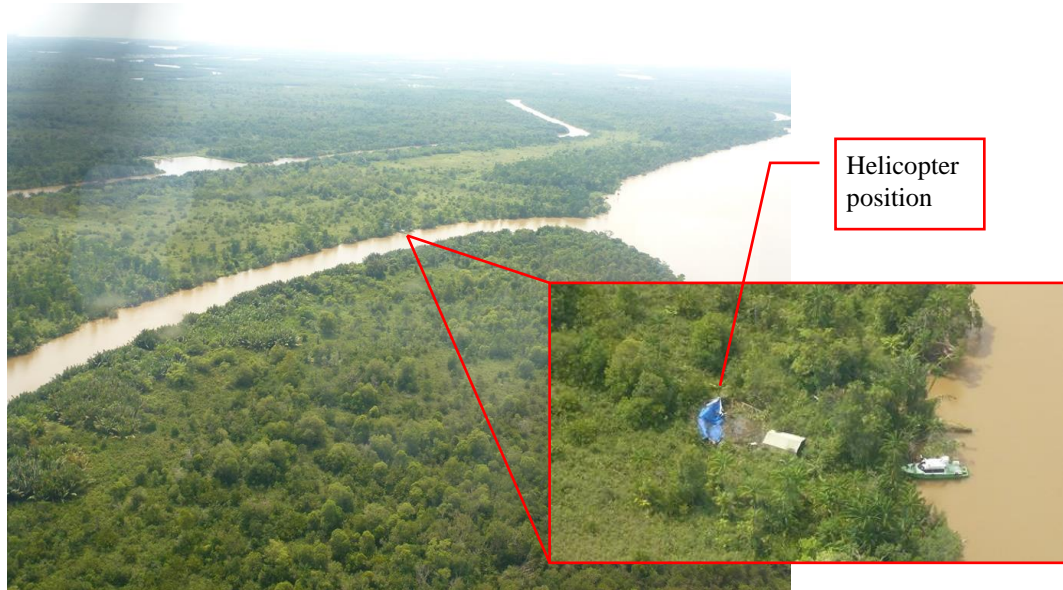
Figure 13: Aerial view of helicopter at crash site

The helicopter was found at coordinates 0°39'22.76" S, 117°20'39.75" E approximately 50 meters from Mahakam River.

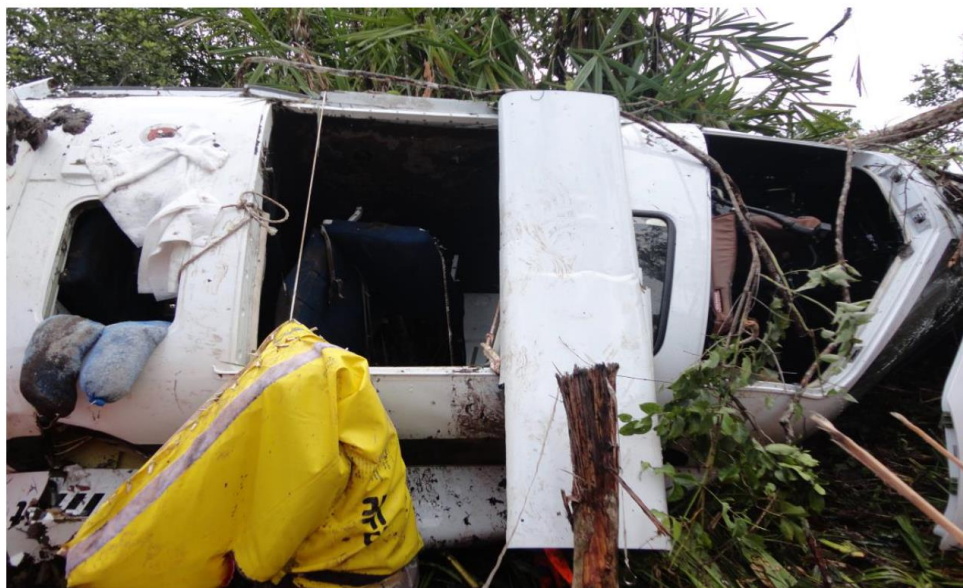
Figure 14: Main fuselage with the cockpit upside down position

Prior to impact, the helicopter hit several treetops. Some trees were cut and collapsed due to impact by the main rotor blades. The tail boom broke and the tail rotor detached. The helicopter stopped in position and tumbled to the left side and up-side down.

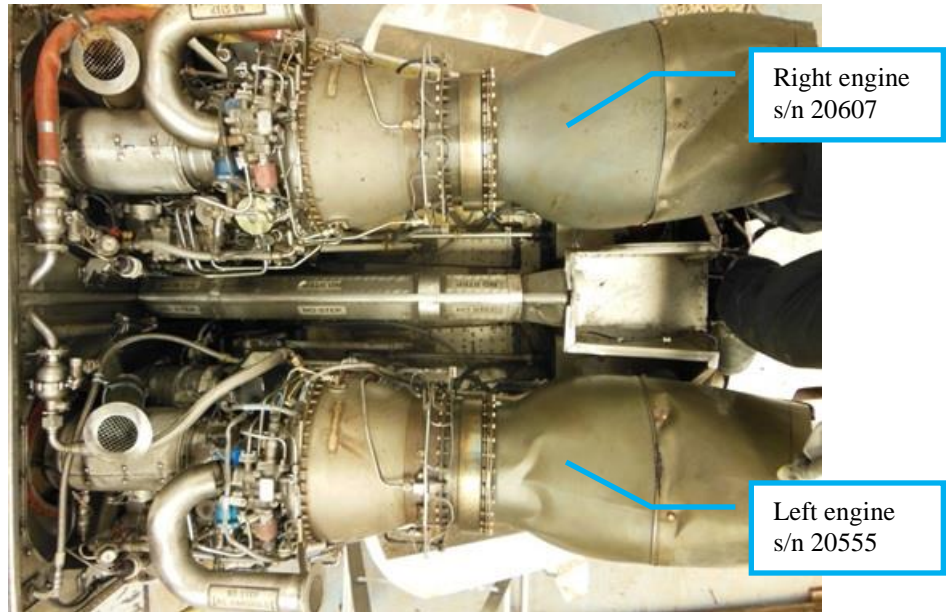
Figure 18: Both engines still intact as recovered

The helicopter wreckage recovered to a hangar in Balikpapan for examination. The engines were found intact.

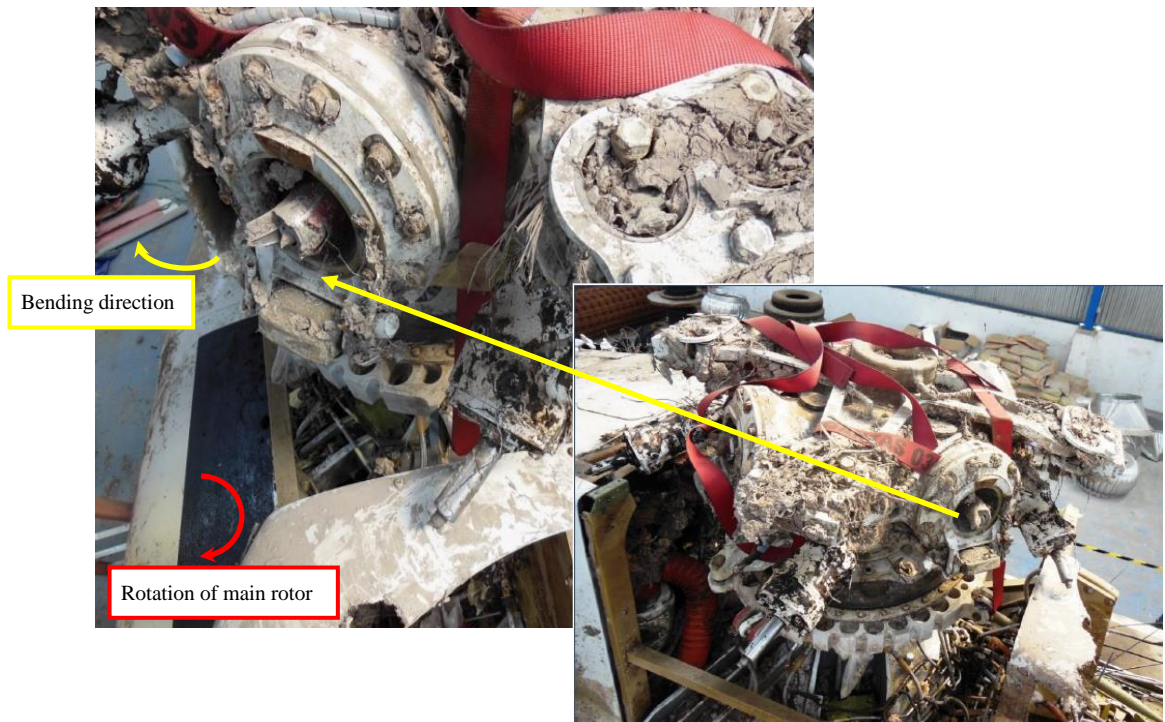
Figure 19: Rotor head

The rotor head showed damage in the direction of rotation indicative of power at the time of impact.

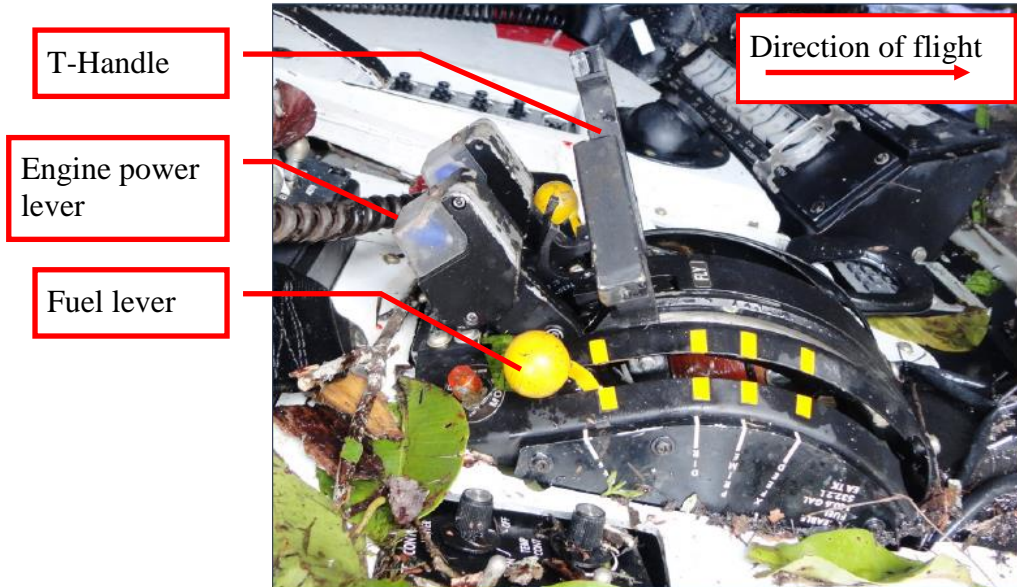
Figure 20: Power lever condition found on the accident site

The power lever was recovered as during the wreckage examination on the site of the accident. The fuel levers were in the OFF position, the power levers were in backward position and the shut-off T-Handles were in the activated position (pulled back). This information corroborates the pilots report that they shut-down the engines after the accident by pulling all the levers back.

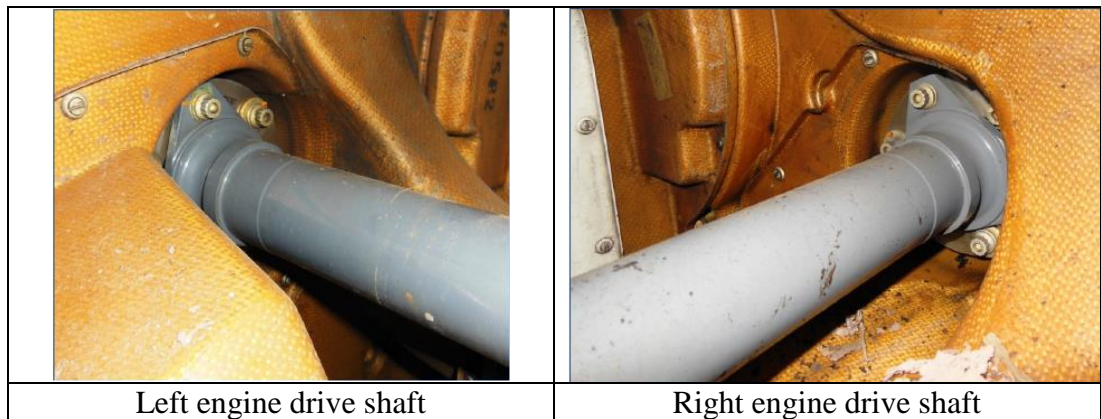
Figure 21: Engine drive shaft observation.

The drive shafts were in place on both sides with no signs of misalignment, damage or deterioration.

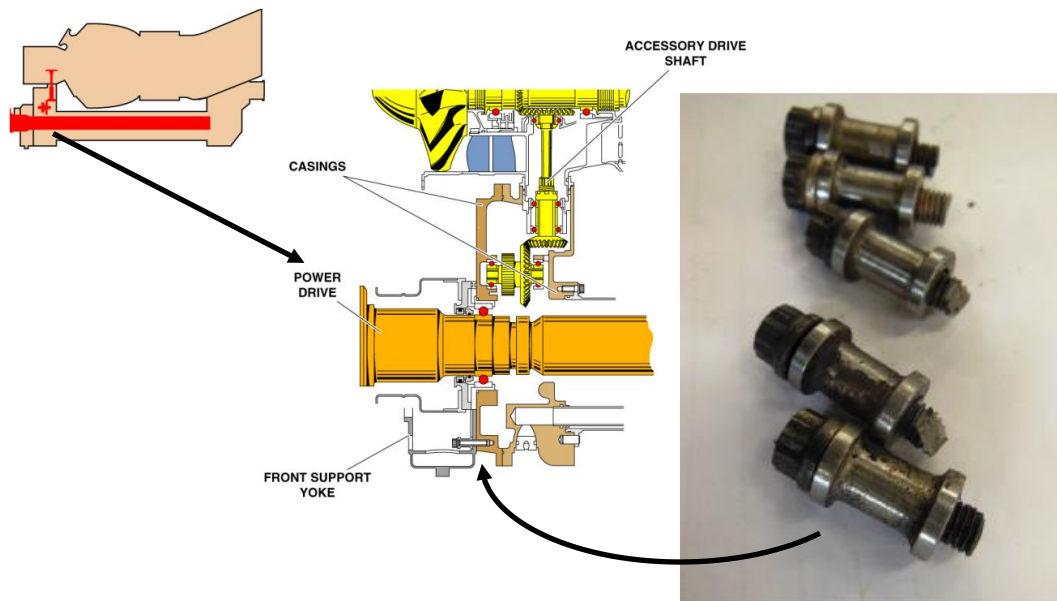
Figure 24: Five shear bolts recovered at engine bay.

The accessories gearbox front casing exhibited some play with respect with the front support and five fixing screws (out of 11) were sheared and they were found on the engine bay floor along with their associated dowels thus indicating excessive lateral or vertical load at the time of impact.

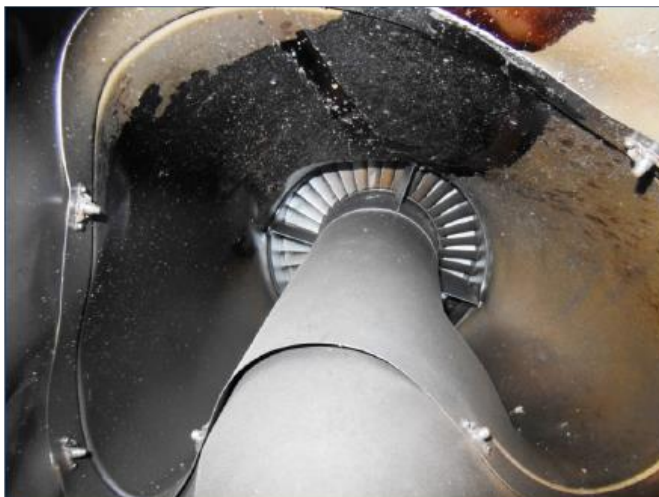
Figure 25: Left engine exhaust condition

The exhaust pipe was locally bent and distorted either as a consequence of the accident or of the salvage operation. An area in the exhaust's upper inner surface was covered with coked oil. This area was the low point when the engine was upside-down after the accident thus indicating that oil dripped from the bearing casings and into the main air path and exhaust and was consumed by the high heat that prevailed in the area shortly after engine shut-down.

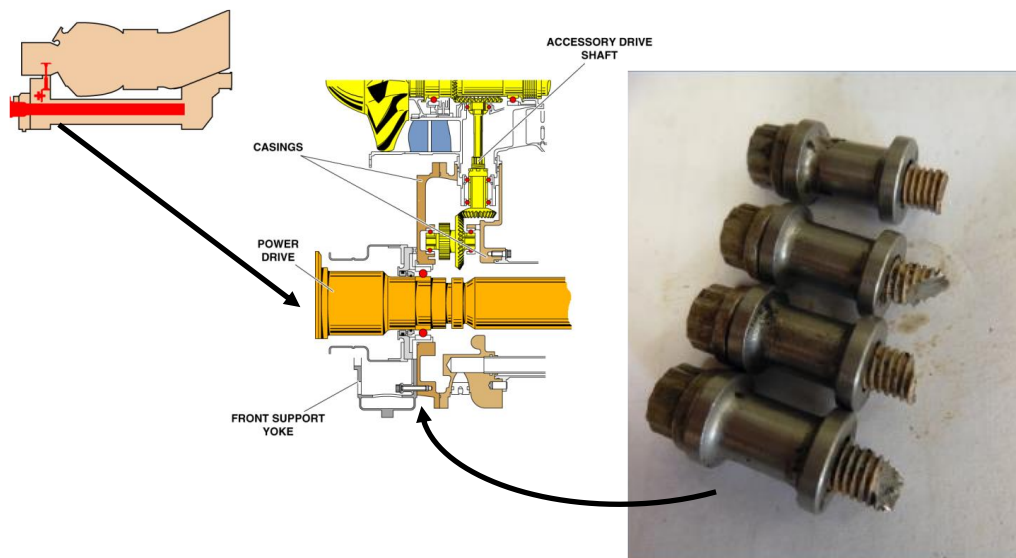
Figure 27: Four shear bolts recovered at engine bay.

The accessories gearbox's front casing exhibited some play with respect with the front support and four fixing screws (out of 11) were sheared and they were found on the engine bay floor along with their associated dowels thus indicating excessive lateral or vertical load at the time of impact.

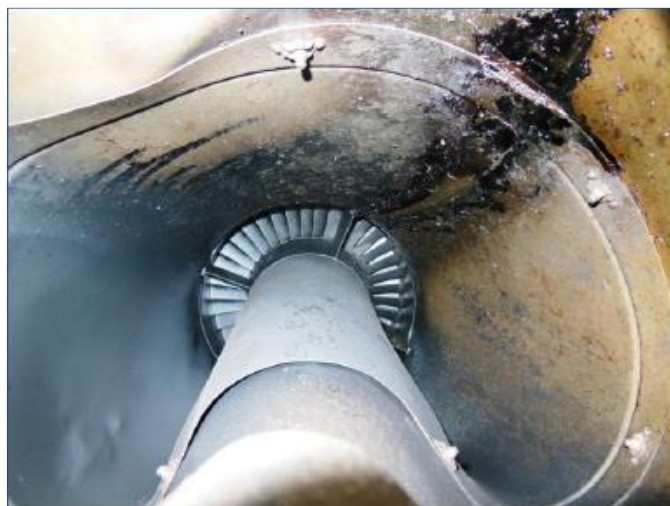
Figure 28: Right engine exhaust condition

The exhaust pipe was locally bent and distorted either as a consequence of the accident or of the salvage operation. An area in the exhaust upper inner surface was covered with coked oil. This area was the low point when the engine was upside-down after the accident thus indicating that oil dripped from the bearing casings and into the main air path and exhaust and was consumed by the high heat that prevailed in the area shortly after engine shut-down.

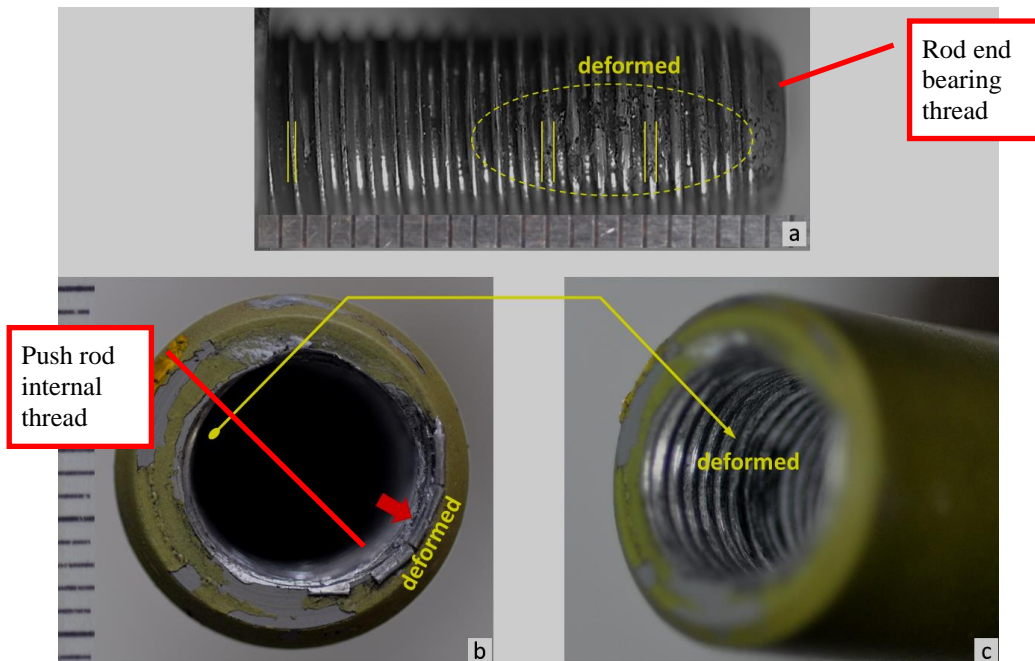
Figure 32: Deformation on the push rod and rod end bearing thread

Visual inspection on the push rod found that the internal thread of the forward push rod and the rod end bearing thread were deformed as shown in the figure below.

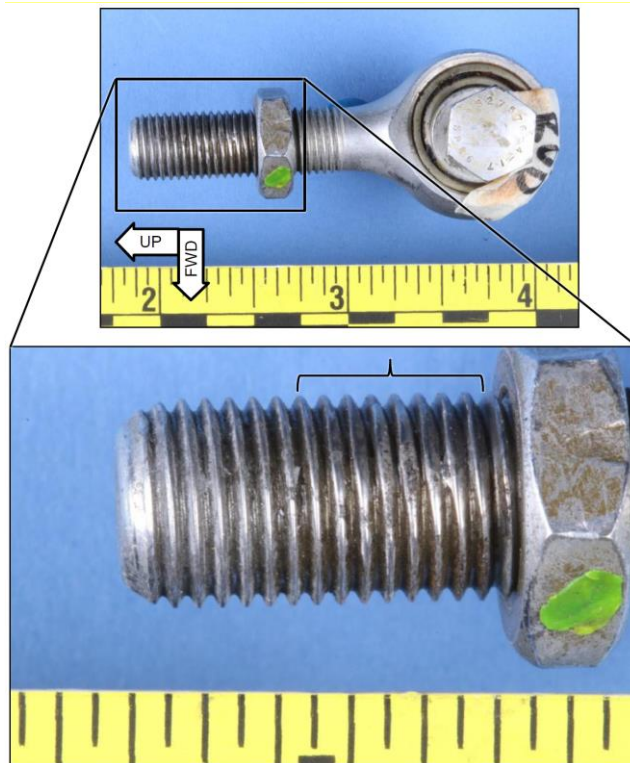
Figure 35: The deformation rod of end bearing (forward push rod)

In the worn area (area that contacted with push rod or jam nut) at the upper end, the diameter of rod end measured 0.3713 inch forward to aft, and 0.3682 inches inboard to outboard. The rod end bearing exemplar of new forward push rod assembly had diameters ranging from 0.3709 inch to 0.3717 inch with an average of 0.3713 inch as measured at multiple locations along the shank. The worn area of the rod end bearing thread is shown in the figure below.

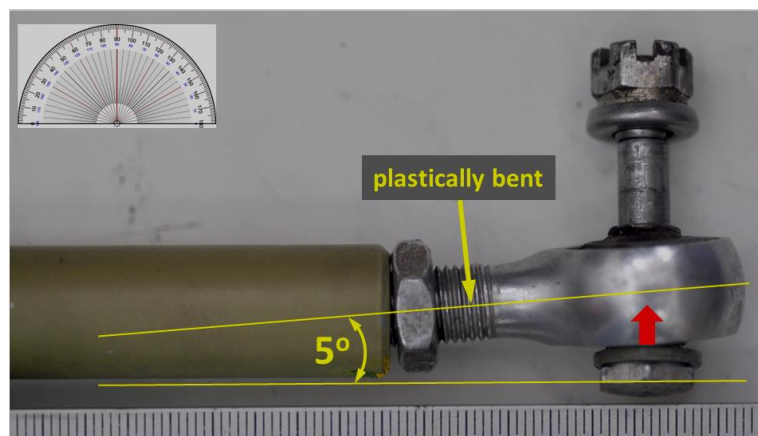
Figure 36: Illustrated bend measurement of the rod end bearing with the push rod

The examination reconnected the rod end bearing to the push rod and found that rod end bearing bent with an angle approximately of 5°. This indicated that the push rod experienced transverse load in the direction as shown with red arrows in figure below.

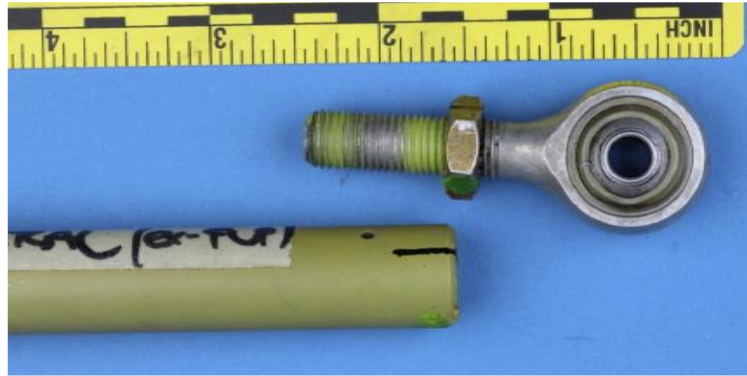
Figure 42: Rod end bearing was unscrewed from the push rod assembly

The inspection hole in the push rod was blocked consistent with sufficient rod end bearing thread engagement. Approximately 2 or 3 threads were exposed on the rod end bearing shank below the jam nut. The bearing inner race on the rod end bearing was received contacting the bearing grease shield, and the grease shield was bent on both sides of the bearing in the corresponding contact areas.

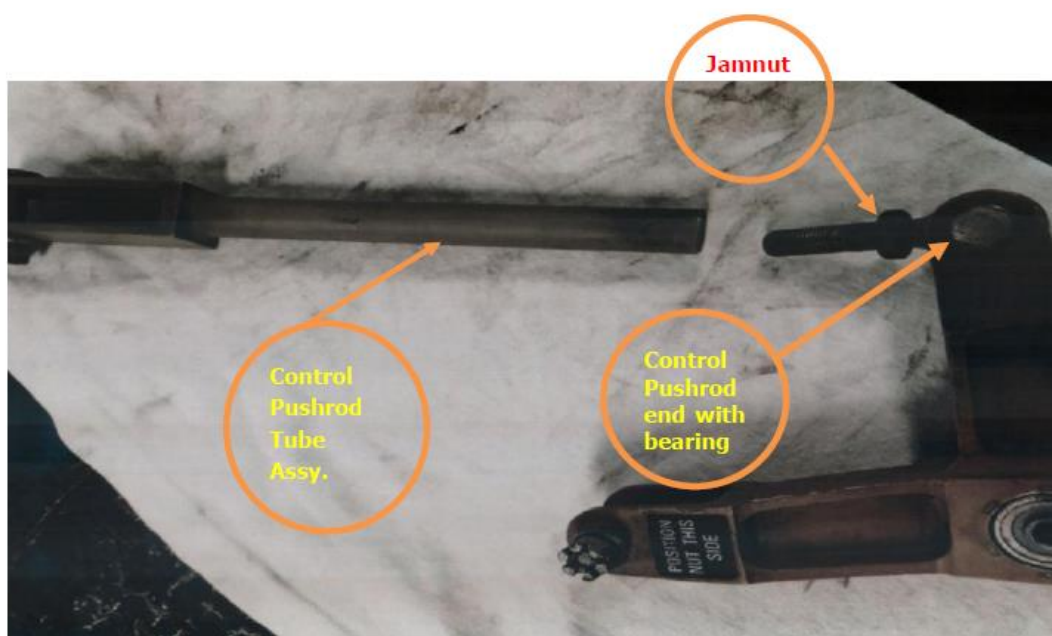
Figure 50: The rod end bearing was separated from the push rod

The investigation determined the contributing factor was the helicopter un-commanded attitude caused by loosening of the jam nut on the forward rod end bearing which subsequently separated from the push rod, resulted in the un-commanded servo movement.
