**KOMITE NASIONAL KESELAMATAN TRANSPORTASI
REPUBLIC OF INDONESIA**

FINAL
KNKT.15.08.18.04

Aircraft Accident Investigation Report

Airbus 330-200; PK-GPO

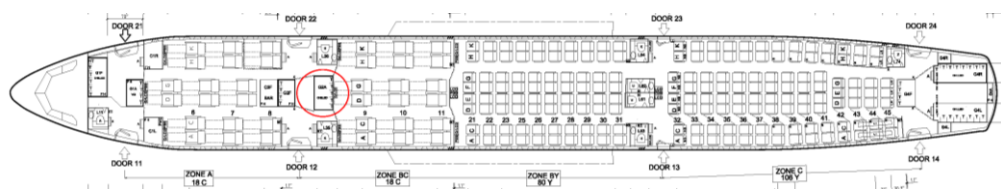
Figure 2: The location of the blown out refrigeration unit door

At about 0700 UTC, or approximately 3 minutes after the dry ice was inserted into the refrigeration unit, the unit door burst. The refrigeration unit door was thrown towards and hit the face of one of the Flight Attendant (FA) who was standing in the galley (Figure 2). The FA fell down onto the floor with a bleeding face and remained conscious. The injured FA was assisted by a passenger and another FA to be seated on a passenger seat.

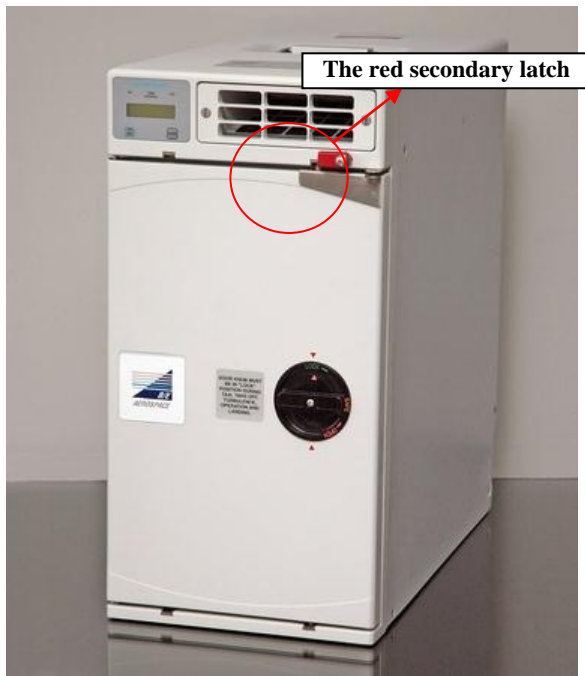
Figure 4: The refrigeration unit

The door was fitted with a red secondary latch should be put in the LOCK position during take-off and landing (Figure 4). The door was also fitted with a pressure relief valve, which would open to relieve pressure differences between the inside and outside of the unit.

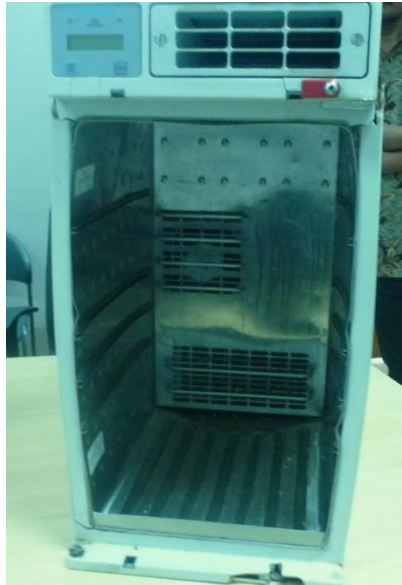
Figure 7: Bulging on the refrigeration unit

- The refrigeration unit door detached and bent in a U shape;
- The refrigeration unit compartment bulged outwards (Figures 7 and 8).

The damage showed that the door was severely deformed and thrown towards. The refrigeration unit walls were bulged, indicating that the damage was caused by a build-up of pressure from inside the unit.

8. The PIC did not declare the event to the ATS either by urgency or emergency message as required by the operators BOM.
9. The observation of the damage showed that the door folded and the bulging on the refrigeration unit indicated that the damaged was caused by the significant build-up of pressure inside the refrigeration unit.

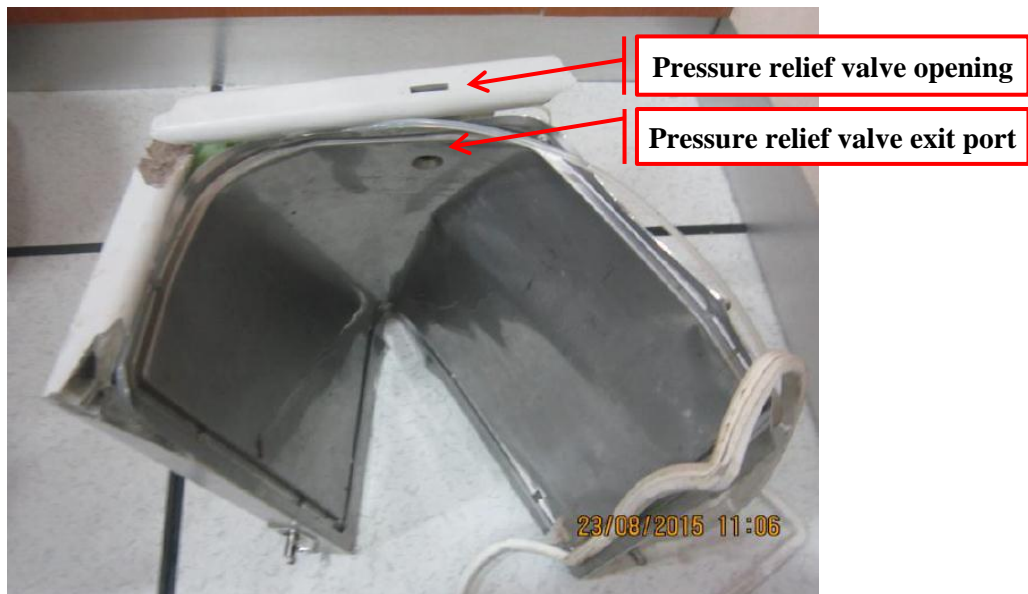
Figure 8: The deformation of the separated door (note: the time stamp was the camera time and was not set correctly)

A safety relief valve was fitted in the refrigeration unit door to relieve pressure differences between the inside of the compartment and external pressure. However, if the pressure build-up was too rapid, the safety relief valve would not have the capacity to relieve the pressure and a pressure build up would occur within the compartment to the point of failure of the compartment door. The investigation was unable to establish the peak pressure obtained within the compartment that leads to the door failure.
