**KOMITE NASIONAL KESELAMATAN TRANSPORTASI
REPUBLIC OF INDONESIA**

KNKT.15.08.16.04

Aircraft Accident Investigation Report

PAC-750XL; PK-KIG

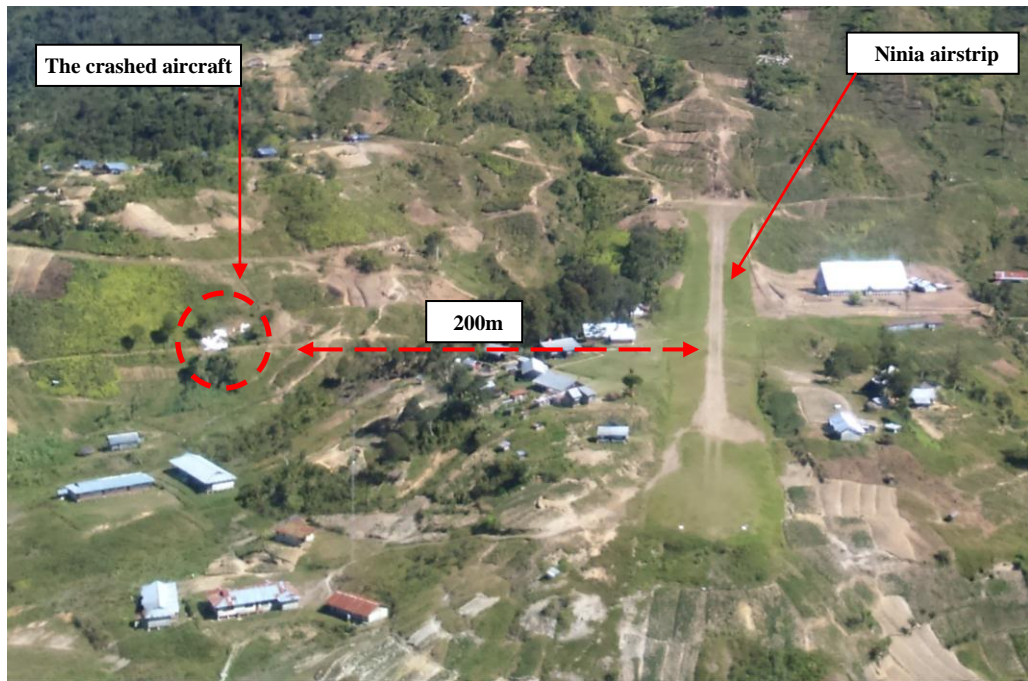
Figure 4: The accident site and Ninia Airstrip

The crash site of the aircraft was about 6,800 feet above mean sea level and 200 meters south-west of the runway, which having a slope angle of approximate 45°. The aircraft last position was on heading of approximately 120°.

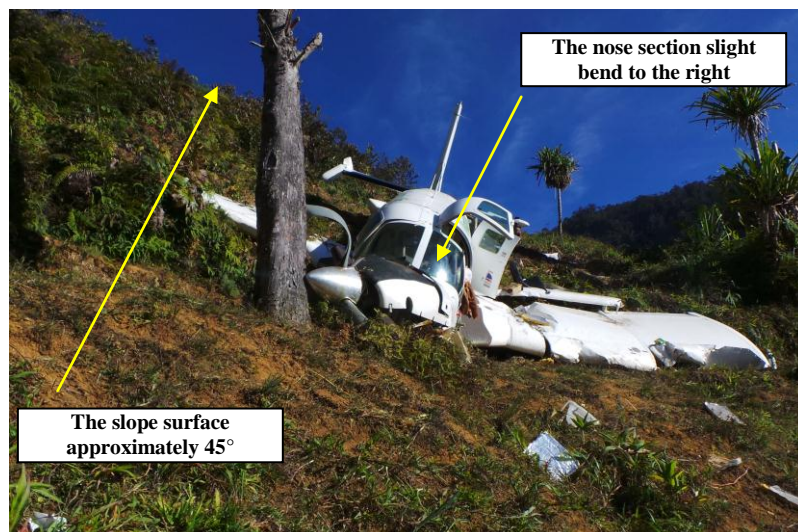
Figure 5: The main wreckage

- The outer right wing detached and was found behind the main wreckage;
- The flap was on position of approximately 20°;
- Flap selector was on full up;
- Power lever and propeller lever were on full forward position;
- Fuel condition lever was on flight / high idle.

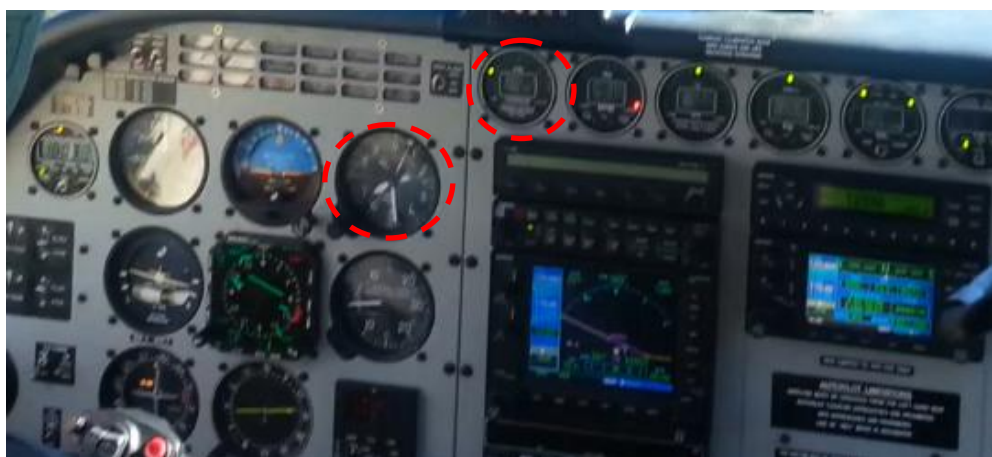
Figure 7: Indications of the instrument panel at 23:03:15 UTC

On the beginning of recording at 23:03:15 UTC showed: the torque indicator analog reading displayed a green light, the digital form displayed 25 psi, the altimeter displayed 6,500 feet.

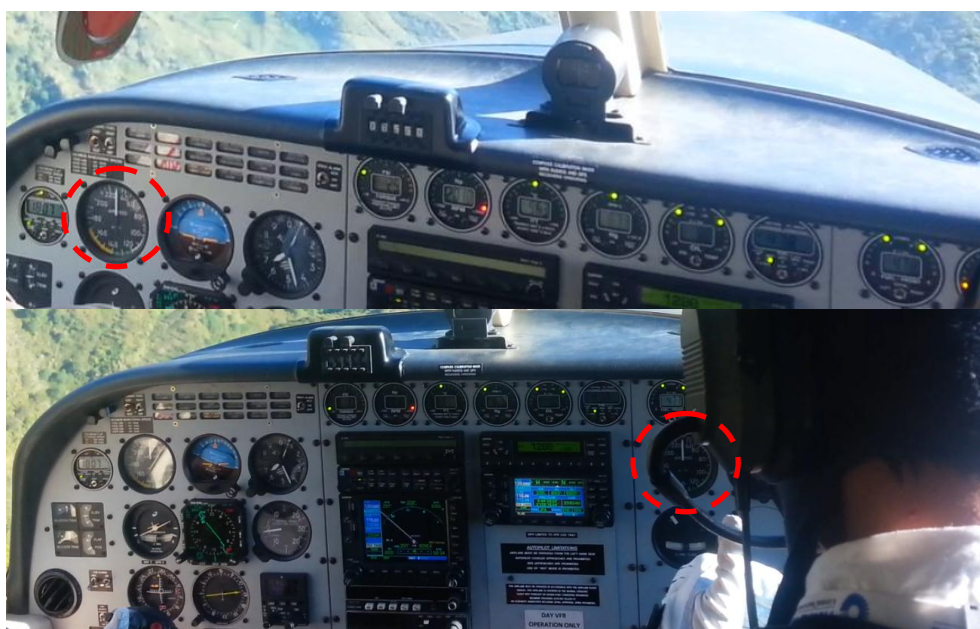
Figure 8: The airspeed indicators indicated zero

The airspeed indicators were first clearly seen at 23:03:27 UTC for the pilot side and at 23:03:41 UTC for the right side. Both airspeed indicators showed zero at that time. The video did not record any change of airspeed indication up to the impact.

The FAA Pilot's Handbook of Aeronautical Knowledge 2008, described that the airspeed indicator reading decreases to zero, as a result, the airspeed indicator senses no difference between ram and static air pressure, this is caused by blocked pitot system, which can be completely or only partially blocked. The indication of zero airspeed on the accident flight might have been because of a blocked pitot system.

Concerning to the loss of airspeed indicator of this accident flight, KNKT recommends DGCA to provide a regulation which requires pilot to be trained for flight with unreliable airspeed.

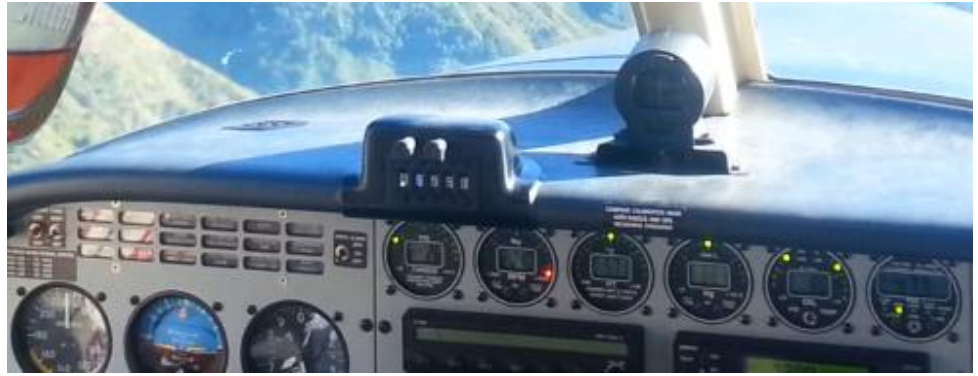
Figure 9: Indications of the instrument panel at 23:03:28 UTC

At 23:03:28 UTC, the video recorded: aural stall warning was recorded for 1 second, the torque indicator analog reading displayed a green light, digital form displayed 25 psi, and the altimeter indicated 6,500 feet.

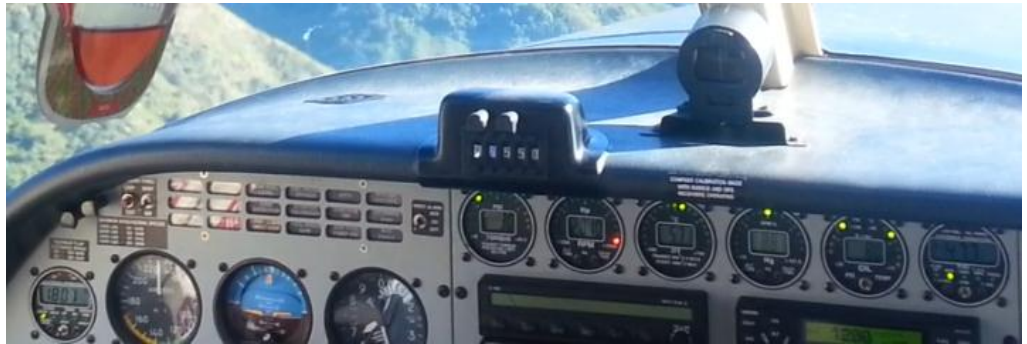
Figure 10: The instrument panel indicators at 23:03:30 UTC

At 23:03:30 UTC, the video recorded: aural stall warning was heard for 2 seconds, the torque indicator analog reading displayed a green light, and digital form displayed 30 psi.

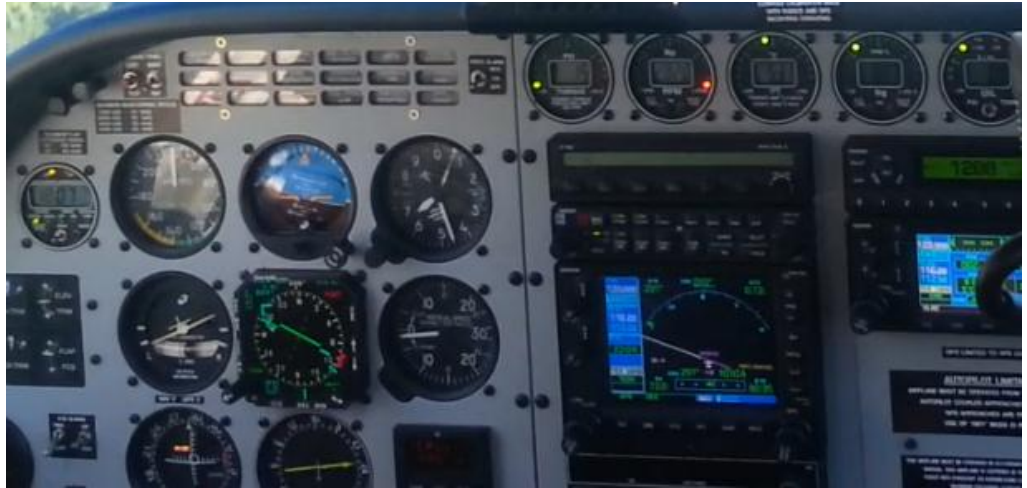
Figure 11: The instrument panel indicators at 23:03:35 UTC

At 23:03:35 UTC, the video recorded: the aural stall warning was heard for 2 seconds, the aircraft rolled to the left, the torque indicator analog reading displayed a green light.

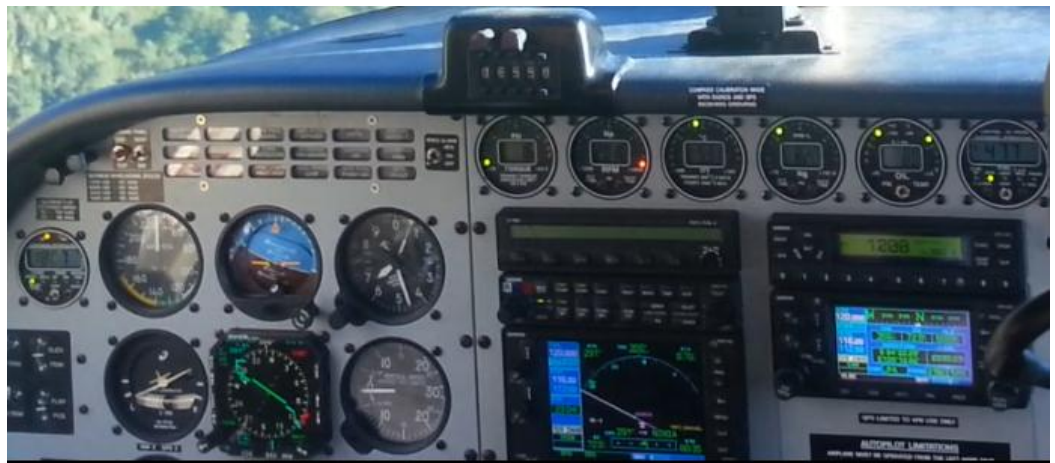
Figure 12: The instrument panel indicators at 23:03:38 UTC

At 23:03:38 UTC, the video recorded: the aural stall warning was heard continuously, the torque indicator analog reading displayed a green light, and digital form displayed 15 psi.

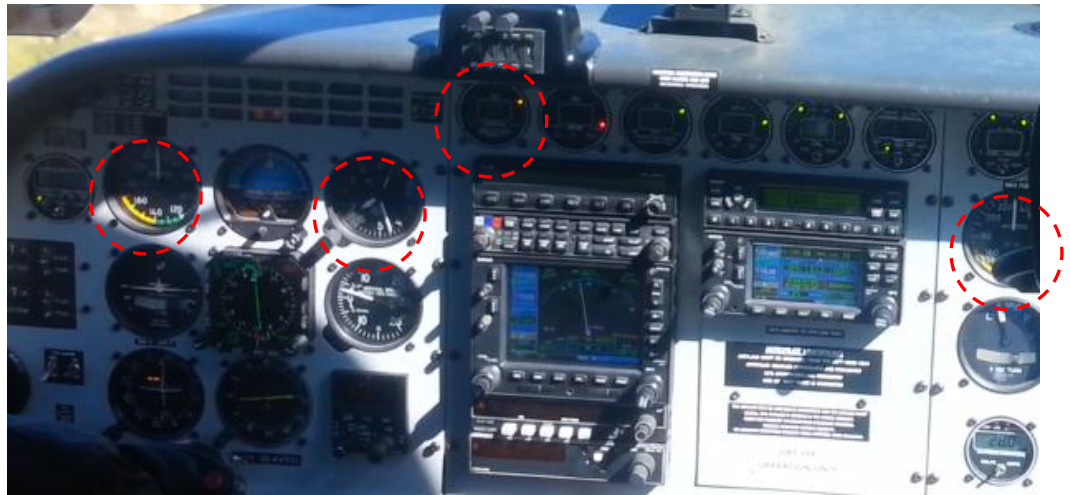
Figure 13: The instrument panel indicators at 23:04:04 UTC

At 23:04:04 UTC, the video recorded: the torque indicator analog reading displayed a yellow light, both air speed indicators at zero and the altimeter indicated 6,500 feet.

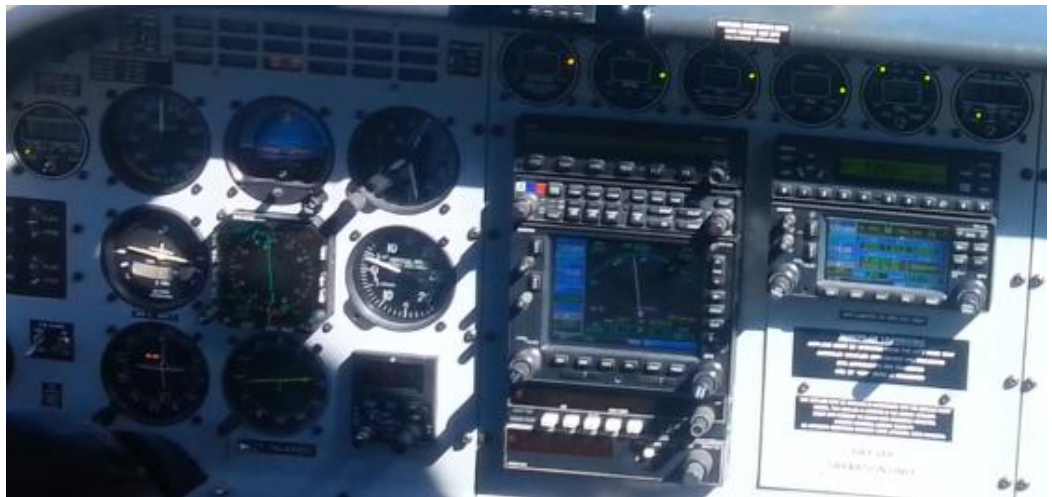
Figure 14: The instrument panel indicators at 23:04:07 UTC

At 23:04:07 UTC was the last time of the flight instrument panel indicator recorded, the torque analog indicator displayed yellow light.

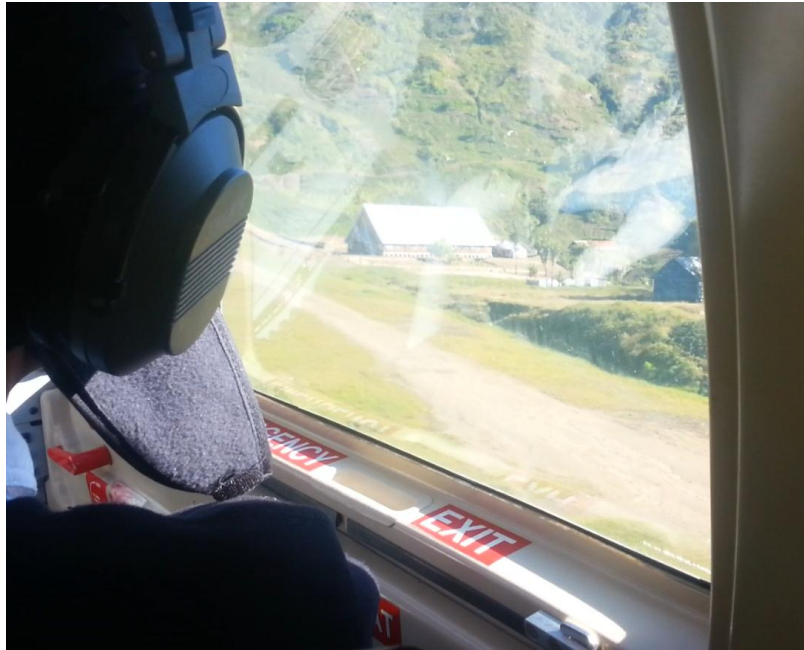
Figure 15: The aircraft flew parallel runway 30 at 23:04:13 UTC

At 23:04:13 UTC, the aircraft flew on the left side parallel to the runway 30, thereafter climbed and rolled to the left.

The action of increasing engine torque, climb and turn indicated that the pilot intended to escape from the area. This maneuver was not suitable on that aircraft position and environment condition. The bank angle increases the stalling speed. Maneuver at low speed and high bank angle resulted in the aircraft stall.
