**KOMITE NASIONAL KESELAMATAN TRANSPORTASI
REPUBLIC OF INDONESIA**

Aircraft Serious Incident Investigation Report

Liberty XL2; PK-LLA

Selaparang Airport, Lombok

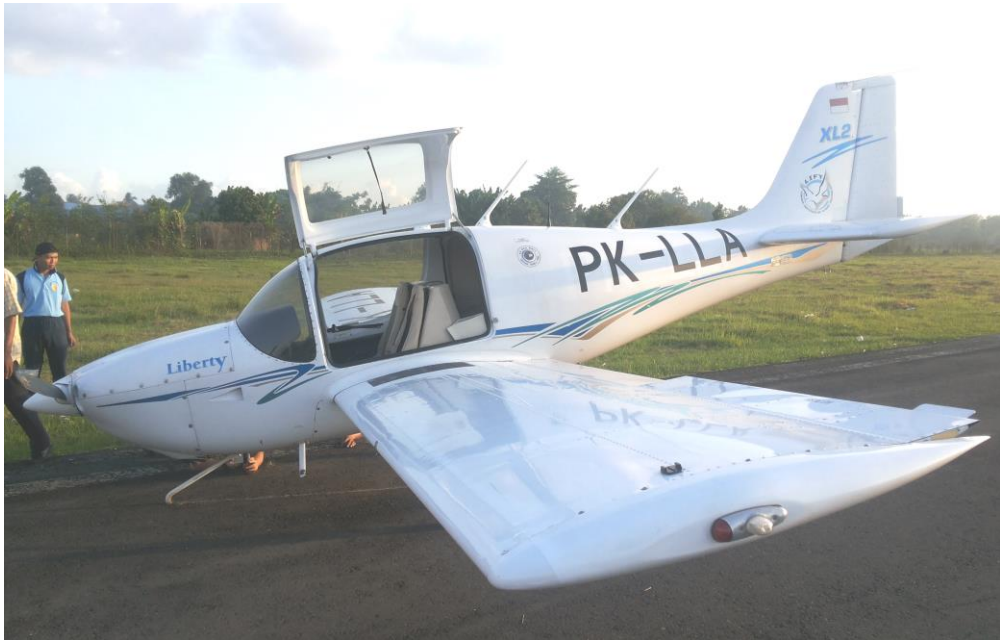
Figure 1: The aircraft was substantially damaged

The aircraft was substantially damaged as the result of the occurrence, and the damage were as follows:

- propeller blades bent;
- lower skin scratch;
- lower tail section scratch;
- left flap dent.

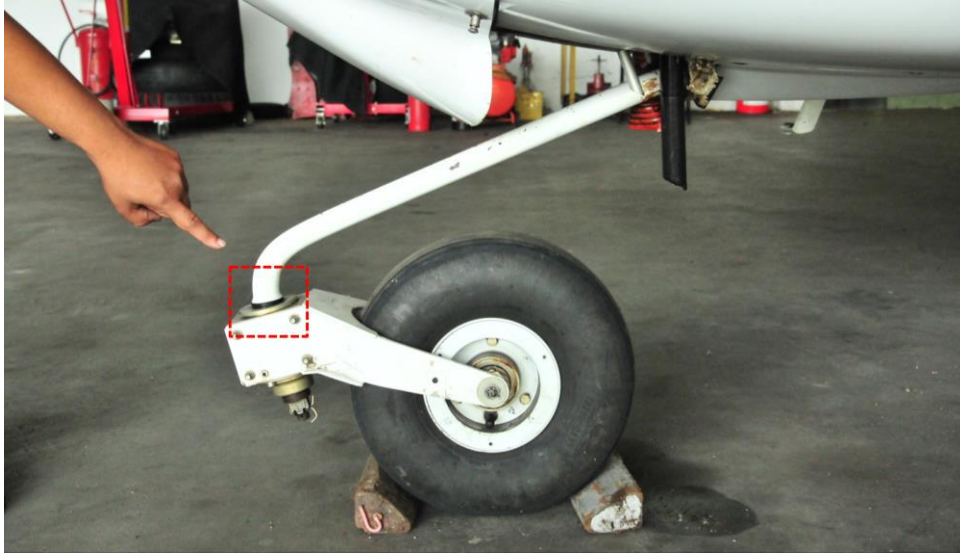
Figure 2: The location of collapsed strut using other aircraft

During the fourth touch-and-go, the nose wheel detached. The following figure showed the location of the broken nose landing gear (square red-dotted line) used other Liberty XL-2 aircraft.

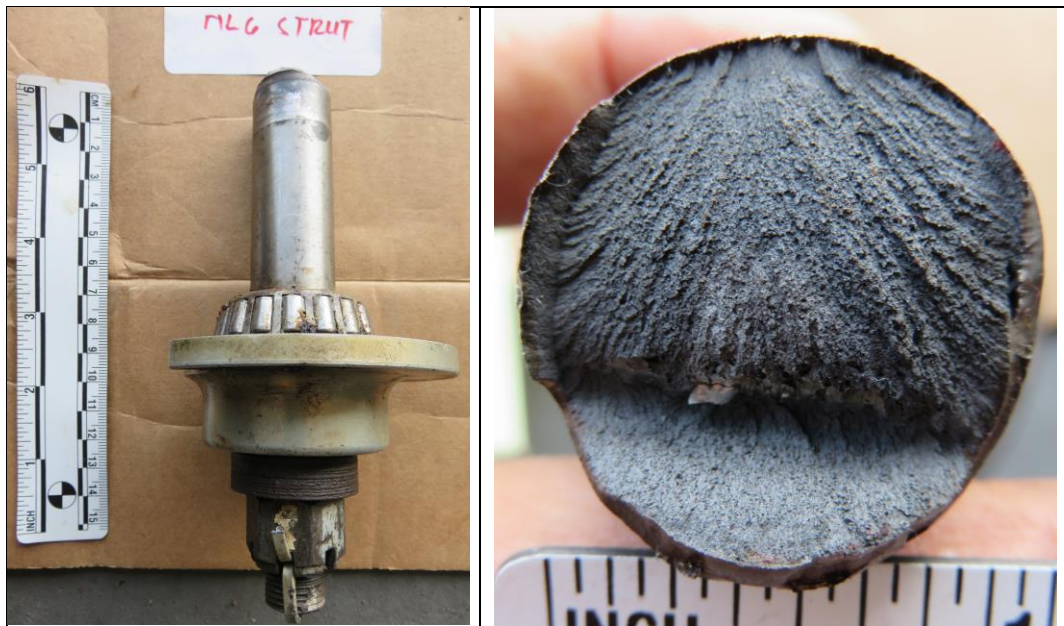
Figure 3: The collapsed nose landing gear strut (left) and its collapsed surface (right)

The aircraft landed runway 09 and veered to the right then stopped approximately 1,099 meters from beginning runway 09. The collapsed nose landing gear strut impacted with the runway surface and created scratch mark on the runway.

The examination of the nose landing gear assembly was performed by KNKT investigator in the LIFT facilities. The observation of the fracture surface indicated low cycle fatigue. This type of failure occurred due to excessive force. The observation of the fracture surface indicated that the nose landing gear collapsed due to excessive impact forces.

A pilot report after experiencing a hard landing may trigger aircraft engineer to inspect the aircraft landing gear strut. Crack on the nose landing gear strut can be detected by thorough inspection conducted by aircraft engineer.
