**KOMITE NASIONAL KESELAMATAN TRANSPORTASI  
REPUBLIC OF INDONESIA**

**Aircraft Serious Incident Investigation Report**

**Tecnam P2006T Aircraft; PK-LTK**

**Nusawiru Airport, Pangandaran, West Java**

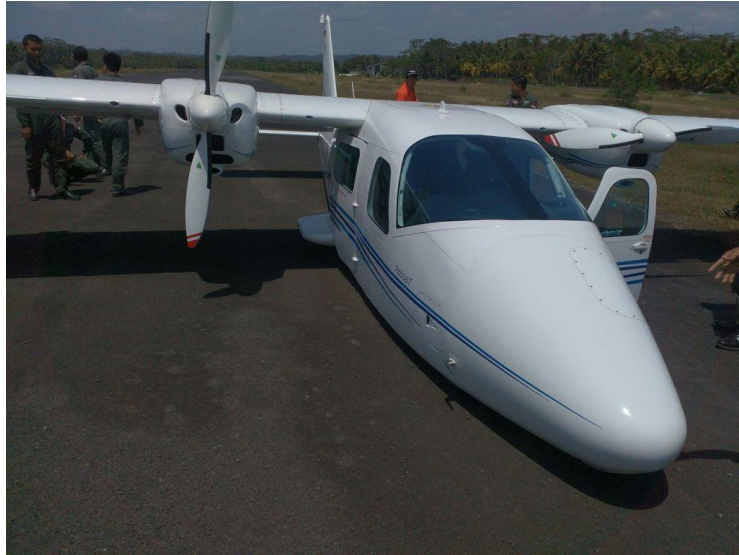
At 0316 UTC, the aircraft landed on runway 07 of Nusawiru Airport. After touchdown, the pilot informed to the AFIS personnel that the aircraft landing gear was not extended. The pilot did not recall activation warning. The pilot shut down engines and evacuated the aircraft. The aircraft stop about 400 meters from the touchdown point.

No one injured in this serious incident. The aircraft lower fuselage skin and the VOR/DME antenna damage.

**Figure 1: The aircraft position after the serious incident**

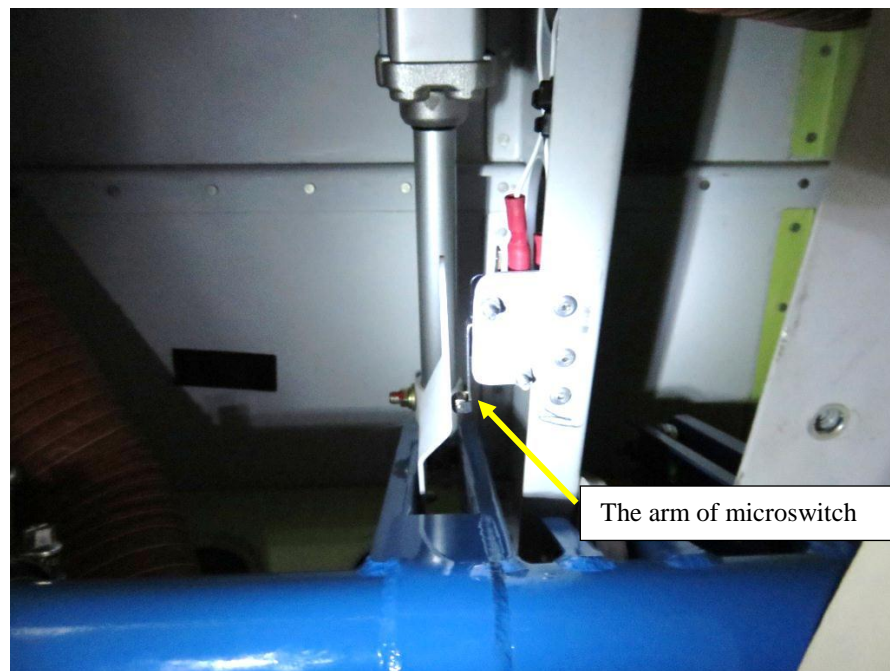
The sensor for the landing gear warning system which triggered by flap position used

a micro switch located on the upper side of the central cabin. Installation of this micro switch was not part of assembling process by MS Tech.

**Figure 2: Micro switch of the landing gear warning on the flap system**

The evidence showed that the landing gear handle was on UP position after the aircraft stop was consistent with the fact that the landing gear retracted during landing. The post occurrence test of landing gear warning system performed by the MS Tech engineer at Nusawiru found that the landing gear warning did not active when the flap full down and landing gear not extended.

10. The post occurrence landing gear warning system test found that the landing gear warning system did not active when the landing gear not down and lock with flap full down as stated in the aircraft flight manual.

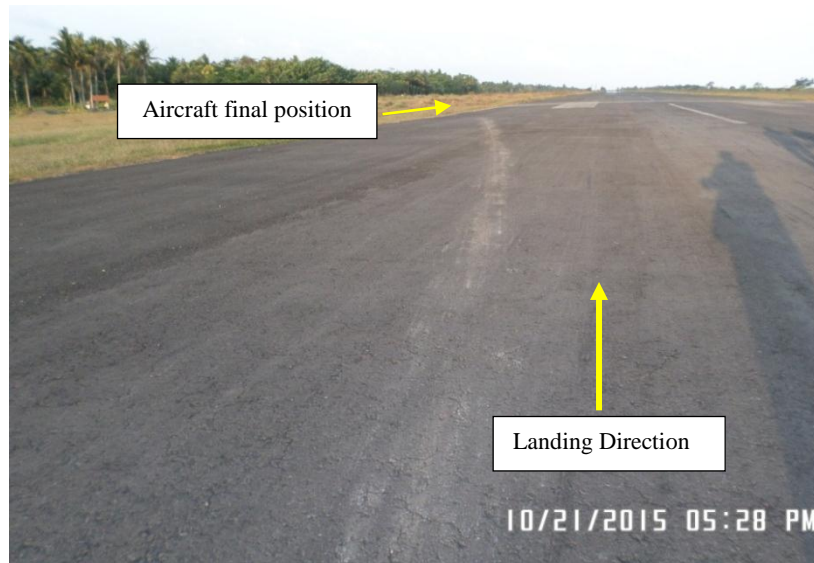
There was white mark on the runway surface indicating scratch mark of painted metal on the runway.

**Figure 3: Metal scratch mark on the runway**

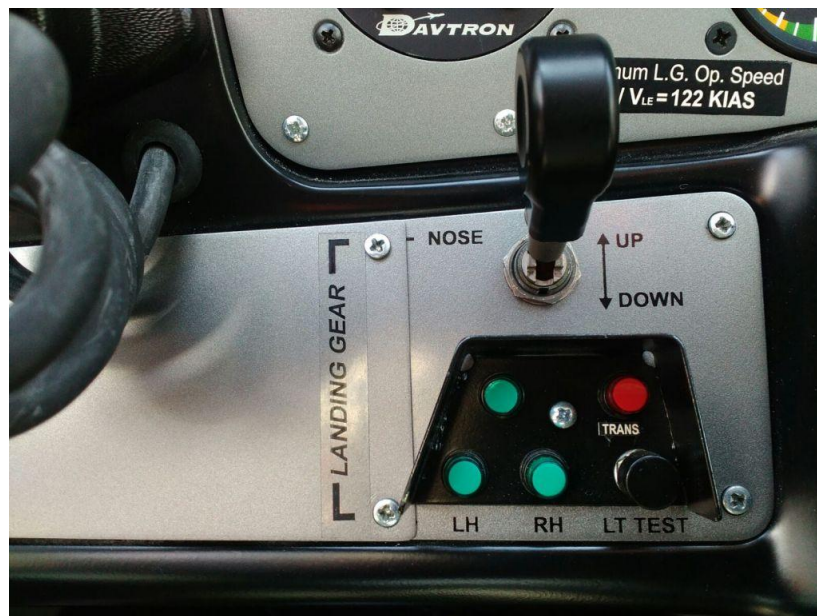
**Figure 4: The landing gear handle found at UP position**

Since the aircraft did not equipped with recorder, the investigation could not determine whether the checklist was read. Assumed that the checklist had been read, the evidence of the landing gear knob that was found at UP position was an indication of improper checklist execution.

8. The landing gear handle was found at UP position after the aircraft stop and the pilot stated that he did not recall any warning.
9. The evidence of the landing gear handle was on UP position indicated that the pilot did not perform the checklist appropriately
