PRELIMINARY
KNKT.15.10.25.04

Aircraft Serious Incident Investigation Report

**PT. Enggang Air Service
Cessna 208B Grand Caravan; PK-RSE
Sinak Airport, Papua
Republic of Indonesia
27 October 2015**

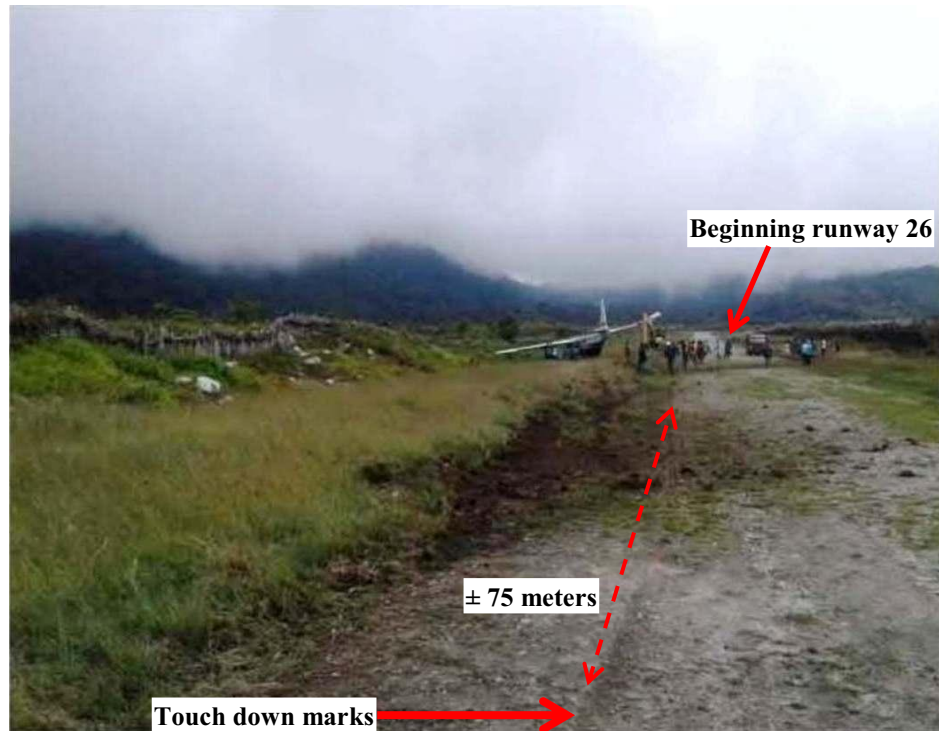
The aircraft landed at about 75 metres before beginning of runway 26 and veered to the left side. The aircraft stopped at about 10 meters on the left side of beginning runway 26.

Figure 1: The aircraft trail during landing roll

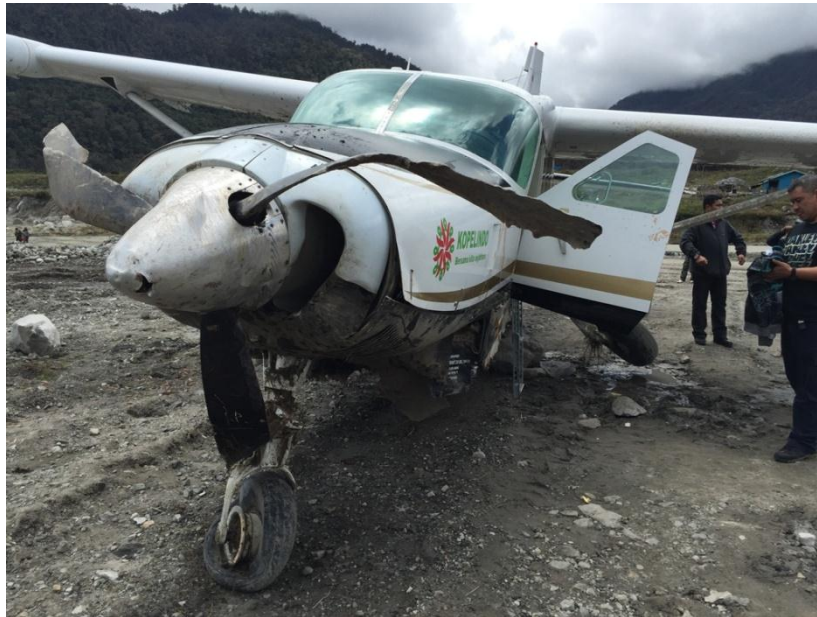
- Right outer wing bent upward and dented;
- Left landing gear shifted backward;
- Nose wheel burst;
- Propeller blades bent backward;
- Engine mounting strut bent;
- Lower nose cowling broken.

Figure 2: The damages to the aircraft

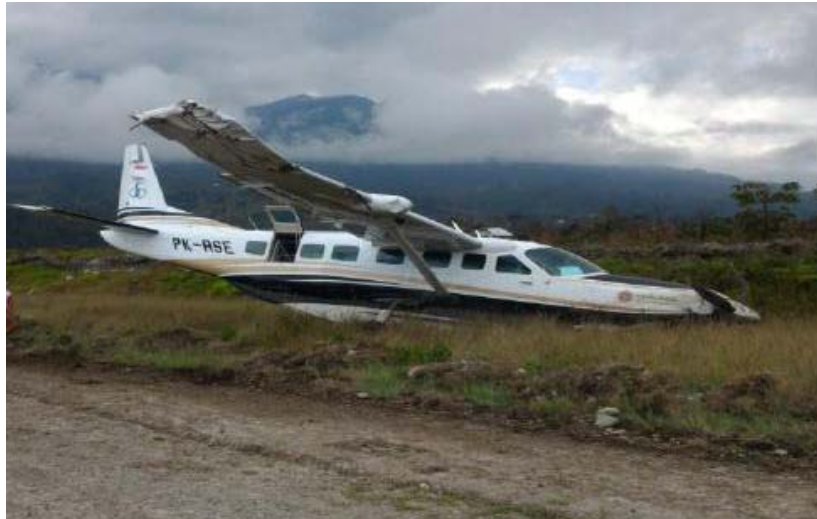
The aircraft touched the ground at about 75 meters before runway 26 then veered off to the left and stopped at 10 meters on the left side of beginning runway 26.

Figure 3: The aircraft final position

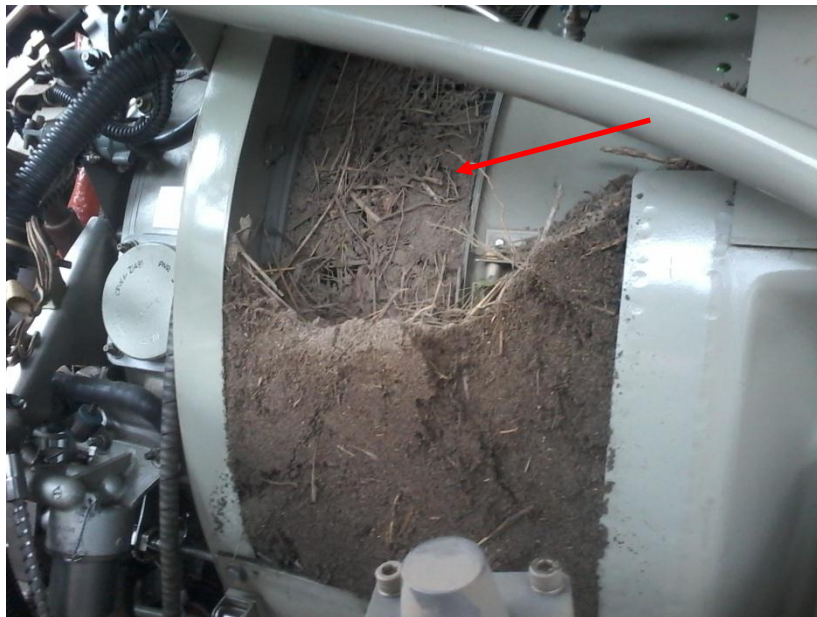
There were debris such as grass, small wood stalk, and mud was found on screen of the engine compressor air intake.

Figure 4: Debris on the screen of the engine compressor air intake

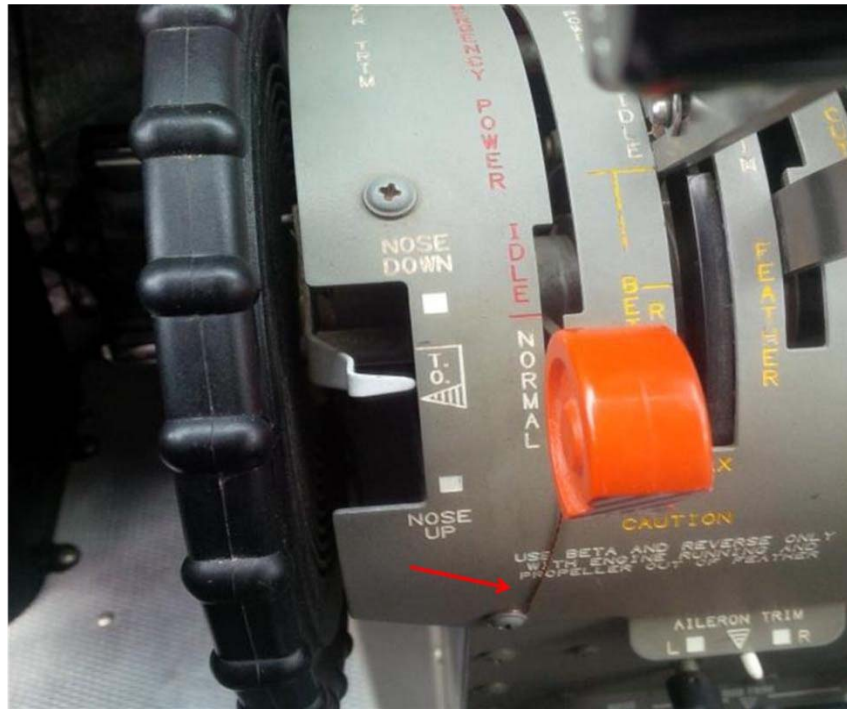
Figure 5: The emergency power lever safety wire found intact

12. The emergency power lever safety wire found intact.

To emphasize the pilot emergency training related to engine malfunction.
