**KOMITE NASIONAL KESELAMATAN TRANSPORTASI
REPUBLIC OF INDONESIA**

Aircraft Accident Investigation Report

Etihad Airways

Airbus A330 -243; A6-EYN

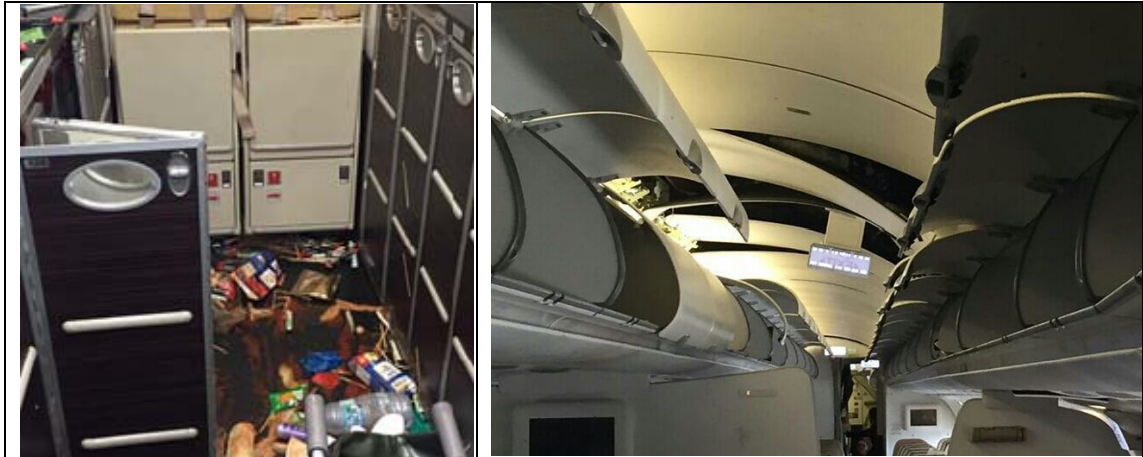
The aircraft had several interior parts damaged such as damage passenger service units and detached ceiling panels (figure 2). The damage of cabin ceilings occurred above seat 10H and the other damage were spread out in the aft cabin between seat rows 21 to 45 (figure 3). Several passenger oxygen containers were damaged and the oxygen mask dropped (figure 4).

Figure 2: Aft Cabin ceiling and mid galley condition after the severe turbulence

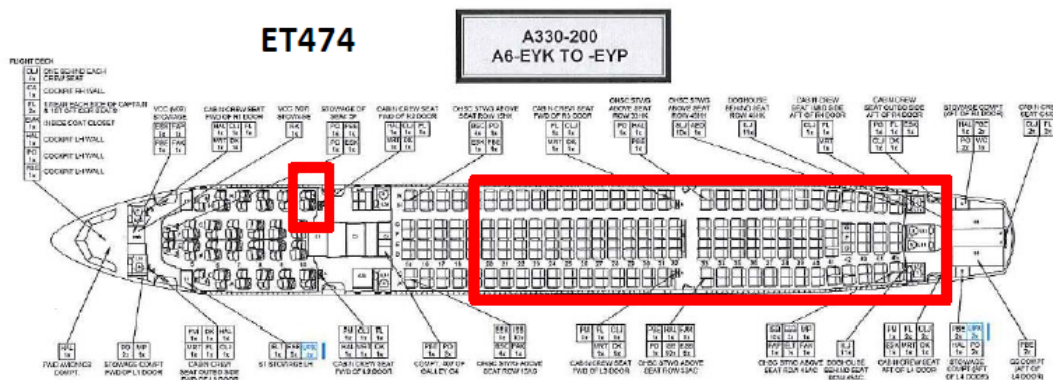
Figure 3: The area of the injured passenger seats and the damaged ceiling

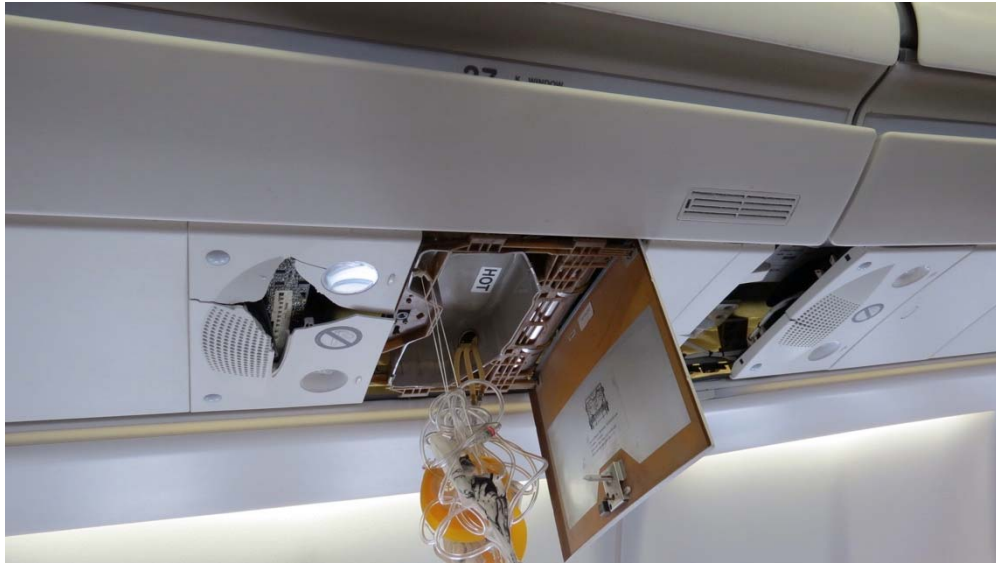
Figure 4: The damaged passenger service unit

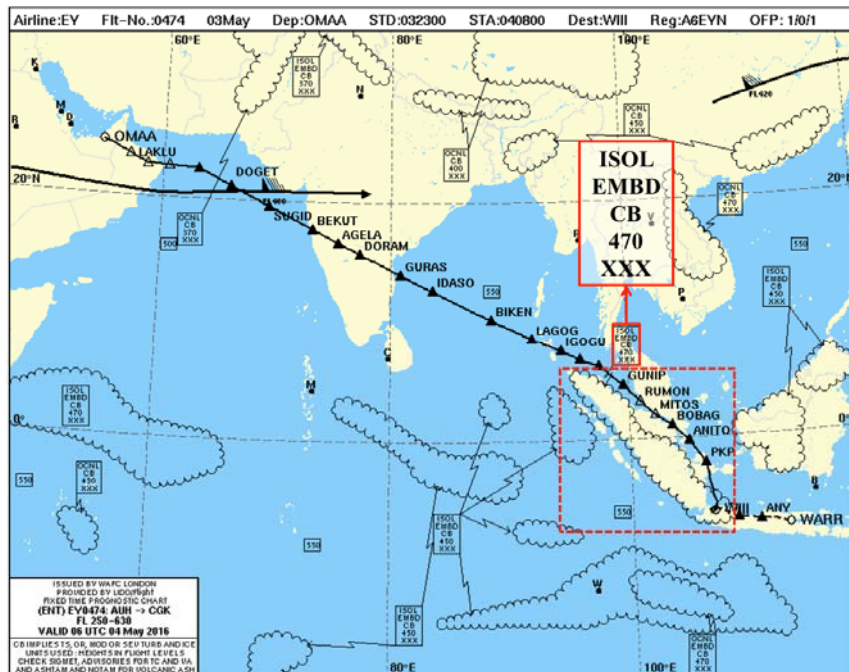
Figure 5: The prognosis chart which highlighted development of cumulonimbus clouds extending above FL470

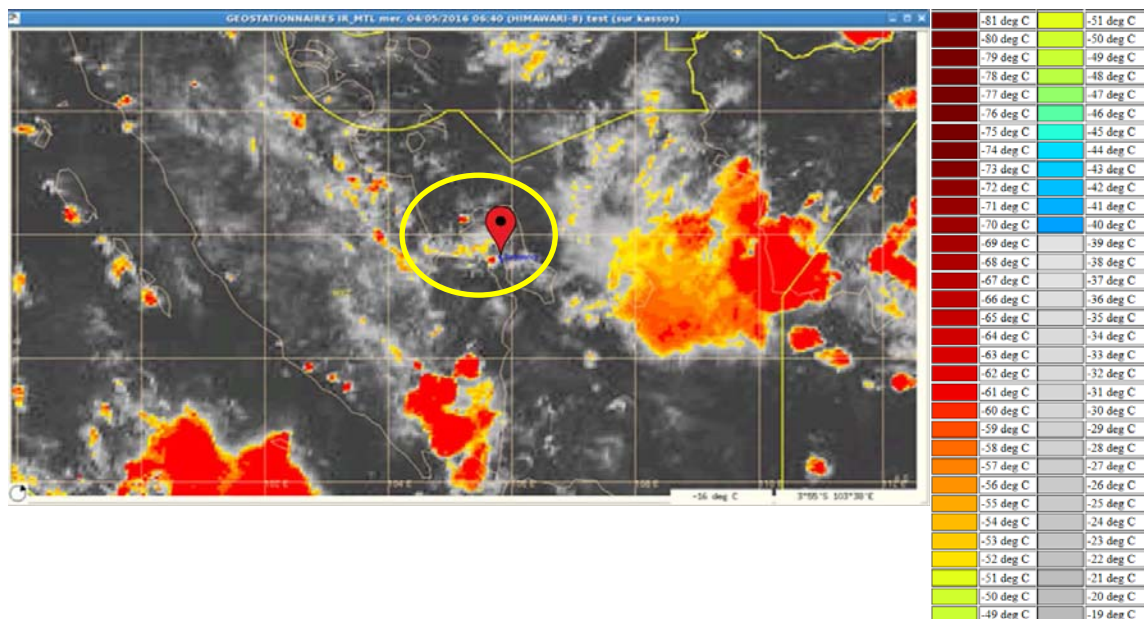
Figure 7: The Satellite weather image at 0640 UTC

The satellite weather image showed low temperature indicating the development of cumulonimbus clouds.

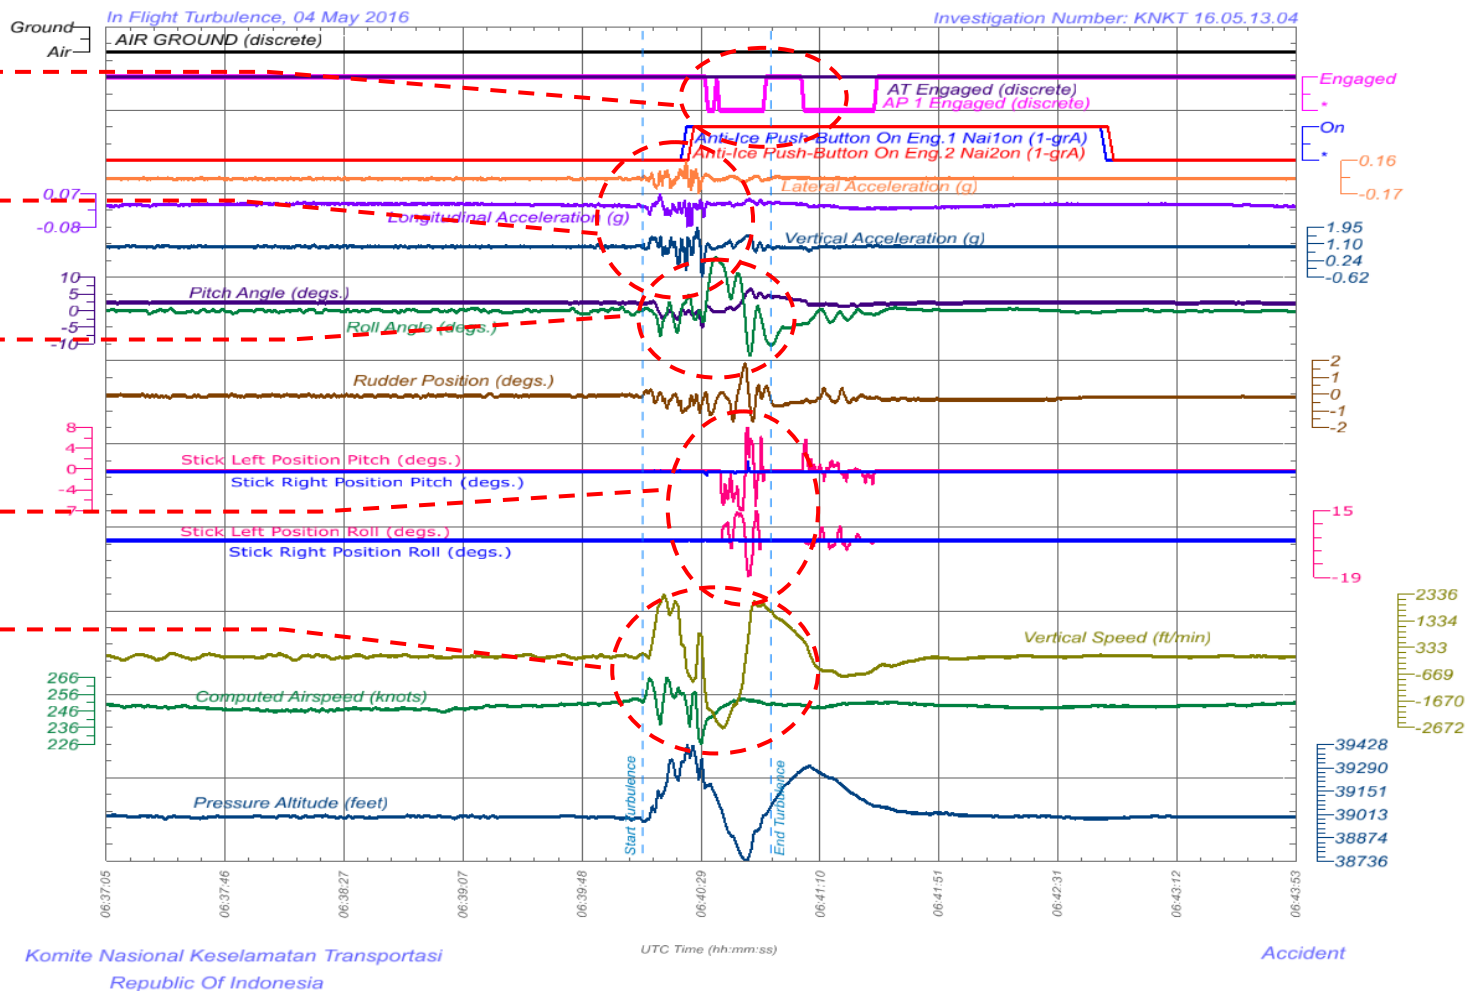
Figure 8: The related in turbulence flight data downloaded from FDR

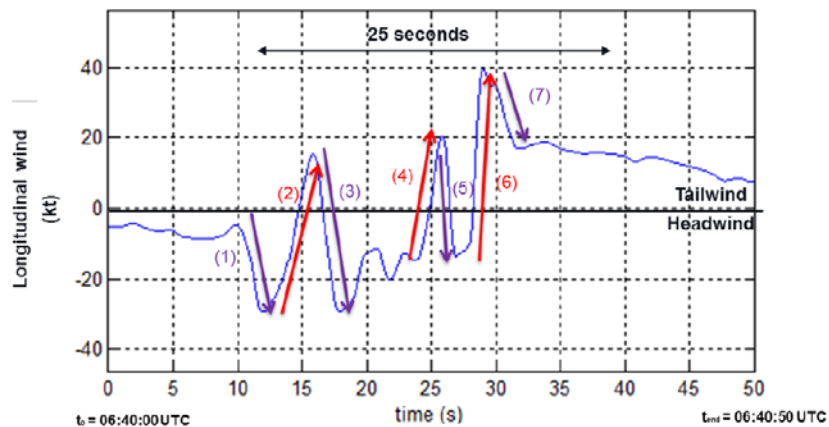
Figure 11: Longitudinal axis wind profile

- (11 knots/second).
- (2) The wind value of 29 knots headwind inverted to 15 knots tailwind in 4 seconds (11 knots/second).
- (3) The wind value of 15 knots tailwind inverted to 29 knots headwind in 2 seconds (22 knots/second).
- (4) The wind value of 14 knots headwind inverted to 21 knots tailwind in 2 seconds (18 knots/second).
- (5) The wind value of 21 knots tailwind inverted to 14 knots headwind in 1 second (35 knots/second).
- (6) The wind value of 10 knots headwind inverted to 39 knots tailwind in 1 second (49 knots/second).
- (7) The wind value of 35 knots tailwind decreased to 17 knots in 1.8 seconds (10 knots/second).

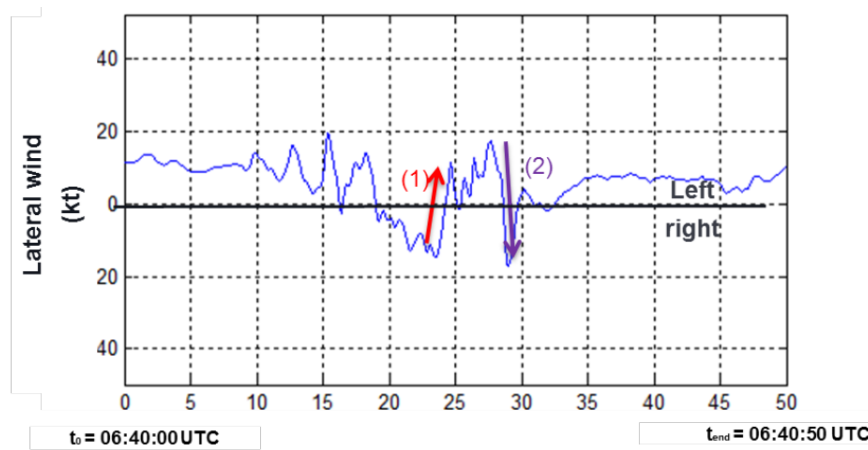
Figure 12: Lateral axis wind profile

- (1) The wind value of 15 knots from the right inverted to 12 knots from the left in 1.1 seconds (23 knots/second).
- (2) The wind value of 17 knots from the left inverted to 17 knots from the right in 1.2 seconds (28 knots/second).

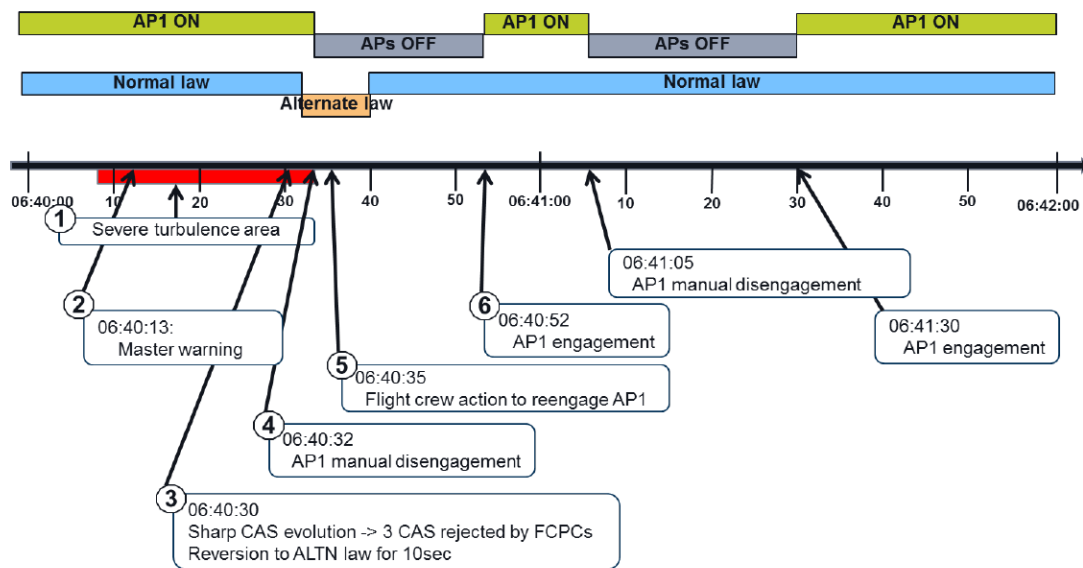
Figure 14: The events recorded during the turbulence

- At 06:40:13 UTC, most likely the master warning triggered by the aircraft speed when experience changed which caused by the change of wind during the turbulence.

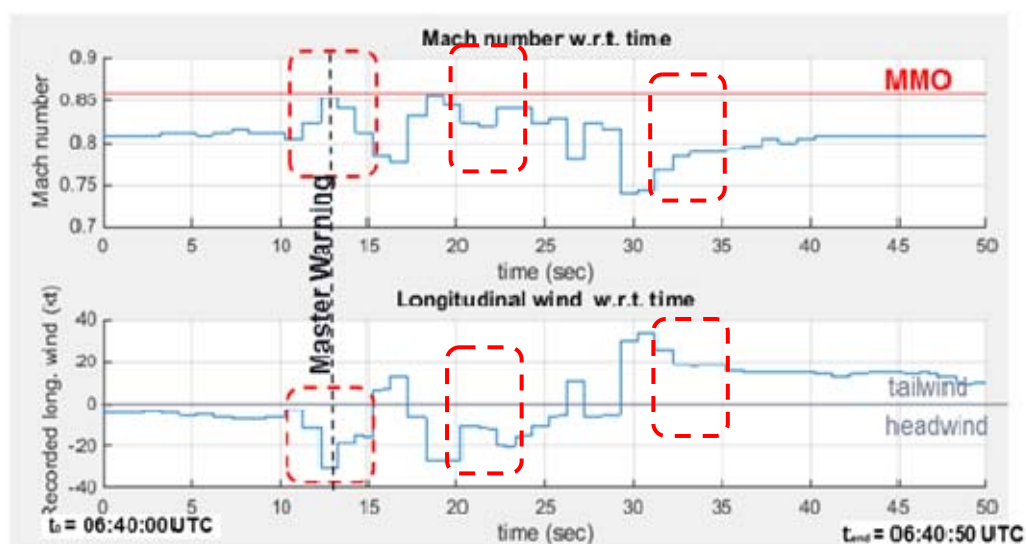
At 06:40:13 UTC, the AP1/ATHR was engaged and in Mach mode, with the speed was managed with target of 0.8 Mach. The FDR recorded the aircraft speed was 0.852 Mach (recording sampling rate was 1 pulse per second (pps)), the recalculated wind showed a 15 knots head wind gust (11 knots/second) then the Master Warning was recorded on FWC (recording sampling rate was 1 pps) while VMO/MMO warning was not recorded.

Figure 15: The aircraft speed and the rapid change of wind profile
